# *Excavation report of the VOC-ship Avondster (1659)*

The  
Anglo-Dutch  
East-Indiaman  
that was wrecked  
twice in Ceylon

# 1 *Avondster: an East-Indiaman in Asia*

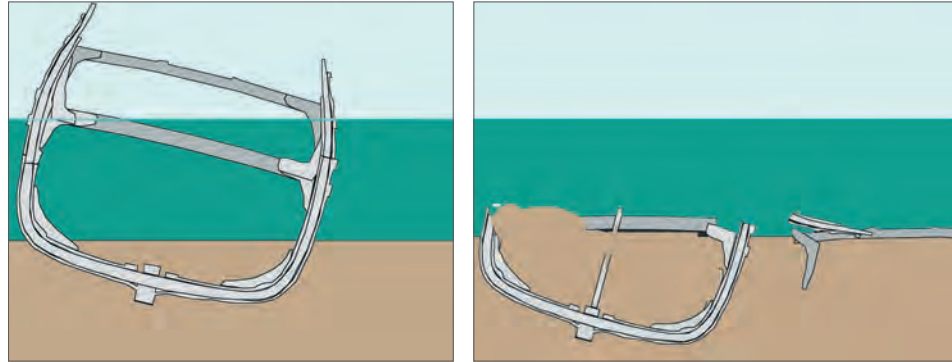
Figure 1.4 First speculative theory for the wreck formation of the Avondster site.

Based on the early surveys and an understanding of conditions on the site in July during the SW monsoon (the season the *Avondster* wrecked), the following speculative theory was developed for the formation of the *Avondster* wreck (Figure 1.4 ):

*The Avondster has been stranded (left): sand flows in through the open back of the ship, the ship submerges quickly in the soft sediment near the outlet of the river. (right) The superstructure of the ship breaks off in the swell, parts of the upper deck stay together*

*Following this reconstruction of the wreck formation process it is possible that the loss of the sternpost and the later collapsing superstructure was the 'immediate break up' of the vessel stated in the account. It is even possible that Adriaan van der Meijden felt that his lack of or failed attempts to salvage goods from the wreck could be best explained by an account stating that the ship broke up immediately when grounded. Indeed it must have been a very difficult task to reach the stranded ship in the SW monsoon. However from the archaeological evidence we know that it is likely that locals have tried to salvage goods from the hold of the ship. In 1999 human remains were found underneath a deck in the stern section. Since no casualties were reported during the disaster and the skull was identified from a male of Asian descent, it is possible that this person died in an attempt to salvage goods. This would mean that the hold of the vessel was still intact after the wrecking and the hypothesis for the wreck forming process could be possible. This hypothesis was also subject to further investigations during the archaeological work on the wreck.*

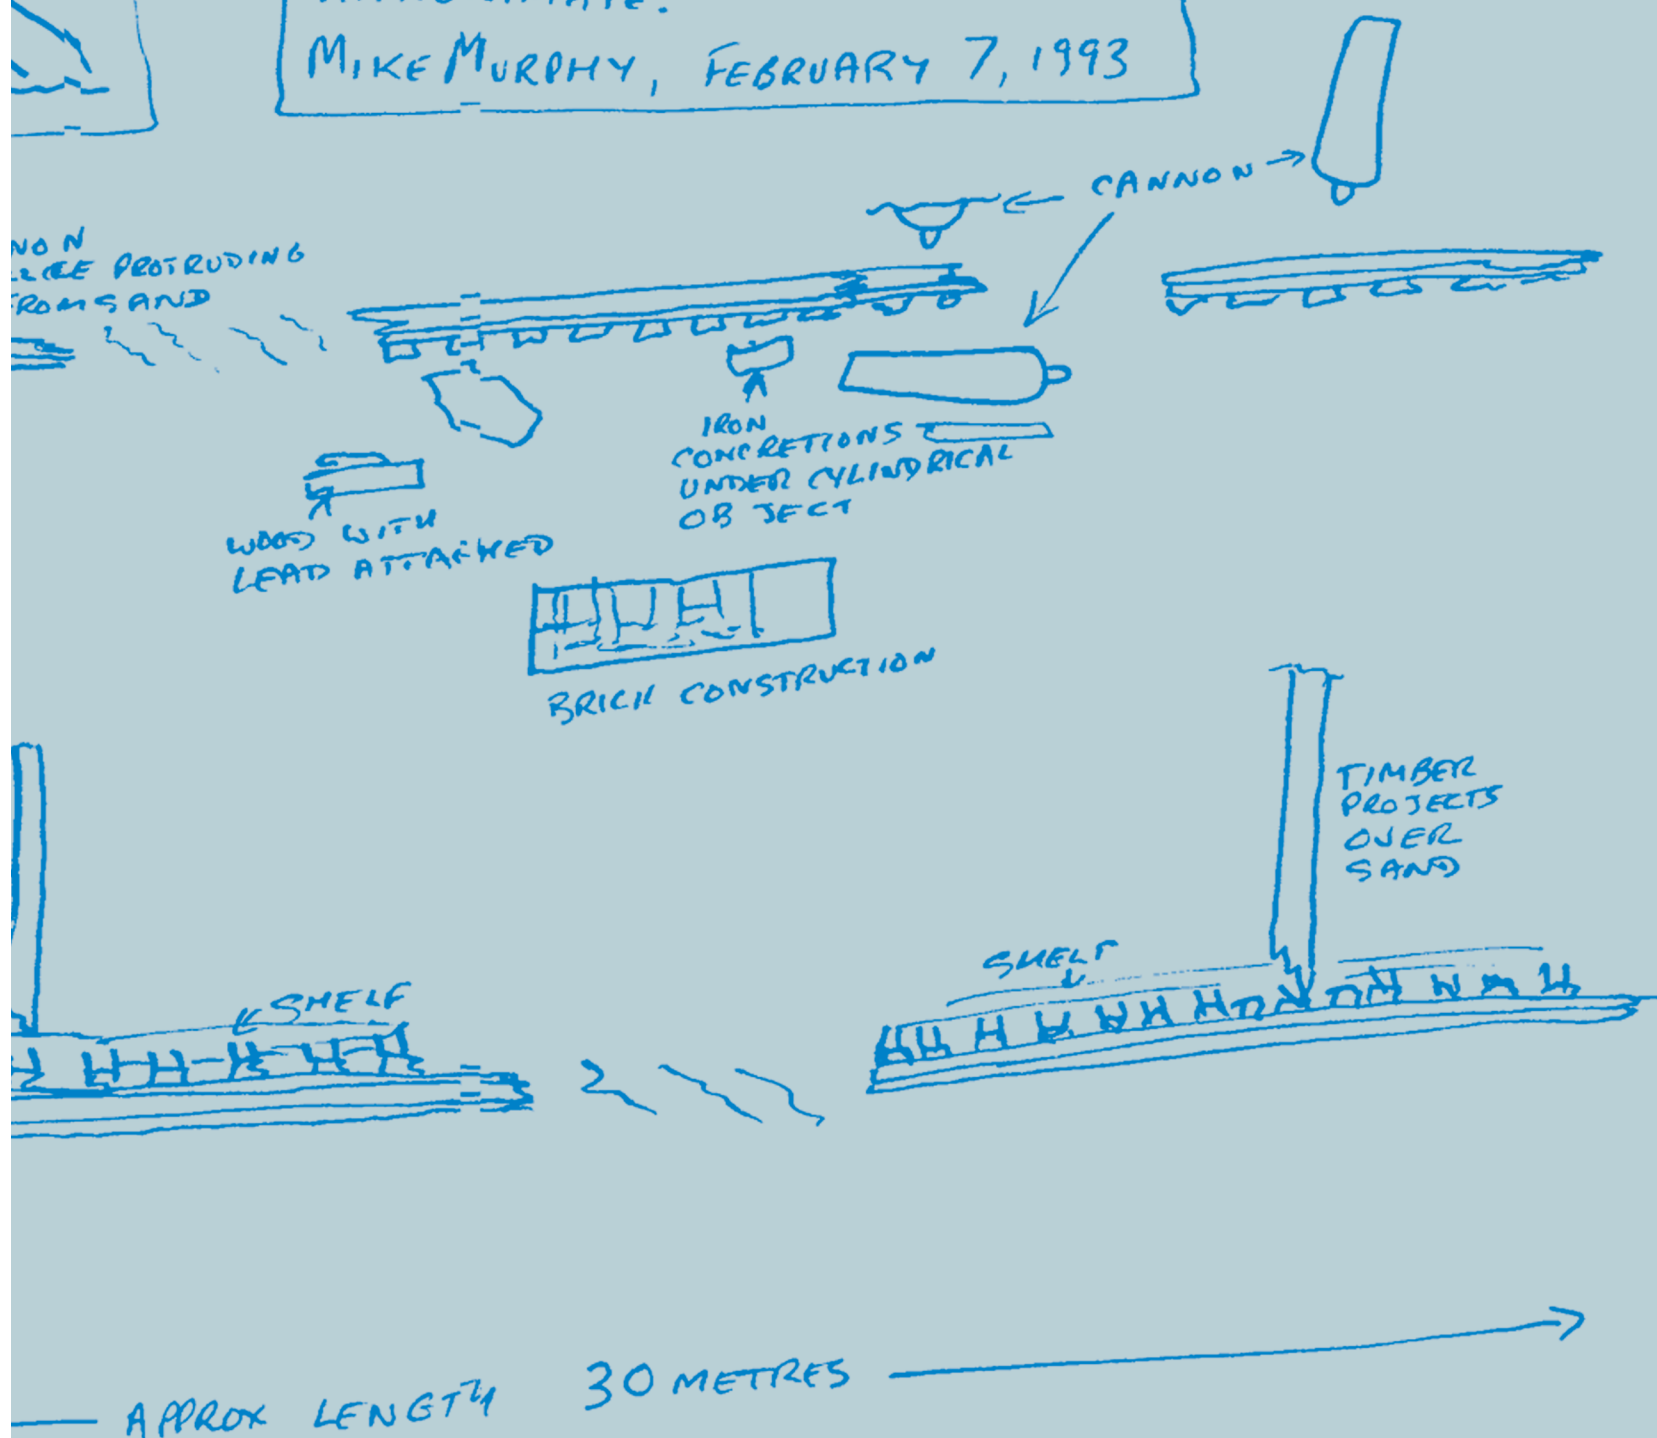
Figure 2.1 Sketch site K [sic] the Avondster site in 1993 drawing M. Murphy

WOODEN WRECK SITE K  
GALLE HARBOUR, SRI LANKA  
INITIAL SKETCH. MEASUREMENTS  
AND RELATIVE POSITIONS  
APPROXIMATE.

MIKE MURPHY, FEBRUARY 7, 1993

After the location and identification of the wreck of the Avondster in 1993 the site was again surveyed in 1996 and in 1997. The focus of the latter surveys was undertake a comprehensive assessment of the site, and compare to the initial sketch and description of the site in 1993 (Figure 2.1)

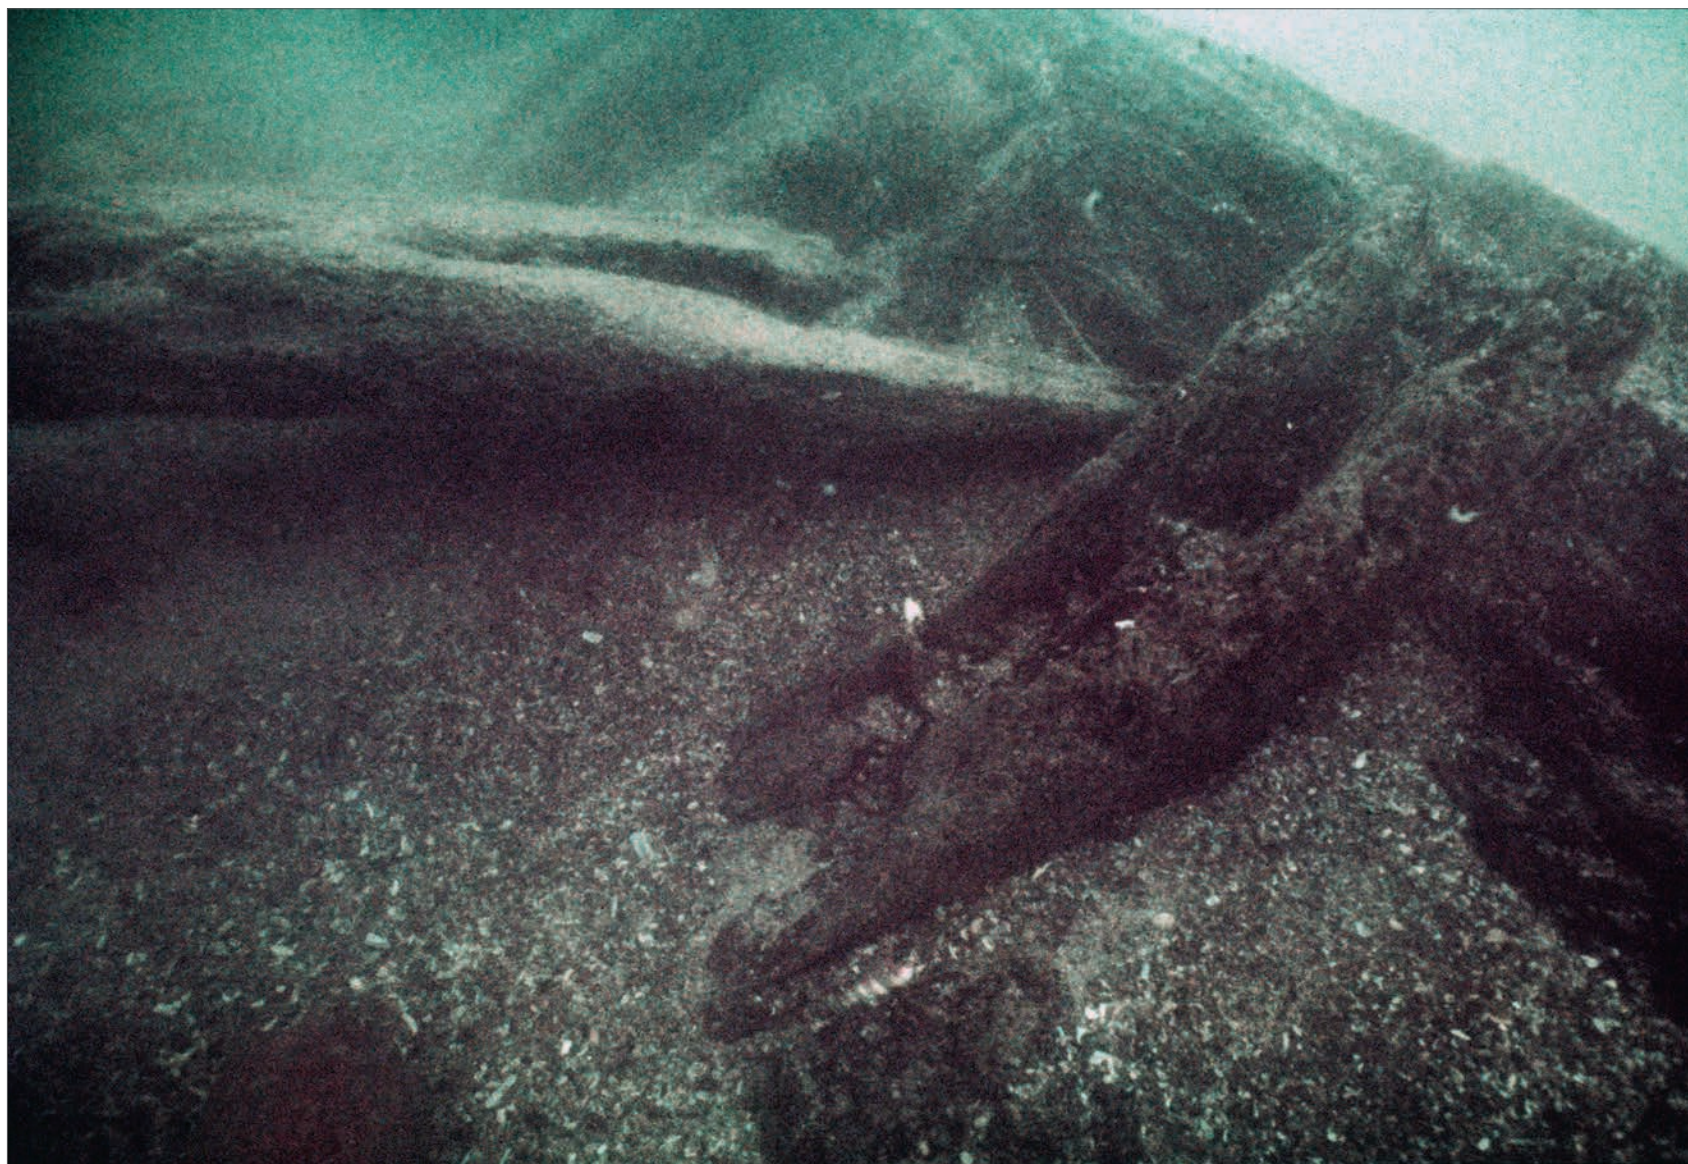
*Figure 3.3: A deck beam and frames on the starboard side of the vessel*

It was known that the wreck heeled on the starboard side towards the shore. The presence of the galley (Figure 3.2), supported by deck beams which run towards the remains of knees on the starboard side, indicated that the uppermost part of the wreck was most likely the remains of the main deck. (Figure 3.3) On the north side of the ship, between the bow section and middle of the ship, five were evident, all with the same orientation (330°), possibly the remains of deck beams. This may indicate that part of the orlop deck –the first deck that completely covers the vessel- (or the deck above it) became separated from the main ship whilst on the seabed. This suggestion is supported by the presence of objects and concretions washed shoreward. Plans for future investigations included a detailed survey of this area. A typical concretion in the form of three or four iron fittings for the rigging (possible a channel) can be seen 8 m north of the main structure. Another potentially important area that required detailed investigation was the area between the main ship structure and the separate stern section. Historical records indicate that the stern section broke away from the rest of the hull during the wrecking process. This was evidenced by the location of the sternpost, along with the under part of the stern section including a deck beam and a possible knee, resting southeast of the main structure.

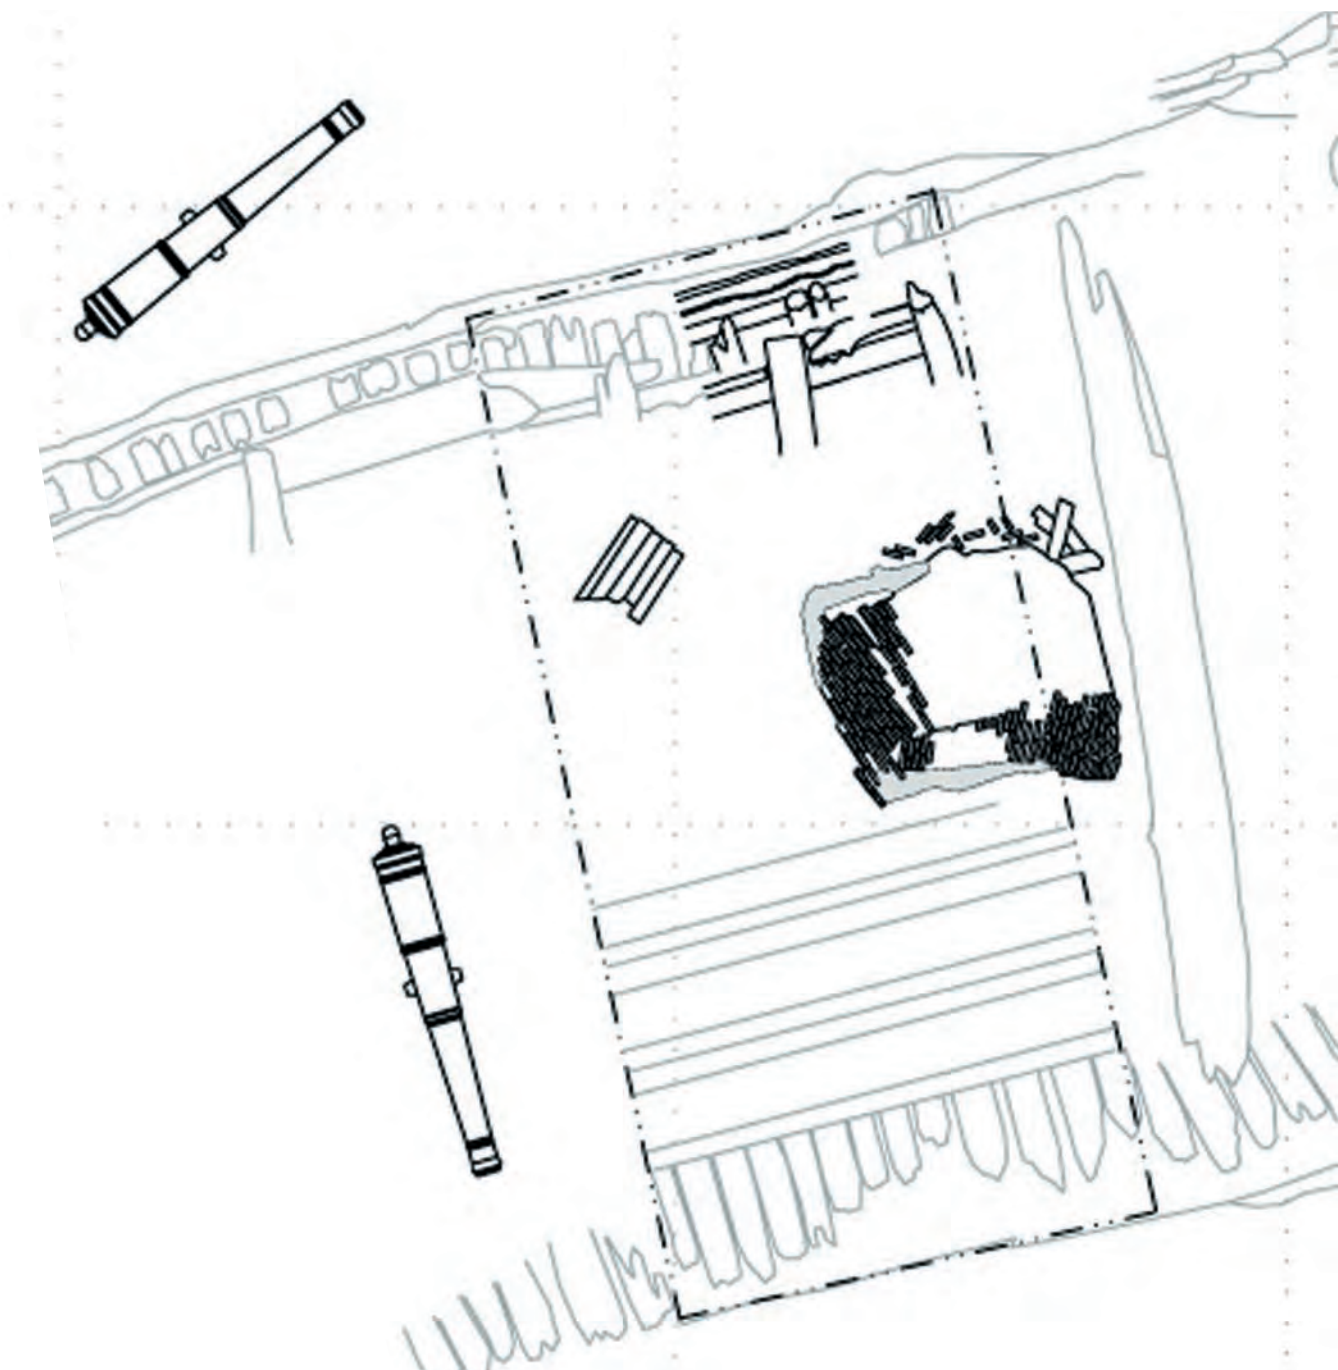
Figure 3.10: Site plan showing midship trench

Beginning in March 2002, excavation was implemented in a 4 m wide (athwart-ships) midship trench. This excavation continued through to April 2004, in conjunction with a number of other activities. An aluminium pole placed in a horizontal manner just forward of the galley was used as a control in measuring the depths of the layers, artefacts and ship's structure during the excavation of the midship trench.

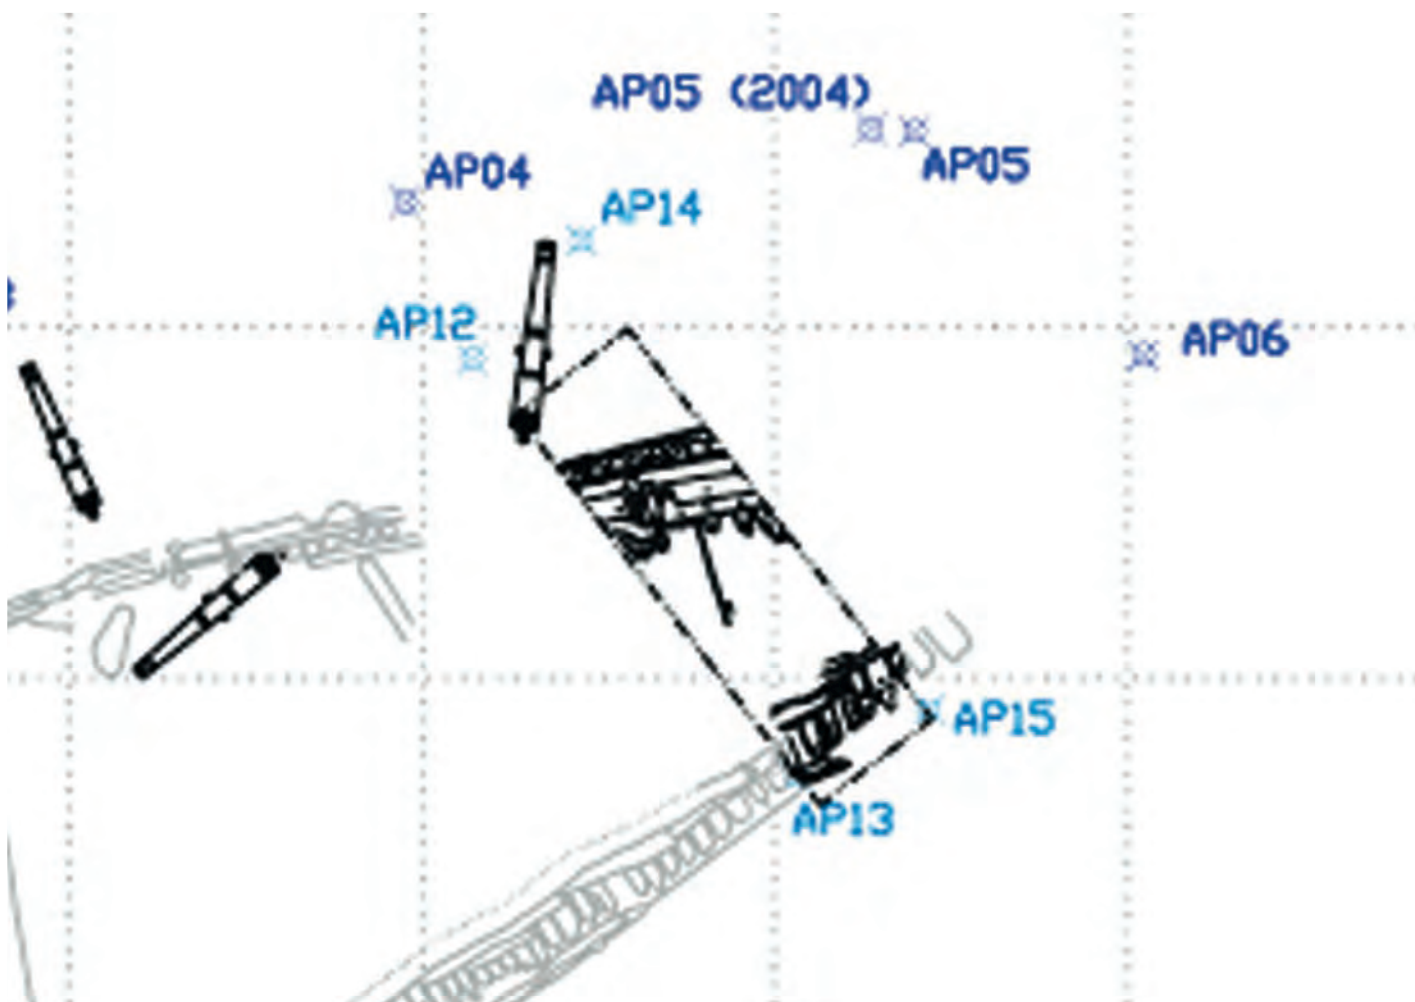
Figure 3.12: Site plan showing location of stern trench

The excavation of a stern trench was carried out in November/December 2004 after an assessment the previous year of the most appropriate area. A bulkhead and part of an upper deck on the starboard side, and what looked like a keelson on the port side, had been observed and the trench was laid out to include these features. In November 2004 it was found that up to 1 m of sand had moved onto the site, making the exact definition of the trench in relation to the permanent survey points difficult. A 2-m-wide trench athwartships was established which ran approximately from the starboard side hull survey points 14 and 15 to 18 and 19 on the port side.

The trench was delineated with two horizontal aluminium poles, one being used as the datum for measuring depths from using Site Surveyor/Recorder software. . Layers of 'sterile' sediments (sediment that had moved onto the site from November 2003 to November 2004 and therefore were considered sterile of *Avondster* structure and associated artefacts) were removed over the whole trench, until structure was encountered on the starboard side.

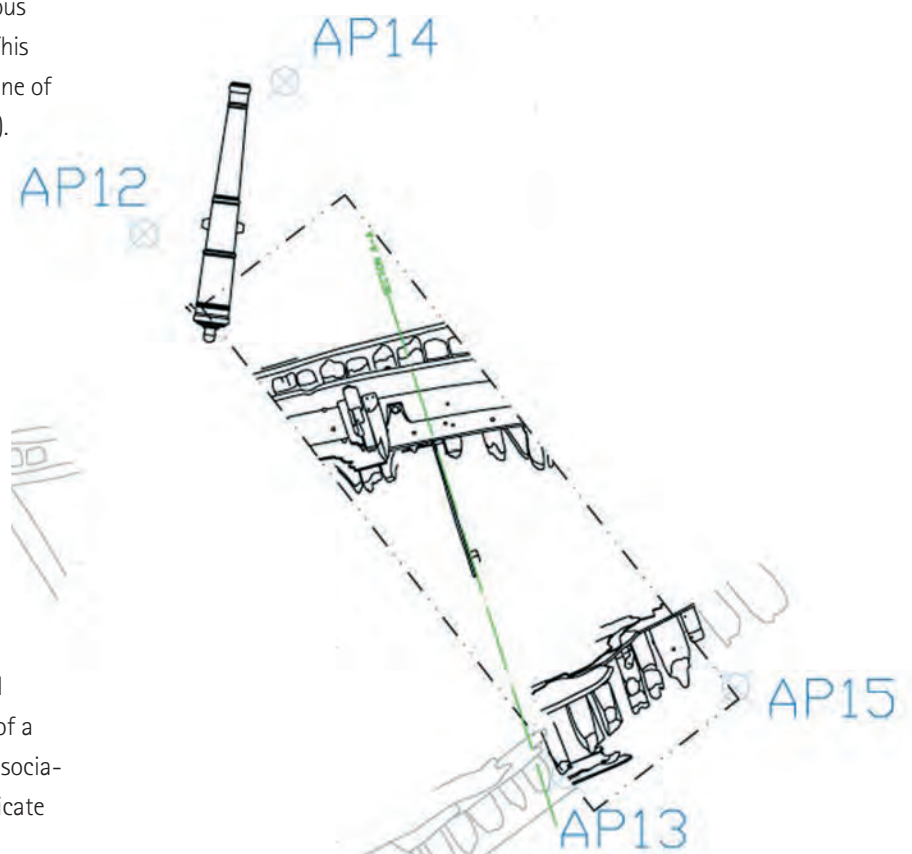
Figure 3.18: The stern trench showing the ship's structure

The excavation continued from the starboard side of the vessel where degraded frames, outside and ceiling planking of the hull were uncovered and as it moved into the vessel, deck planking and deck beams were uncovered and recorded in three dimensions. Artefacts such as rope, medicine jars (Figure 3.13), an intact brown earthenware pot (Figure 3.14), a beardman jug, pulley sheave and musket balls were located on the deck planking and concentrated up against the starboard ceiling planking (indicative of the vessel listing over on its starboard side). Further aft, along the edge of this deck/ceiling planking, a rectangular wooden container was encountered with leather straps that secured the box and its contents (Figures 3.15 & 3.16).

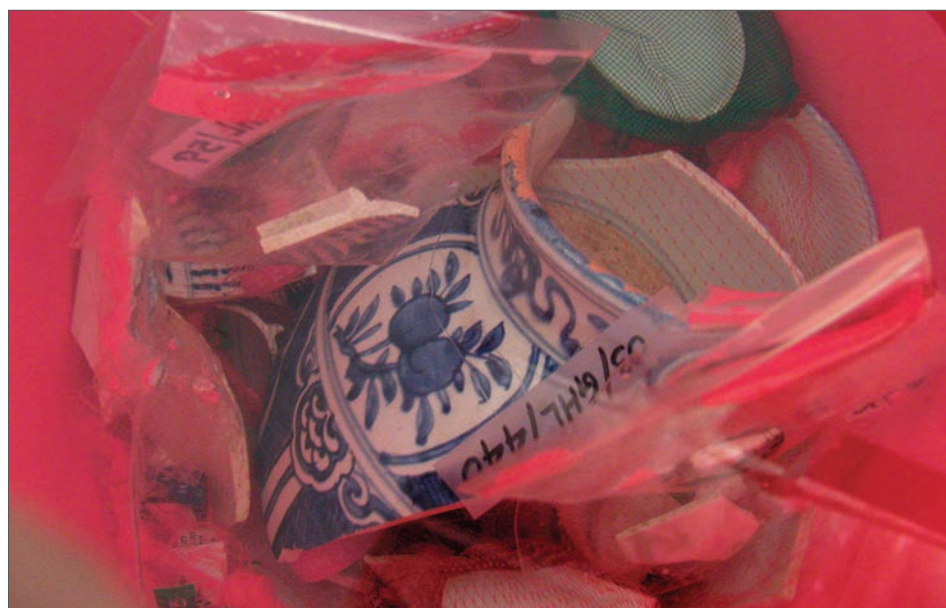
Figure 4.5 Desalination of ceramic artefacts

Marine encrustations were removed mechanically, using wooden sticks and dental picks. The shards were desalinated in baths of fresh water, while the chloride levels were monitored. The shards were removed and air-dried in 2002 when no chlorides were detected in the desalination baths.

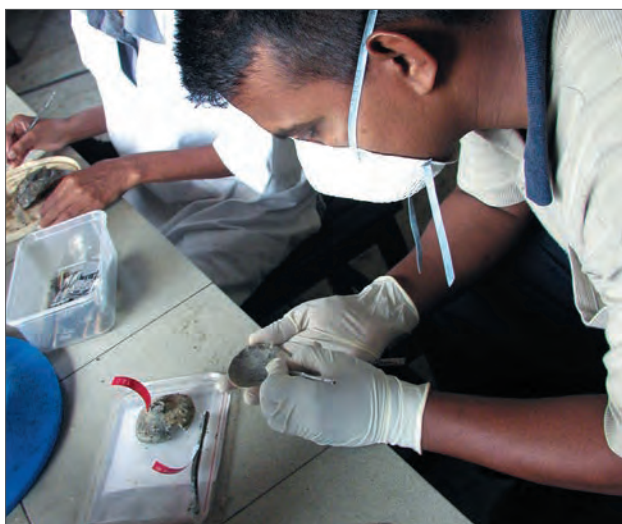
Figure 4.6 Mechanical cleaning of pewter spoon (03/GHL/234)

The protective layer of corrosion and concretion on the spoons were removed by a combination of mechanical and chemical methods. Initial cleaning was carried out with a scalpel and dental picks, taking care not to damage the very soft metal. The artefacts were further treated with alkaline dithionite, a chemical that desalinates as well as removes the remaining concretion and corrosion products. Artefacts were placed in a solution of sodium hydroxide (2%) /sodium dithionite (2%) in tap water. As sodium dithionite oxidises in contact with air, the container must be airtight for the solution to remain effective; a well-sealed lid or layer of paraffin on the solution surface is usually sufficient. After two weeks, the reduced black corrosive products that had formed on the object were removed by brushing the surface with a detergent and fine abrasive powder. Finally, the cleaned and dried metal surface was protected with a coating of 'Becketts Archival Ferrous Polish' (microcrystalline wax in white

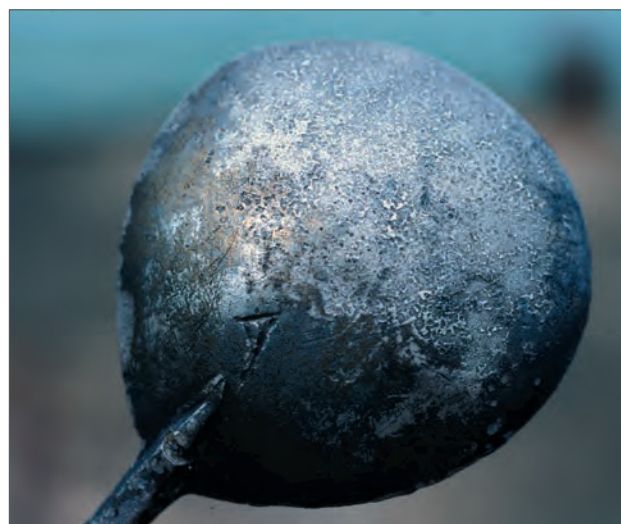
Figure 4.7 Pewter spoon, showing the maker's mark. (03/GHL/234)

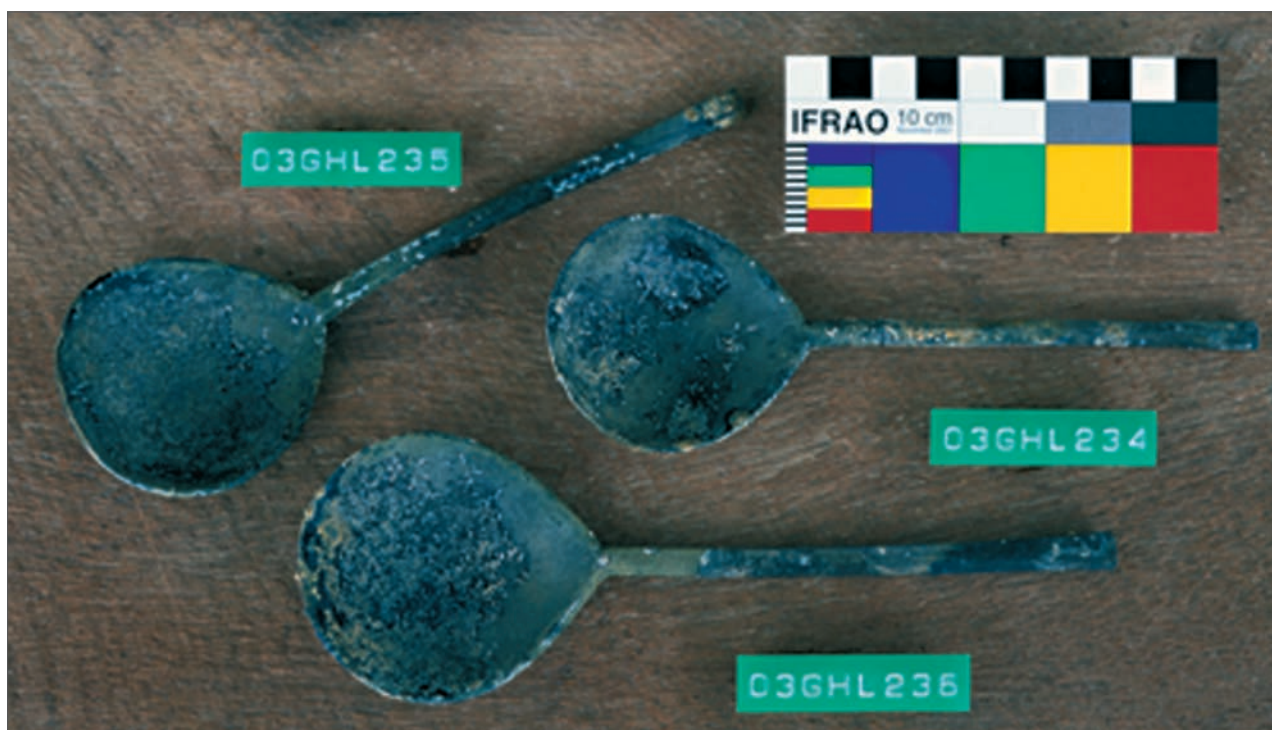
Figure 4.8 Pewter spoon after treatment (03/GHL/234)

spirits). After polishing and applying a wax layer the metal surface was left with a slight shine. The labelled artefacts were stored in well-sealed polypropylene plastic containers that helped to protect the conserved items from organic acid vapours present in the existing storage environment.

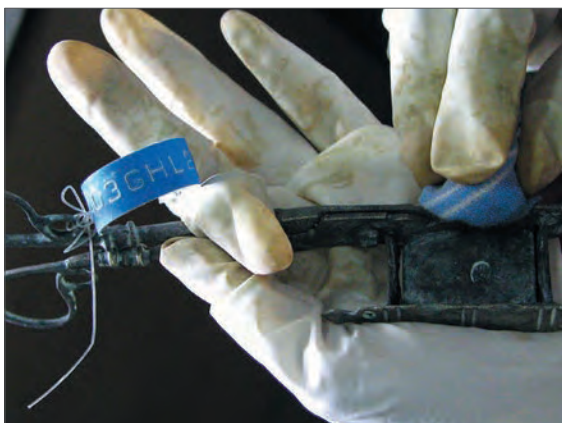
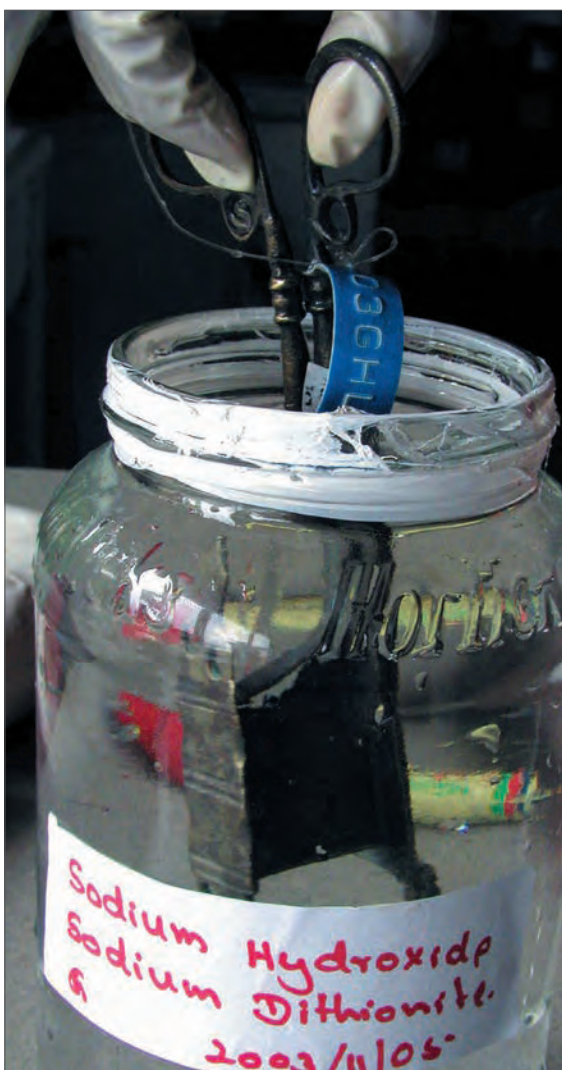
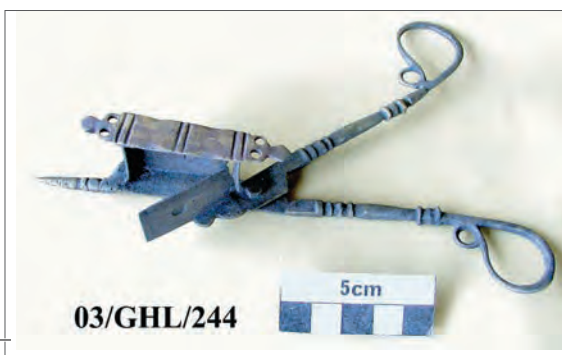
Figure 4.9 (a-d) Candle snuffer (03/GHL/244), Under water and stages of treatment(

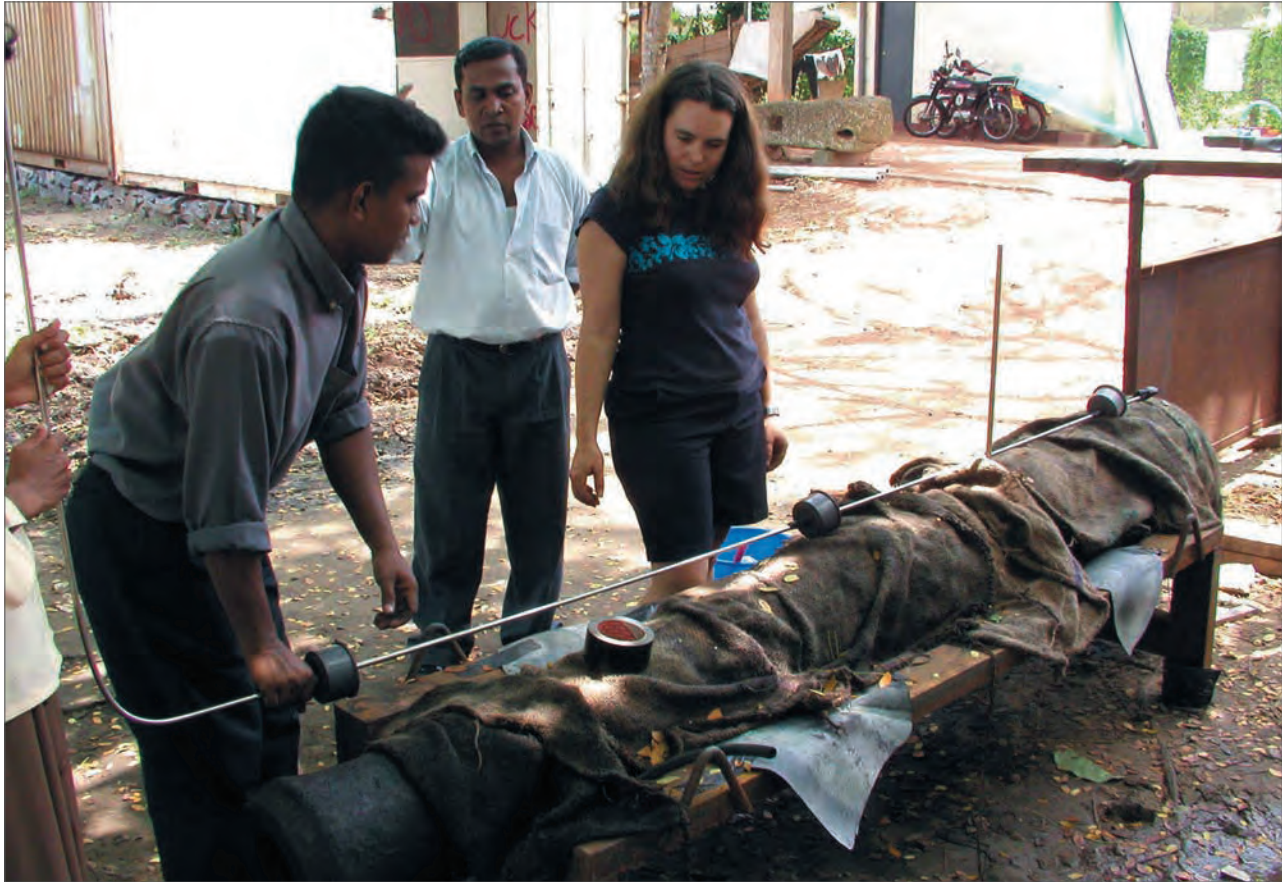
Figure 4.16 Placing the cannon on cradle and internal anodes for the electrolysis treatment of the cannon (02/GHL/175)

When establishing electrolysis treatment, good electrical contact between the artefact and the power supply is essential. As the outer corrosion layers are not very conductive, holes were drilled into both the cannon and the anchor until the metallic core was reached. Threads were cut into the holes and stainless steel cathode rods were threaded and screwed into place. The cathode rods were connected to transformers located inside the air-conditioned area of the MAU.

The initial applied voltage was 1V, increased to 2V after 2 days. The low voltage level ensures that hydrogen evolution is kept to a minimum, as strong bubbling can worsen any cracks present in the artefacts. Samples of the electrolyte (2% sodium hydroxide) taken immediately before electrolysis and after 8 days showed a sharp rise in chloride levels, indicating the increased efficiency of chloride extraction with electrolysis treatment.

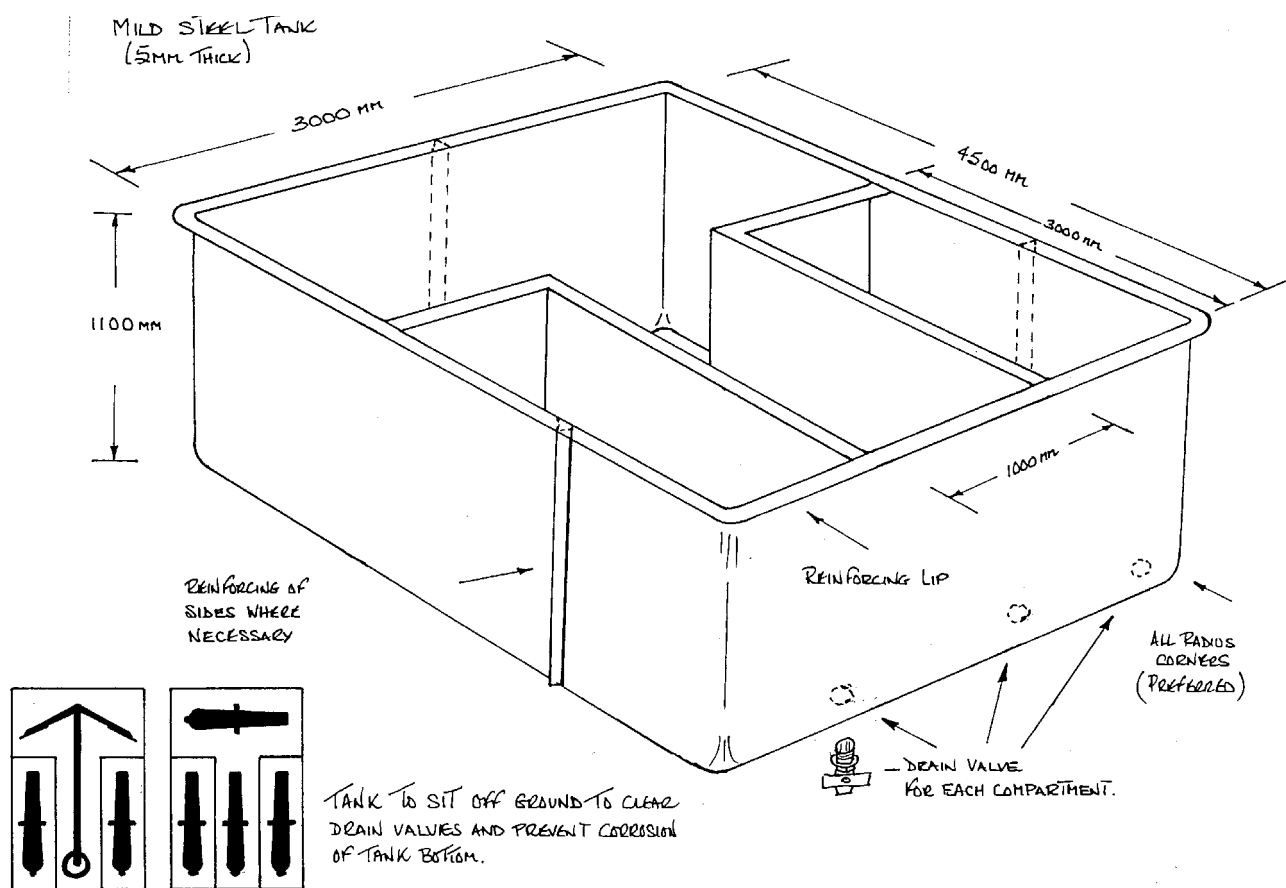
Figure 4.15 Design of steel tank for treatment of the cannon and anchor

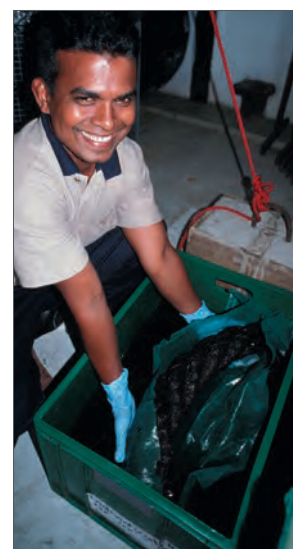
*Figure 4.16 Rope undergoing treatment with 'PEG 400'*

Many pieces of rope were recovered, including a coil of cable laid rope (02/GHL/165), thought to be about 62m long. The rope was cleaned of soil and marine deposits by careful brushing and smaller sections of rope were then supported, by sewing them into a mesh "sausage" to prevent them from becoming entangled and to prevent loss of fibres during treatment. All rope was treated by immersion in an aqueous solution containing polyethylene glycol 400 (10% PEG 400) and ethulose (1%) with boric acid (1.4%) and borax (0.6%) present as a biocide. The duration of treatment, generally one to two months, depended on the size and condition of the rope. Although vacuum freeze-drying is the preferred drying method for treated rope, the best method available at the MAU was slow air-drying in a perforated plastic container. Other drying options typically used include slow drying at reduced temperatures in either a freezer or refrigerator.

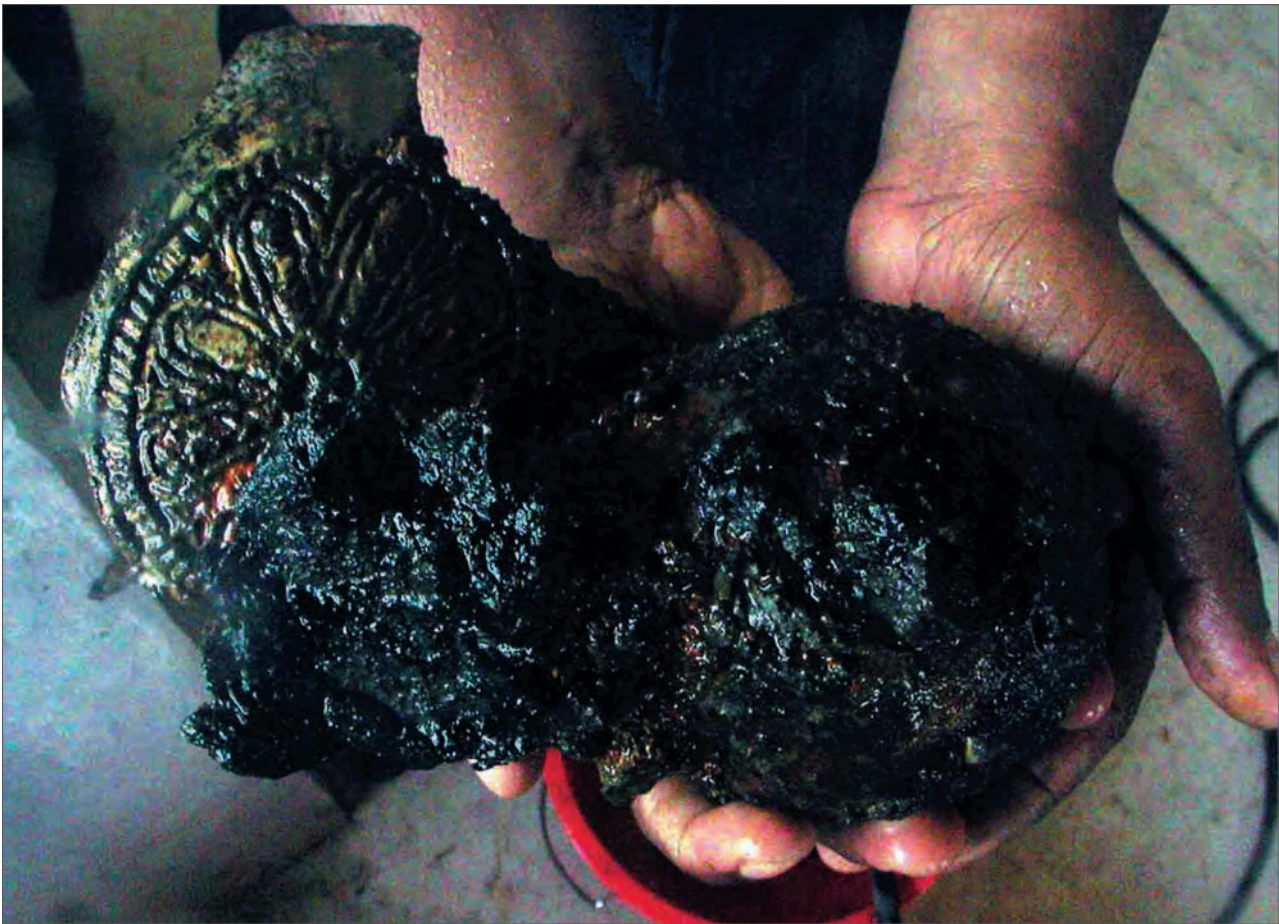
Figure 4.17 (a-b) Cannon ball attached to a ceramic piece before and after mechanical separation (03/GHL/134)

In a marine environment, iron corrosion products will often form concretions that fuse different objects together and thereby complicate the treatment process. One such example found on the *Avondster* site consisted of a ceramic fragment concreted to a cannon ball, registered as 03/GHL/134. After

discussion between the archaeologists and conservators, it was decided that these items were not functionally related and, as the best conservation result would be achieved by treating each component separately, that the components of the concretion would be separated.

The ceramic and iron were separated using hand tools. The corrosion was mechanically removed from the cannon ball before it was placed in 2% sodium hydroxide to desalinate. After separation a large amount of iron corrosion products remained on the surface of the ceramic. Some of this was mechanically removed with hand-tools and scalpels before a solution of 5% diammonium citrate in freshwater was used (by immersion and in poultice form) to remove the last of the corrosion products and to reduce the staining. The fragment was then placed into a freshwater desalination bath.

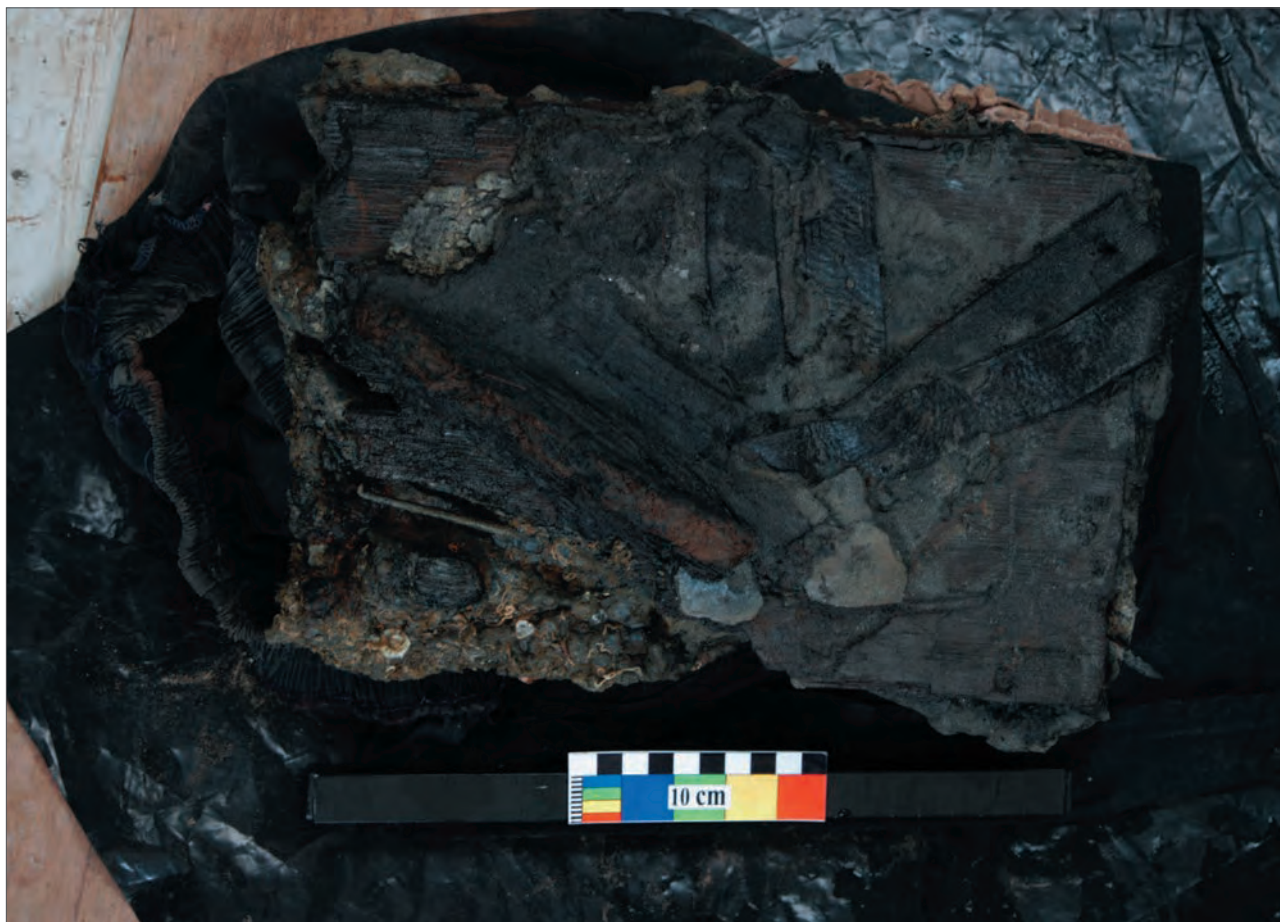
Figure 4.18 The Toolbox of the Mastergunner (04/GHL/357)

One of the most interesting artefacts excavated from the stern section of the *Avondster* was the remains of a wooden toolbox. A considerable part of the wood constituting the box, from the bottom and three of the sides, was preserved. The tools contained in it also remained in situ, concreted together. The ends of some tools were visible, revealing

copper alloys and a wooden handle. Copper wire of different calibres could also be seen on the top and on the sides of the concretion.

Due to its significant research value and the complexity of its components and therefore its likely treatment, a detailed assessment was carried out. Artefacts of this type clearly exemplify the situation that is sometimes described as 'the excavation continuing in the laboratory'. In this case much can be learnt by careful documentation of all components in this artefact assemblage. The types of objects in and around the box, their spatial arrangements, their condition and the impact of contact on preferential preservation are just some of the information that may be revealed with detailed assessment, with further information potentially gained if a decision is made to separate the components of this type of artefact assemblage. After the initial assessment was

made, the box was placed in tap water inside a container and placed inside the refrigerator in order to keep the most vulnerable material (wood) in the most stable possible conditions until active treatment processes commenced.
