# *Excavation report of the VOC-ship Avondster (1659)*

The  
Anglo-Dutch  
East-Indiaman  
that was wrecked  
twice in Ceylon

# 1 *Avondster: an East-Indiaman in Asia*

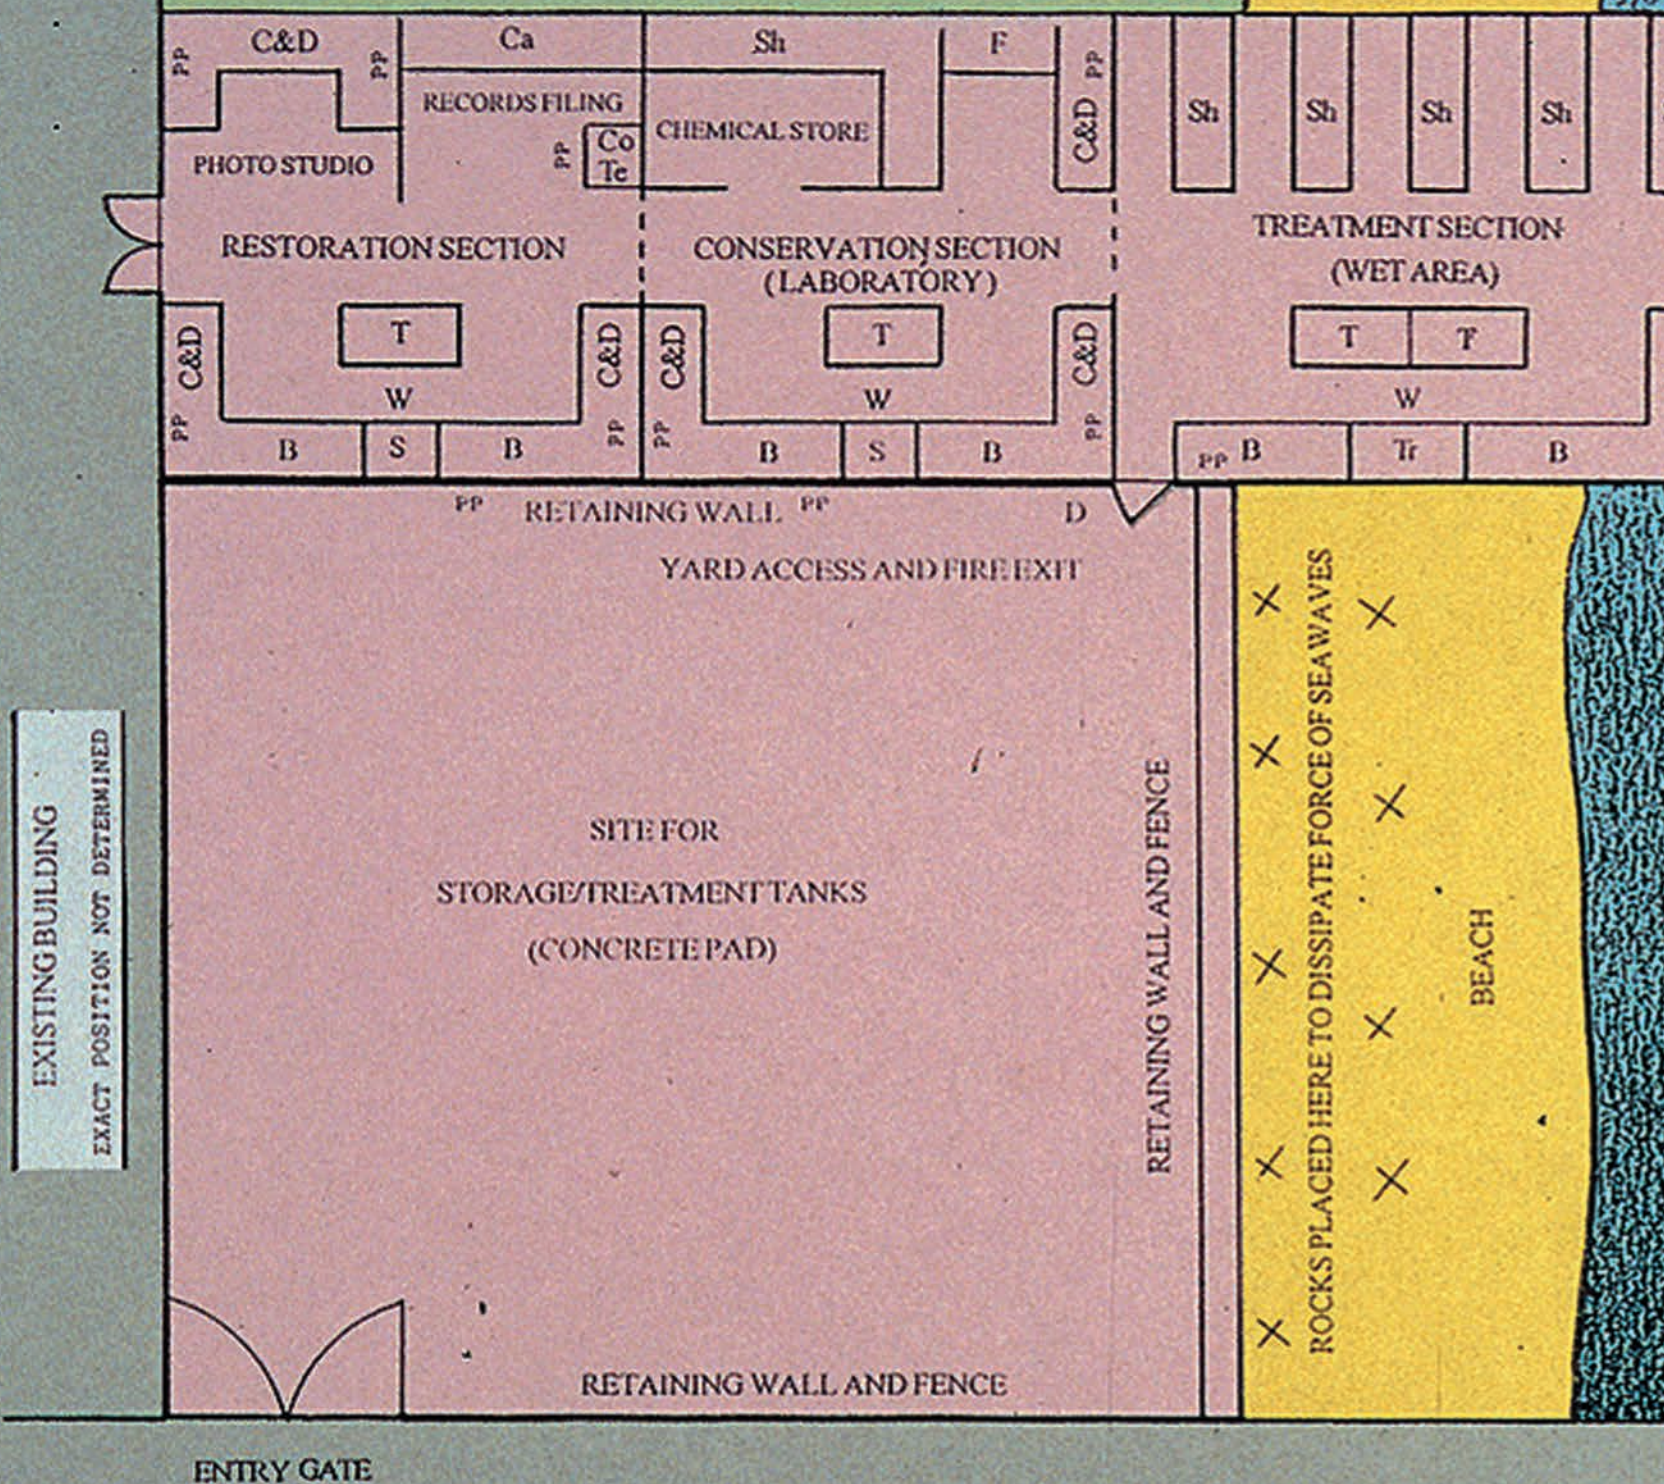
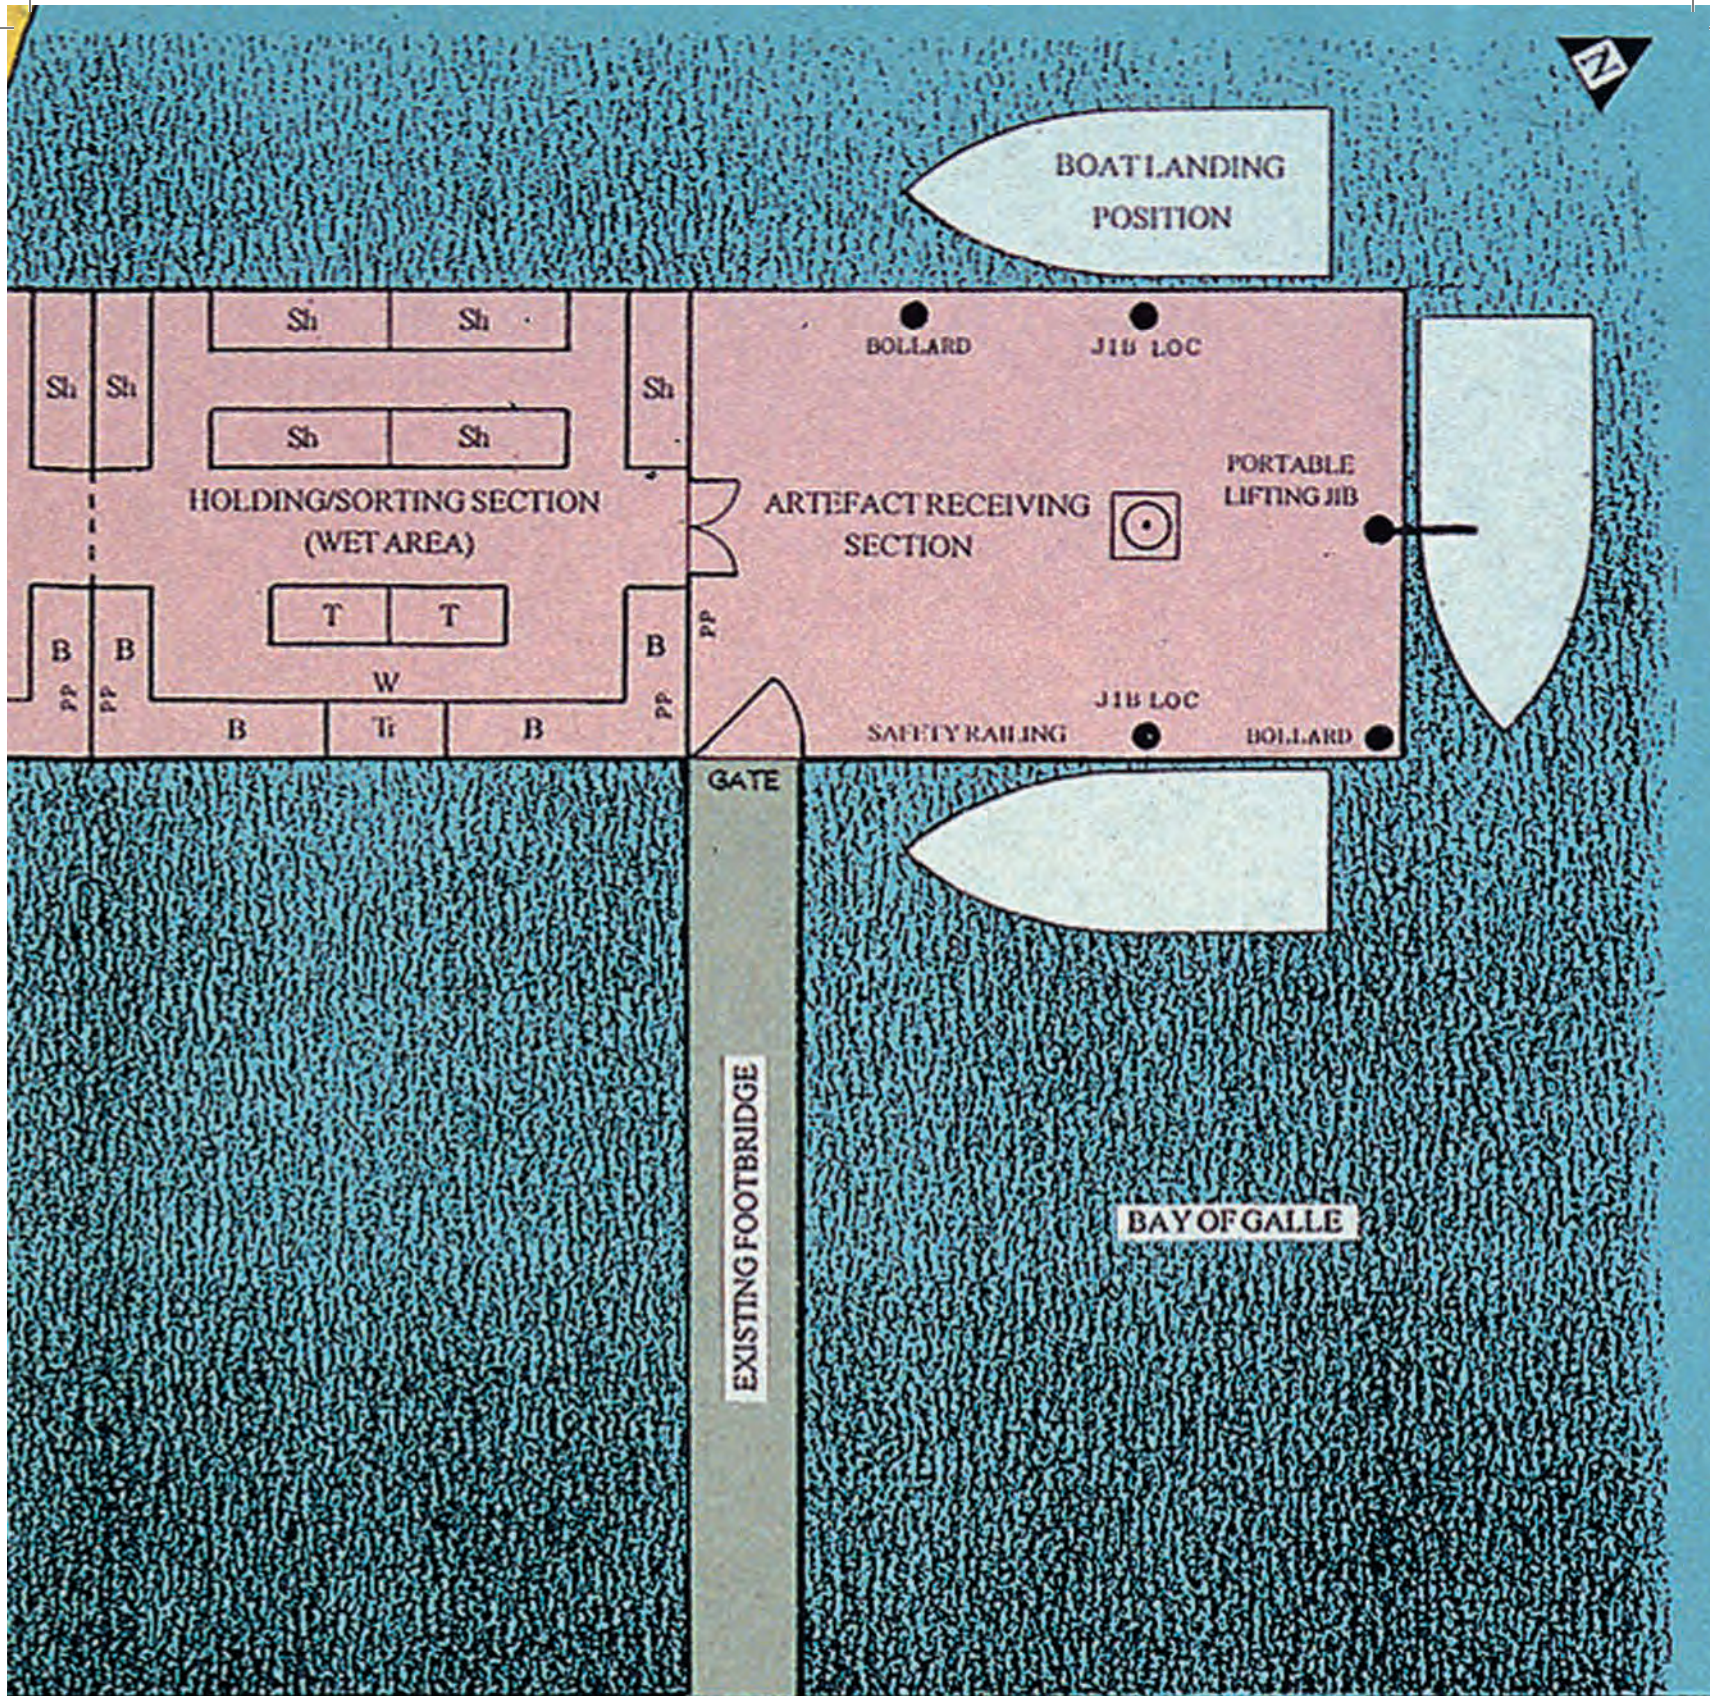
# PROPOSED MARITIME ARCHAEOLOGICAL CONSERVATION LABORATORY GALLE, SRILANKA

EXISTING BUILDING

PLAN & DESIGN - MAY 1996

by Jon Carpenter  
Conservator  
Department of Materials Conservation  
Western Australian Museum

EXISTING JETTY

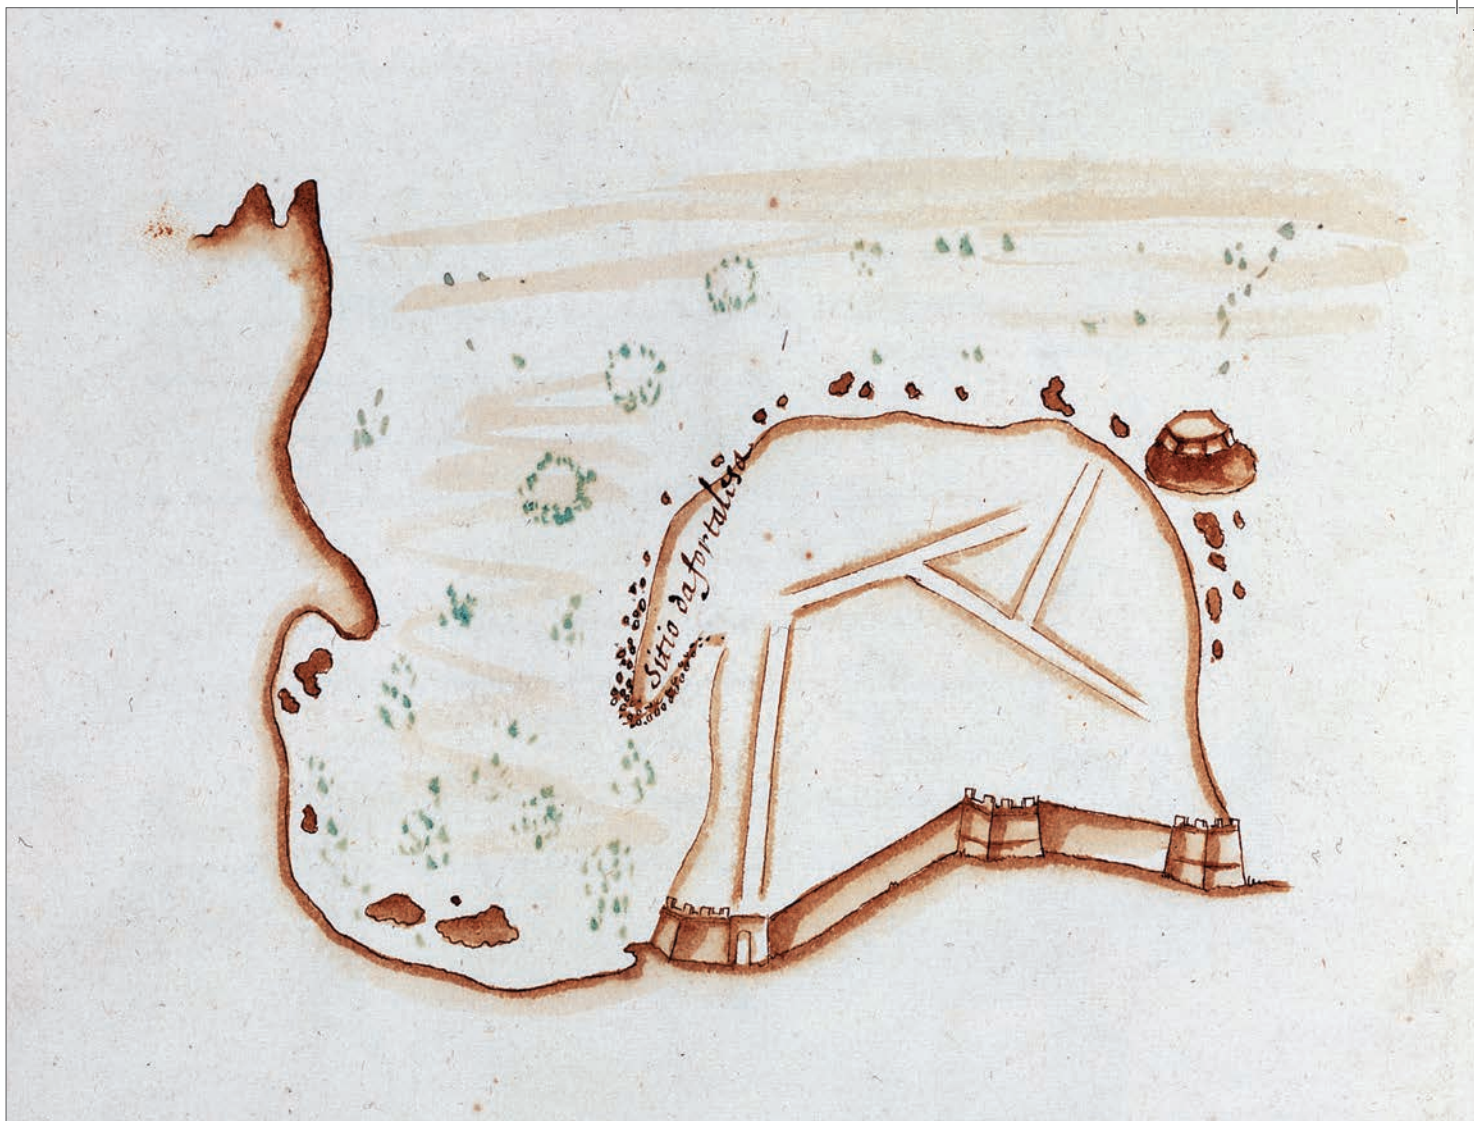
Figure 7.5 *Beschryving ende Caarten van den Eylande Ceylon met afzonderlijke plans van Ceylon*, 1606., Manuscript, Groot 0.32 - 0.405 El., 6 - 10 N.Br., Anonymous; Nationaal Archief -inventarisnr. vel0928(17). Map of Galle as published in: Constantine de Sa's maps and plans of Ceylon (1624-1628). E. Reimers ed. (Colombo 1929). The drawing dates from 1627 and is in the National Archives of the Netherlands (Sheet 928). This is a copy of the drawing. The measurements of Galle are clearly incorrect. The bay and the land opposite are also not drawn to scale. The fort, marked on the map as 'sitio da fortelesa', was on the left in the city. Although four streets can be seen, it is not possible to work out the street pattern. The three bulwarks are on the north side of the city. The bay and the sea around Galle are full of rocks..

Illustrative material, including a map of Galle dating from 1627 (Figure 7.5), provides more information. Constantine de Sa, who represented the Portuguese authorities on Ceylon from 1618-1620 and 1623-1630, commissioned this map. It shows the three bastions on the north side of the city and a fort, marked on the map as 'sitio de fortaleza', which protected the bay

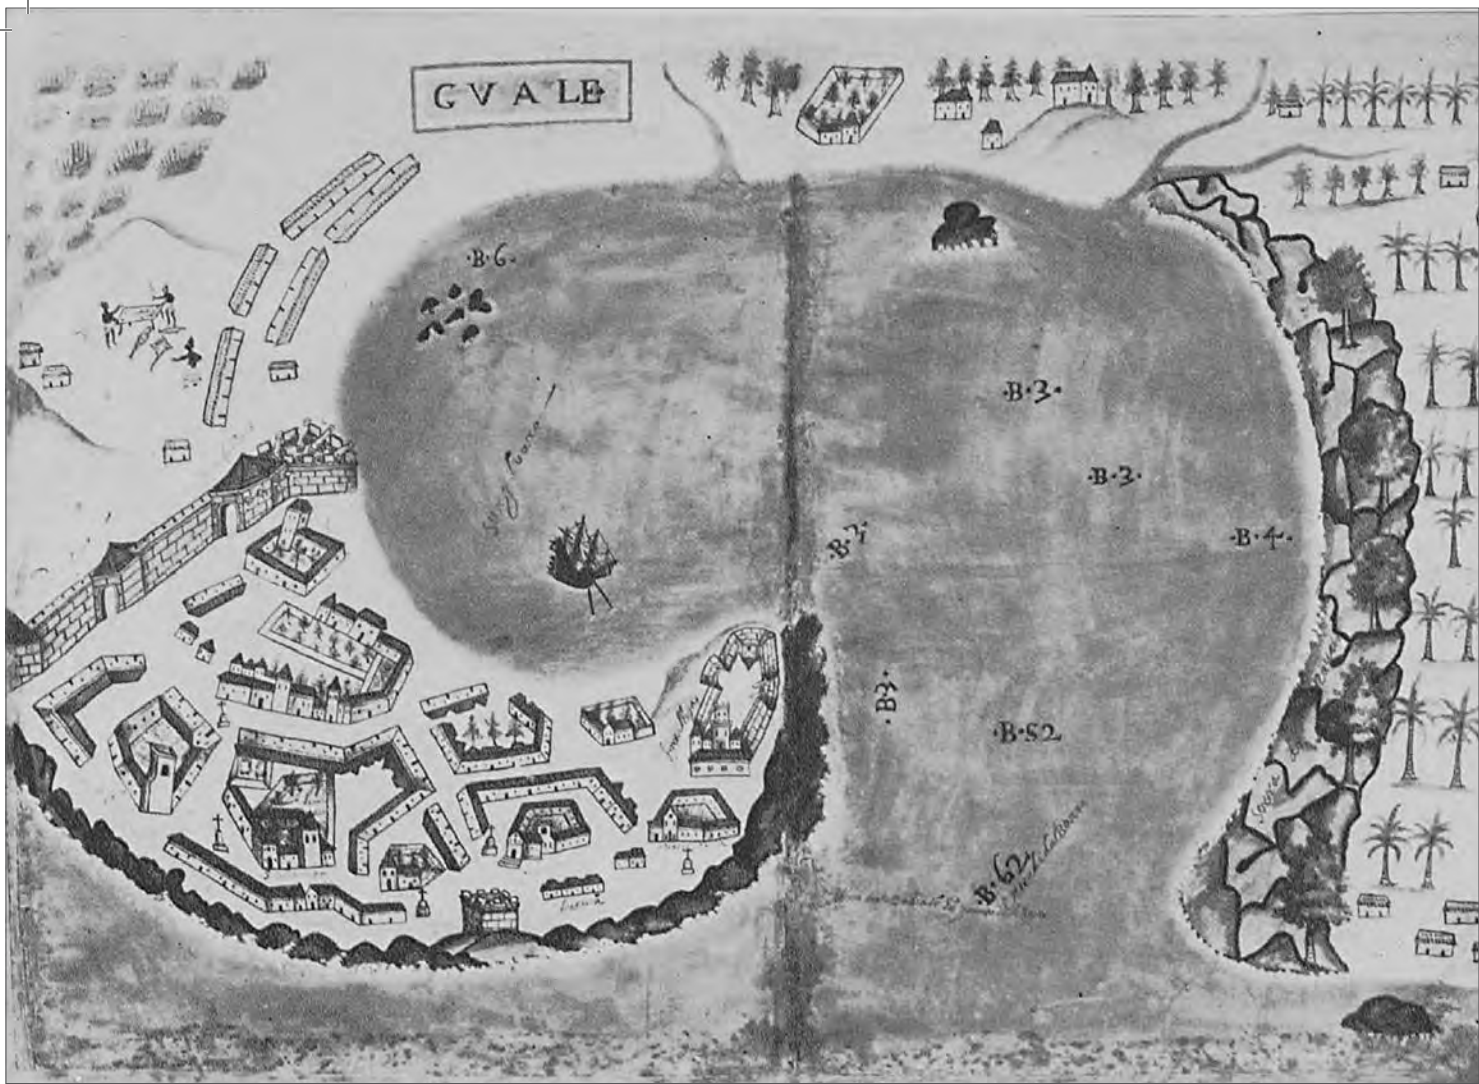
Figure 7.6 Map of Galle by Pedro Barreto de Resende, probably made in 1635 and published in 1646. The map has been reasonably drawn to scale. The city is elongated and curves around the bay. A number of points are shown in the bay, probably rock masses that have been marked for skippers. The city is protected on the north side by a defence wall, which has three fortified points, probably bastions. Two entrances in the wall can be seen. On the southeast side of the city is the 'fortaleza'. It is feasible that this is the Santa Cruz bastion. The street pattern and buildings are clearly depicted. The map gives the impression that the city was completely full of buildings. Three churches are named: the 'St. Domingo', the 'St. Pedro' and the 'St. Francisco'. 'Misericordia' is written below the 'fortaleza', the poor house. Above that is the workplace, described as 'feitoria'. From: Cortesão and Teixeira da Mota, *Portugaliae monumenta cartographica*, 589G

from hostile ships. It is highly probable that this refers to the Santa Cruz bastion. Another map, by Pedro Barreto de Resende, also shows this bastion as well as the defence wall on the north side (Figure 7.6). This map was made in 1635 and depicts the buildings inside the city walls. It is the only map of Galle from the Portuguese period showing so much detail and is hence of great value. More information about how the buildings in the city are depicted on this map is given below.

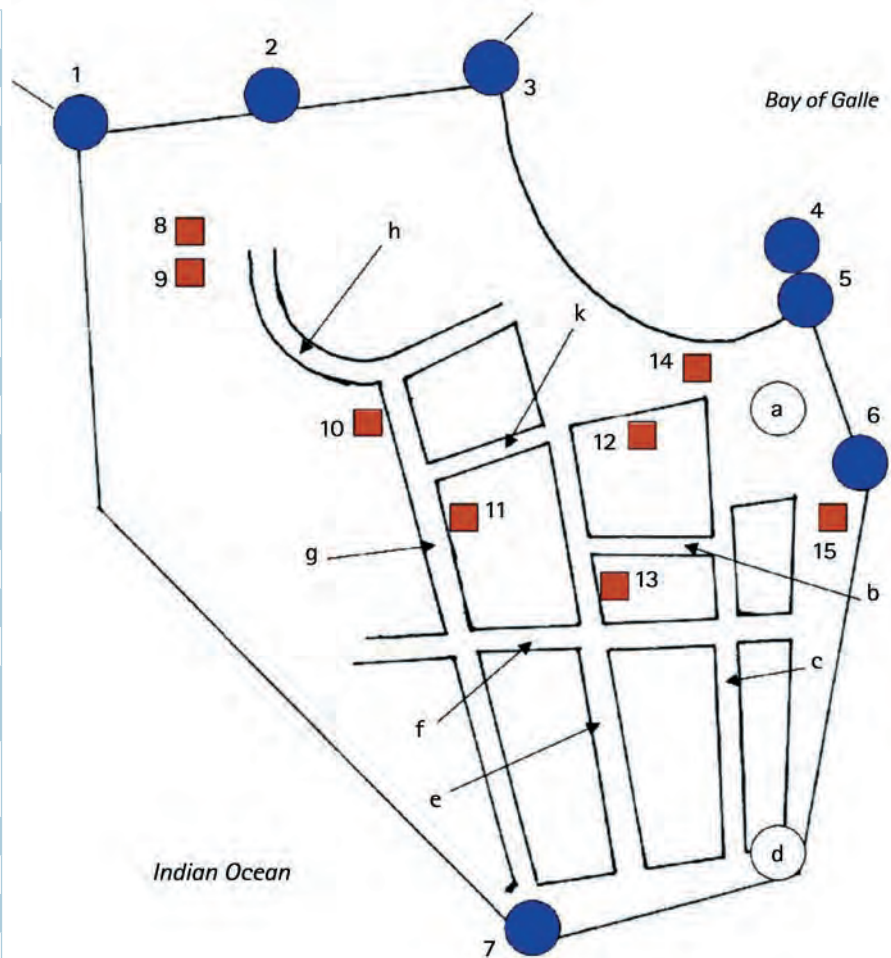
Figure 7.8 Reconstruction of Galle around 1670.

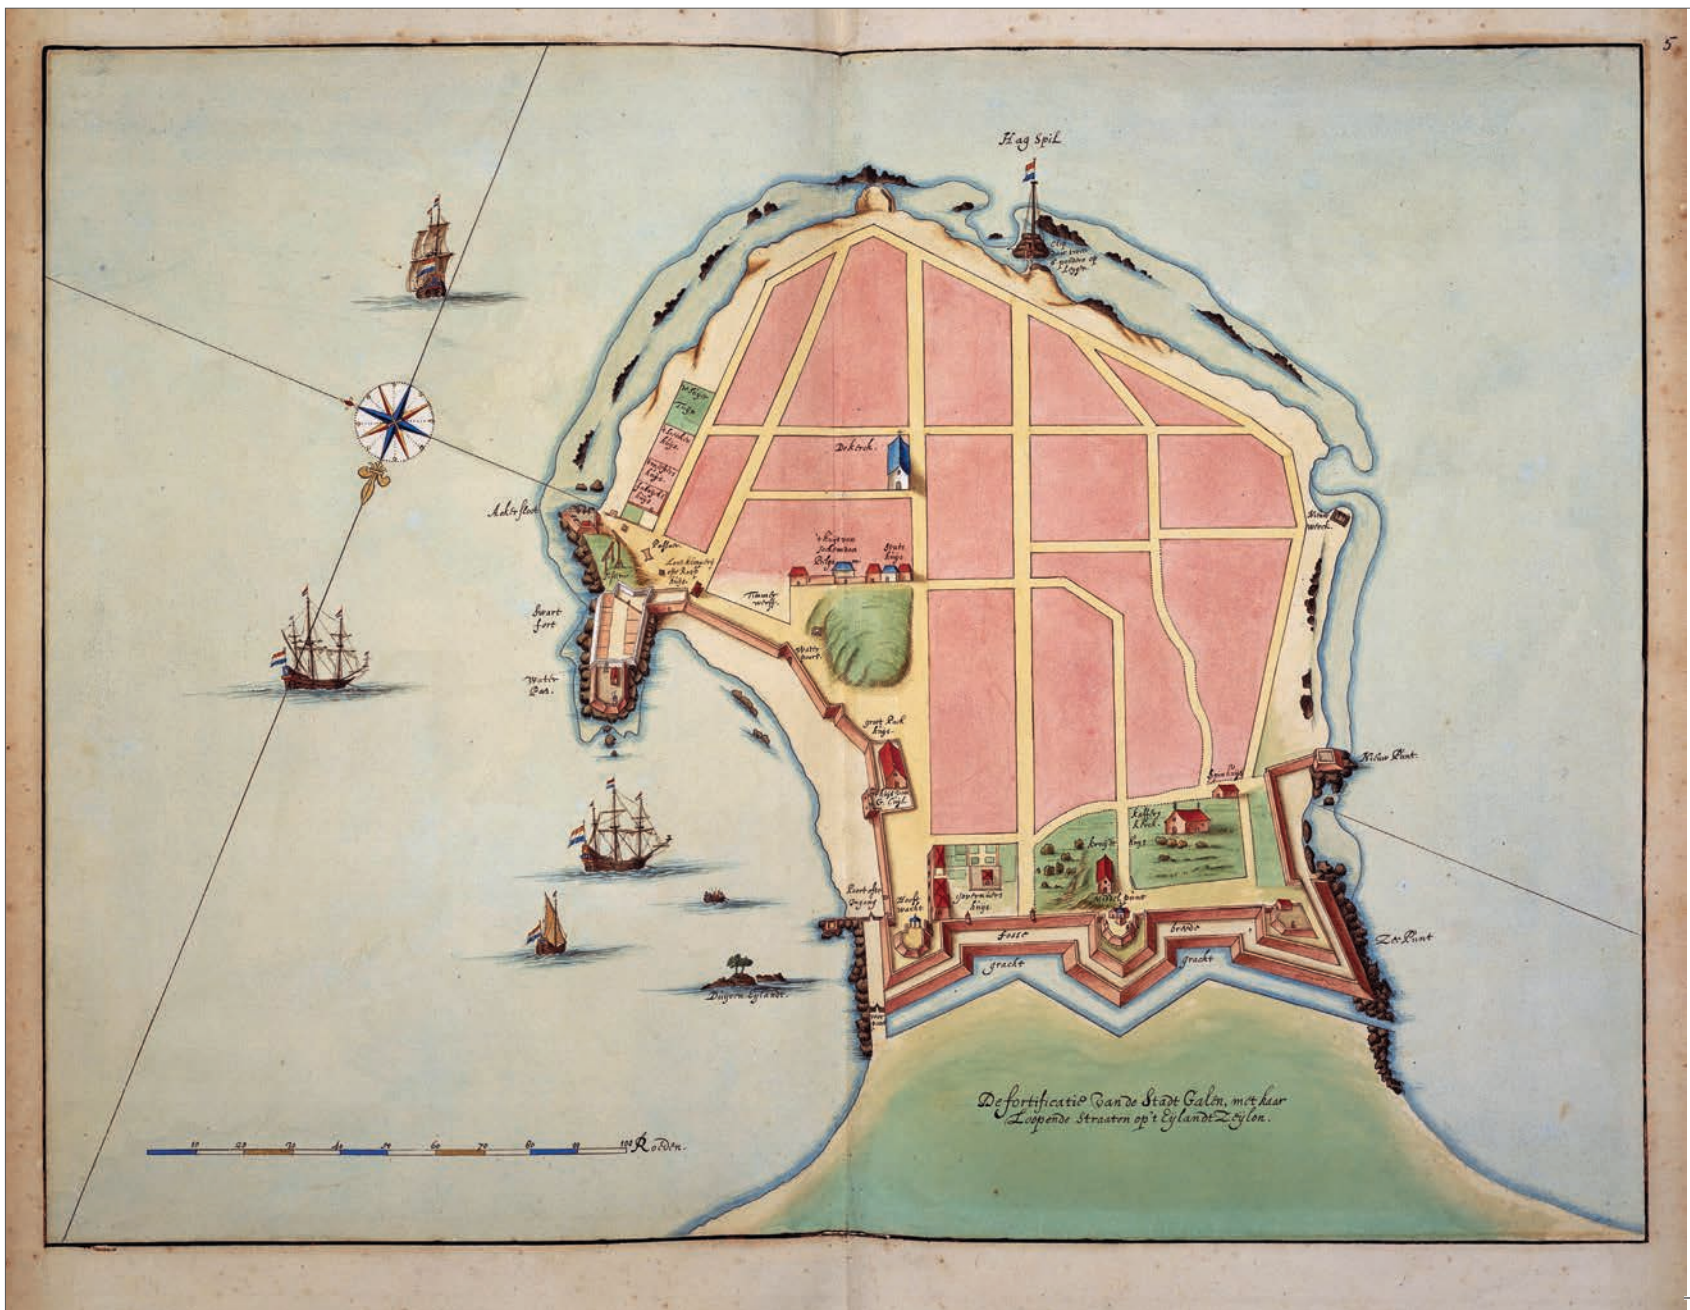
Figure 7.9 Map of Galle from around 1663. The map gives an exceptionally clear picture of how the city looked at this time. The work on the fortifications appears to be almost finished. On the north side of Galle the Main Guard, Middle Point and Sea Point provide protection against attacks by land. A wall runs from the Main Guard to the Sea Point in the direction of the Black Fort. The wall and this fort provide protection against an attack from the sea. Other defence works, such as the Akersloot, the Flag Pole and the bastion on the northwest side of Galle are also depicted.

Furthermore, the map gives a good impression of what had already been built in the city. The street pattern appears to have taken on a definitive form. Whether this was actually the case is dubious, given that the land in the south and southwest was still unused. Moreover, the map shows the hill in the city, mentioned in several sources, as well as a number of buildings and landmarks. The church, timber yard, bazaar, hospital and various houses can all be recognized. From: F.C. Wieder, *Monumenta cartographica: reproductions of unique and rare maps, plans and views in the actual size of the originals accompanied by cartographical monographs V* (The Hague 1933) no. 110.

A map of Galle dating from around 1663 tells us more about the buildings in the city. The map has the title, 'The fortification of the city of Galle, with the streets there on the island of Ceylon' (figure 7.5). The author of the map is unknown. Several landmarks, such as the bastions and the defence walls, can be clearly seen on this map. It is also noticeable that the street pattern now has a definitive form. A comment should be made, however, about the southeast corner in this respect. It is highly questionable whether this part of Galle was already being developed. The *schepenkenisrol* and other sources would indicate otherwise. The bazaar (marked here as the 'passaer') is certainly recognizable. To the south of this is an elongated block of buildings with several descriptions. From south to north: 'de Suijer Tuijn'

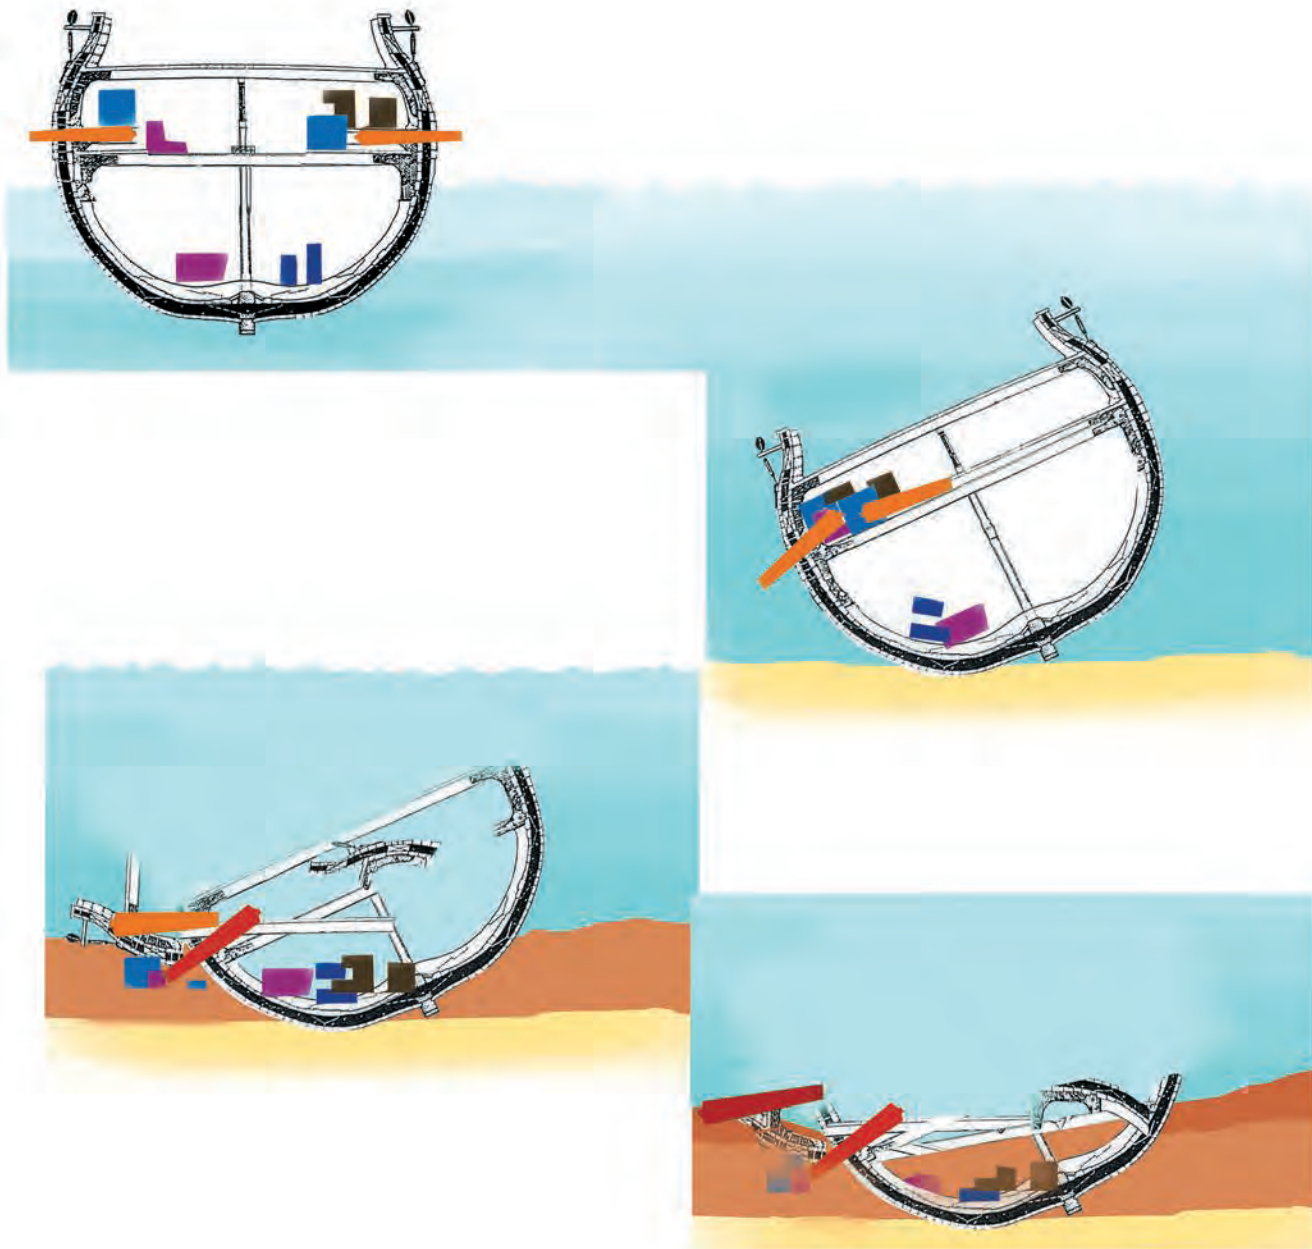
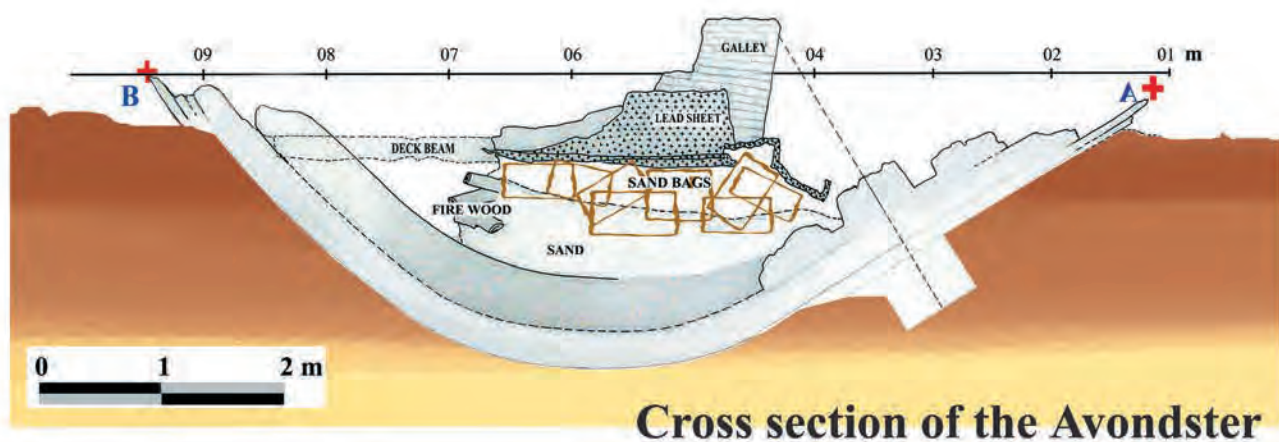
Cross section of the Avondster

## Forming process of the Avondster

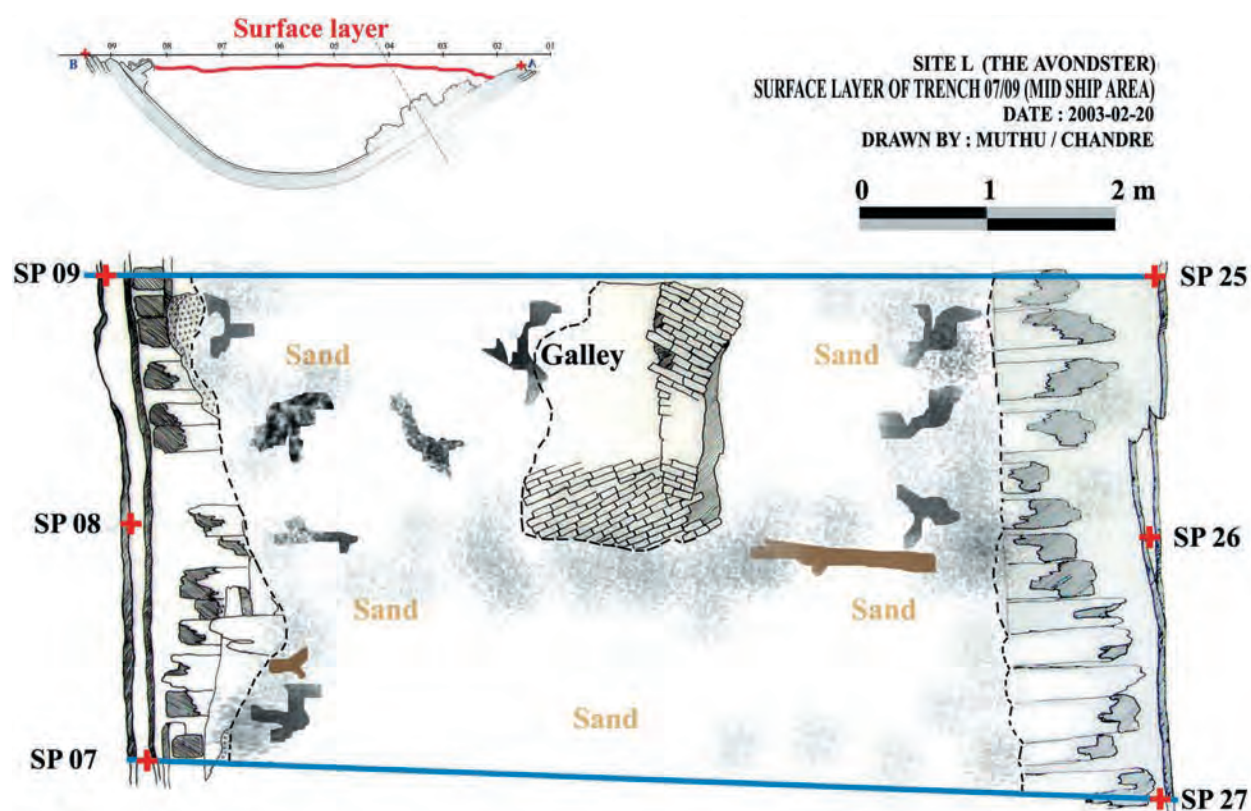
Figure 8.3 Seabed of mid-ship trench before excavation

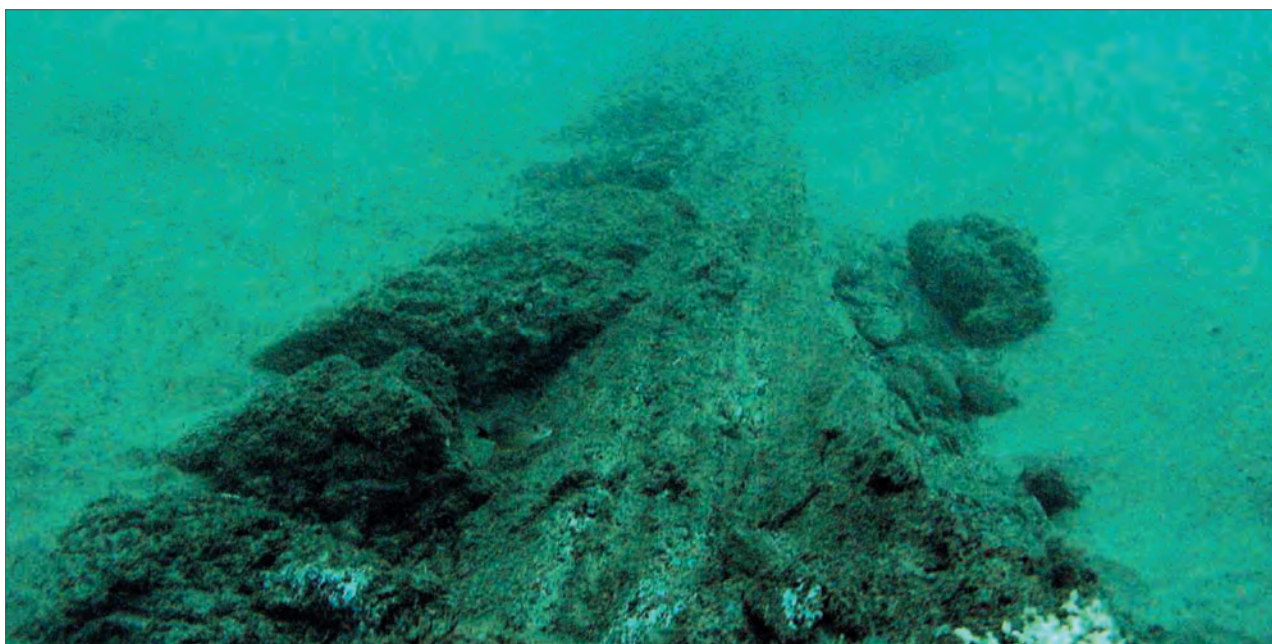
Figures 4.3: Port side of the hull, marking extent of mid-ship trench

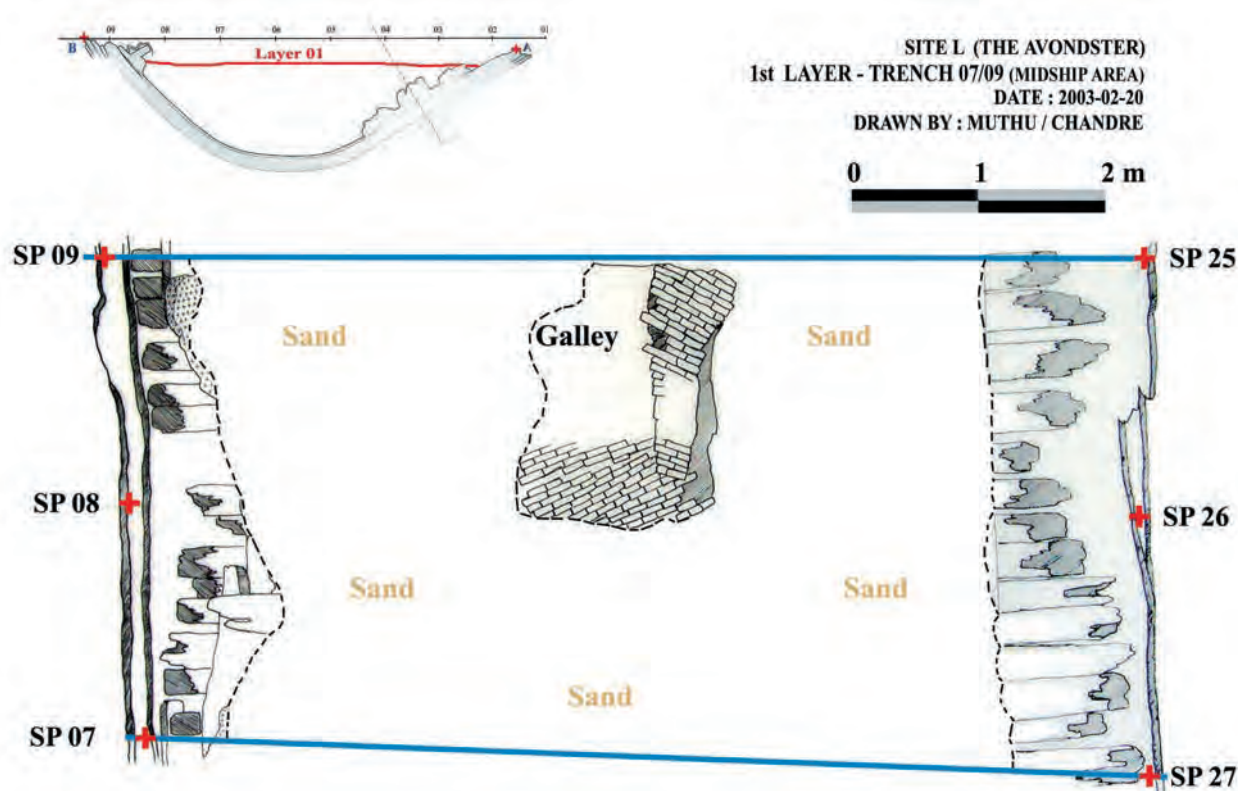
Figure 8.4 First layer of the Trench 07/09

continually deposited and removed by the waves and currents. Excavation began after this layer was removed. The layer below the seabed, (which will be referred to as the first layer), consisted of crabs, waste matter and concretion, which were removed to a depth of about 25 cm. No finds belonging to the wreck were found in this layer.

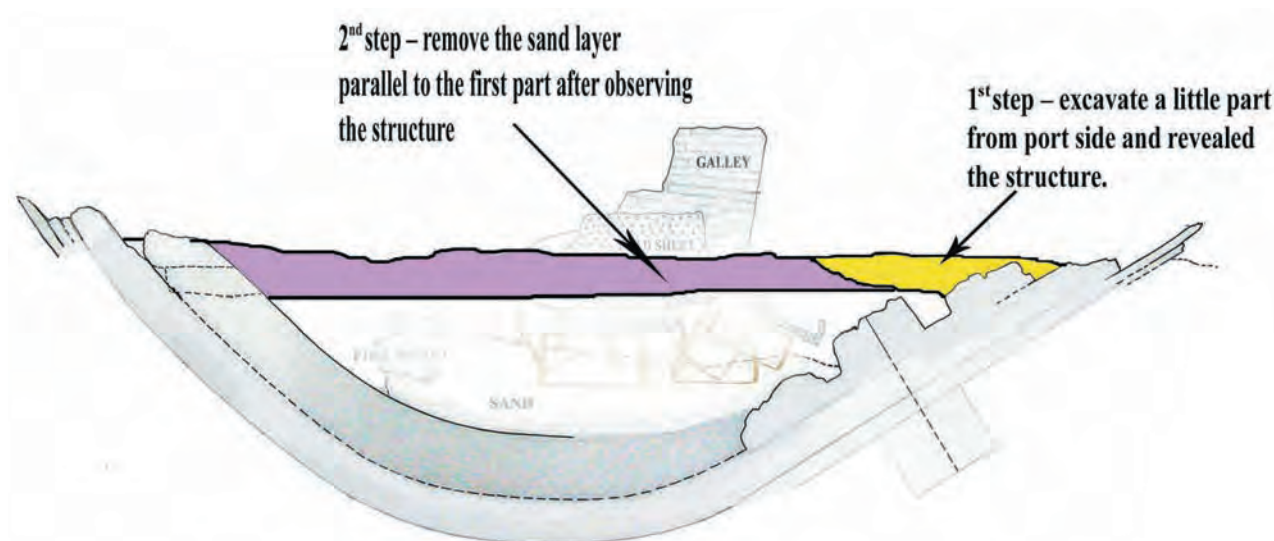
Figure 8.5 Trench cross section, showing how the excavation followed the structure

the ship had inclined towards the starboard side during the wrecking process, the starboard side was expected to lie deeper in the seabed than the port side.

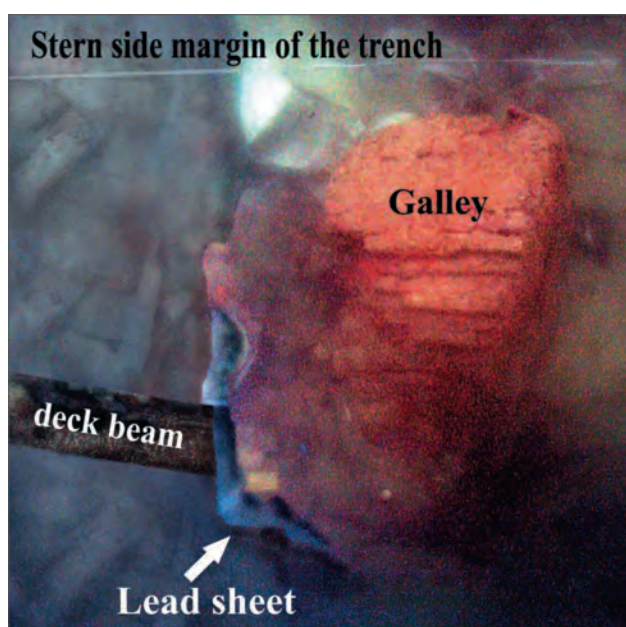
Figure 8.6 Top view of the galley

As the excavation continued, the stability of the galley structure became a concern. Underneath the brick galley construction was a lead sheet. Under that were mostly sand and decayed wooden parts. One side of the galley rested on

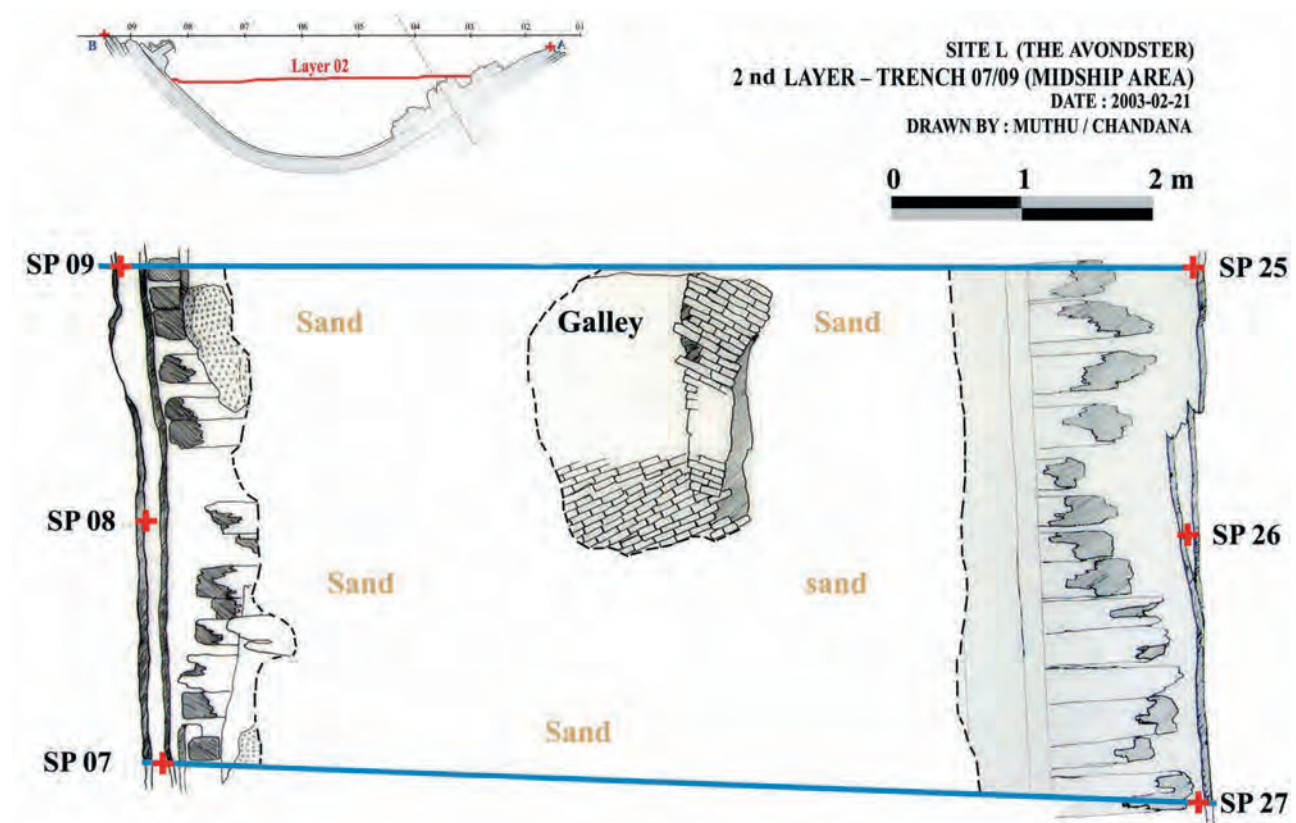
Figure 8.7 2nd layer of the trench 07/09

A 20 cm thick layer of sand was removed to reveal a layer of slightly older, less disturbed material, predominantly gravelly sand and half-decayed crab shells. This second layer was not soft like the first layer, which was newly laid, and contained slightly heavier sand particles. It was not easy to remove this material, which was re-deposited on the site by the waves to form the new upper layer.

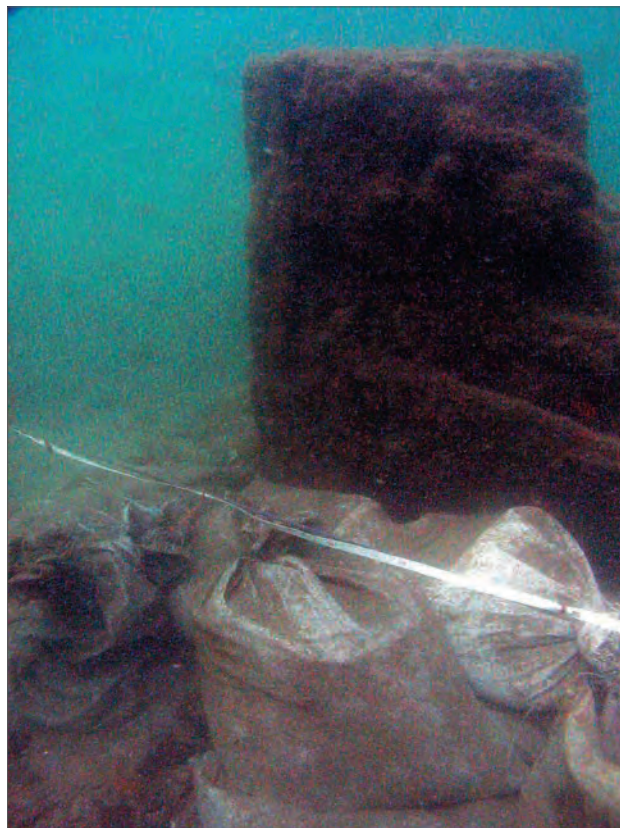
Figure 8.8: The galley supported with sand bags

a deck beam, which extended from the starboard side to port side. This created the possibility of loose bricks dislodging or the galley collapsing when the sand was disturbed in the nearby excavating trench. To prevent these scenarios, the galley was supported with sand bags and excavation activity was kept some distance away.

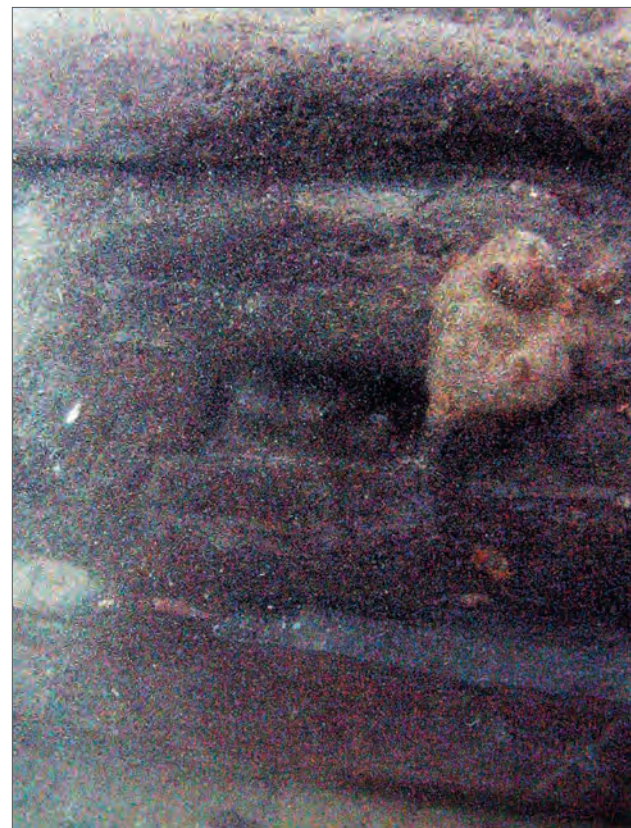
Figure 8.9 The unusual marks on possible keelson

A second longitudinal timber was found about 20 cm away from the first longitudinal timber, also 60 cm in width but only 30 cm thick. This longitudinal timber had an unusual shape and some unknown marks. This could possibly be the keelson. A number of huge round stones were found, lying in-between and on top of the two longitudinal timbers on the port side. These are probably ballast stones.

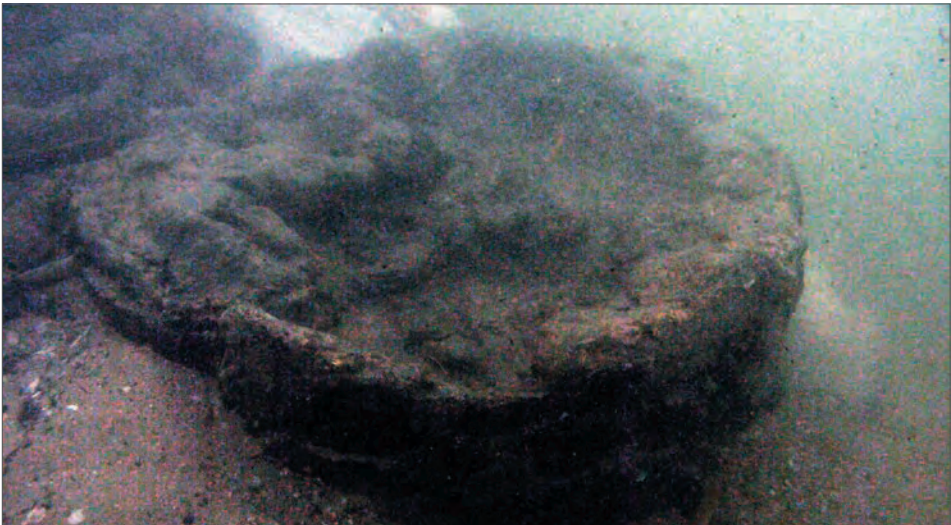
Figure 8.10 Barrel No. 1

Among the objects found in this layer were the remains of a barrel and a length of lead sheet. The barrel remnant is 60 cm in diameter, however the height is unknown since the staves have broken or rotted away. Only what could be the lid or the base was found. Unidentified solid material was attached to the barrel remains, which could have been its contents.
