# *Excavation report of the VOC-ship Avondster (1659)*

The  
Anglo-Dutch  
East-Indiaman  
that was wrecked  
twice in Ceylon

# 1 *Avondster: an East-Indiaman in Asia*

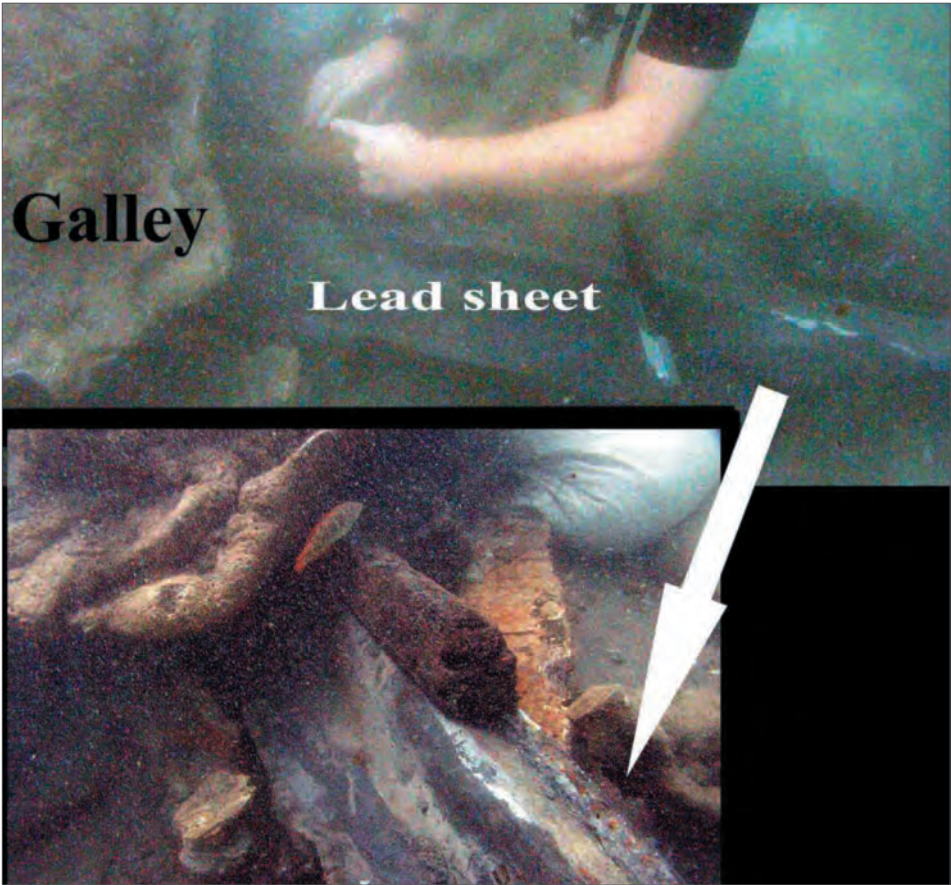
Figure 8.11 Lead sheet / gutter at the base of the galley

The lead gutter, (about 15 cm in width and 70 cm in length), was found at the north west end of the galley. It is made from lead sheeting bent hollow in order to serve as a gutter. It is nailed to a wooden pole for support. The object looks very much like a part of a drain, however it is not certain if it had this function. After exposing these artefacts, they were covered with sand bags. Once they had been measured and drawn in-situ they were raised.

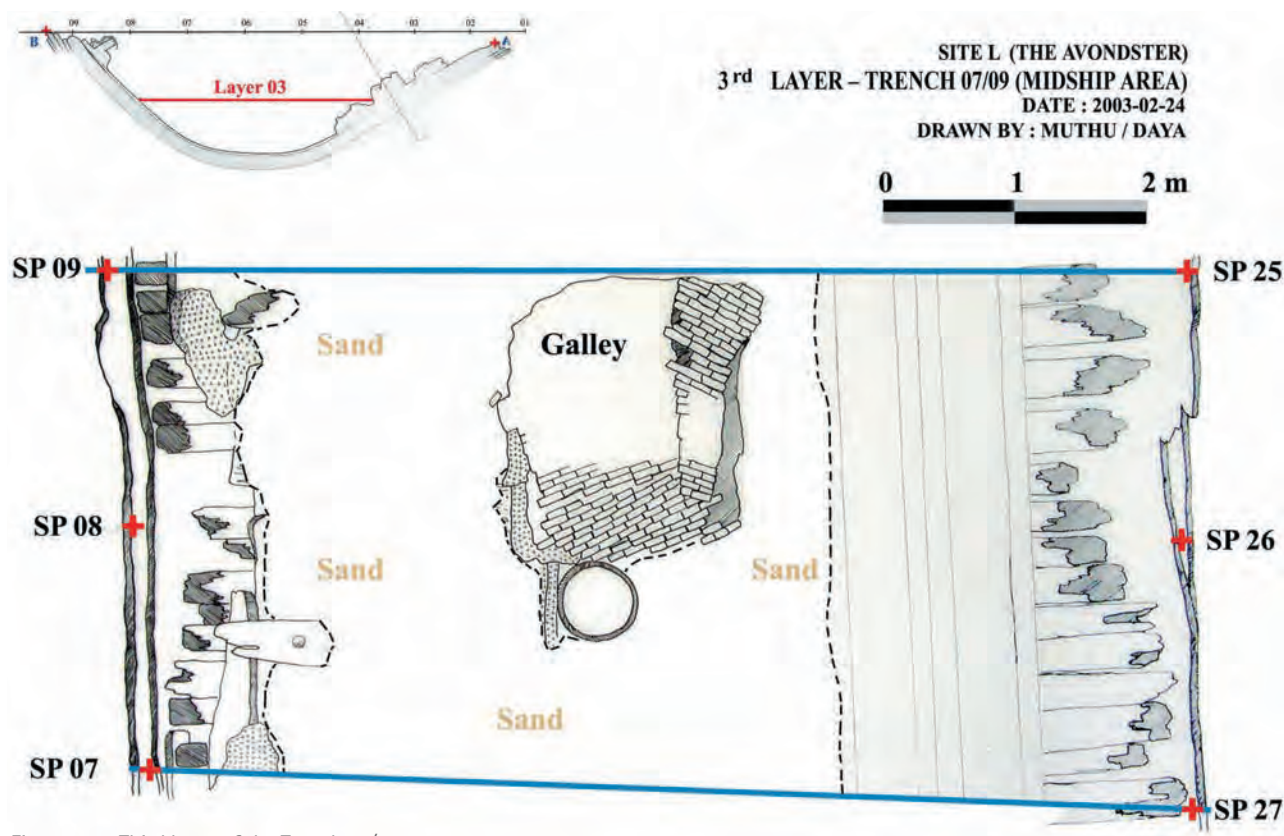
Figure 8.12 Third layer of the Trench 07/09

A layer of sand, very different in composition and about 55 cm in depth was removed during this phase. It was dark grey in colour and made up of small particles, which were very well compressed when compared with the other layers. A hypothesis is that this could be the sediment deposited by the canal (river), which had its outlet in this area at the time the ship sank. A few decayed parts of crabs and decayed wooden pieces were also found in this layer.

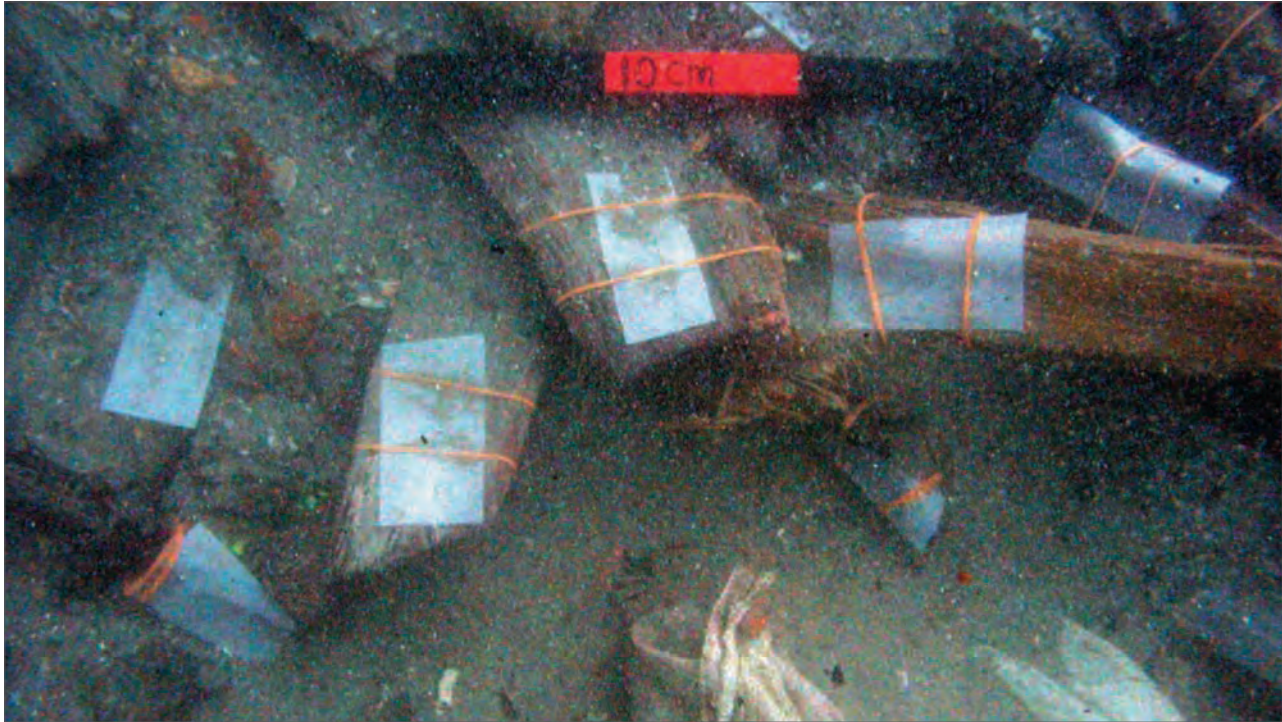
Figure 8.13 Five numbered wooden logs

A special feature of this layer was the number of wooden logs found here. These could have been used as dunnage, which kept the barrels in the midship area from moving or they might have been fire-wood for use in the galley. To come to a conclusion we needed to examine their shape and also find out what species of wood they are. Each piece was numbered underwater and recorded in-situ. They were then brought ashore where samples were taken for further analysis. After that the wooden logs were reburied near the site.

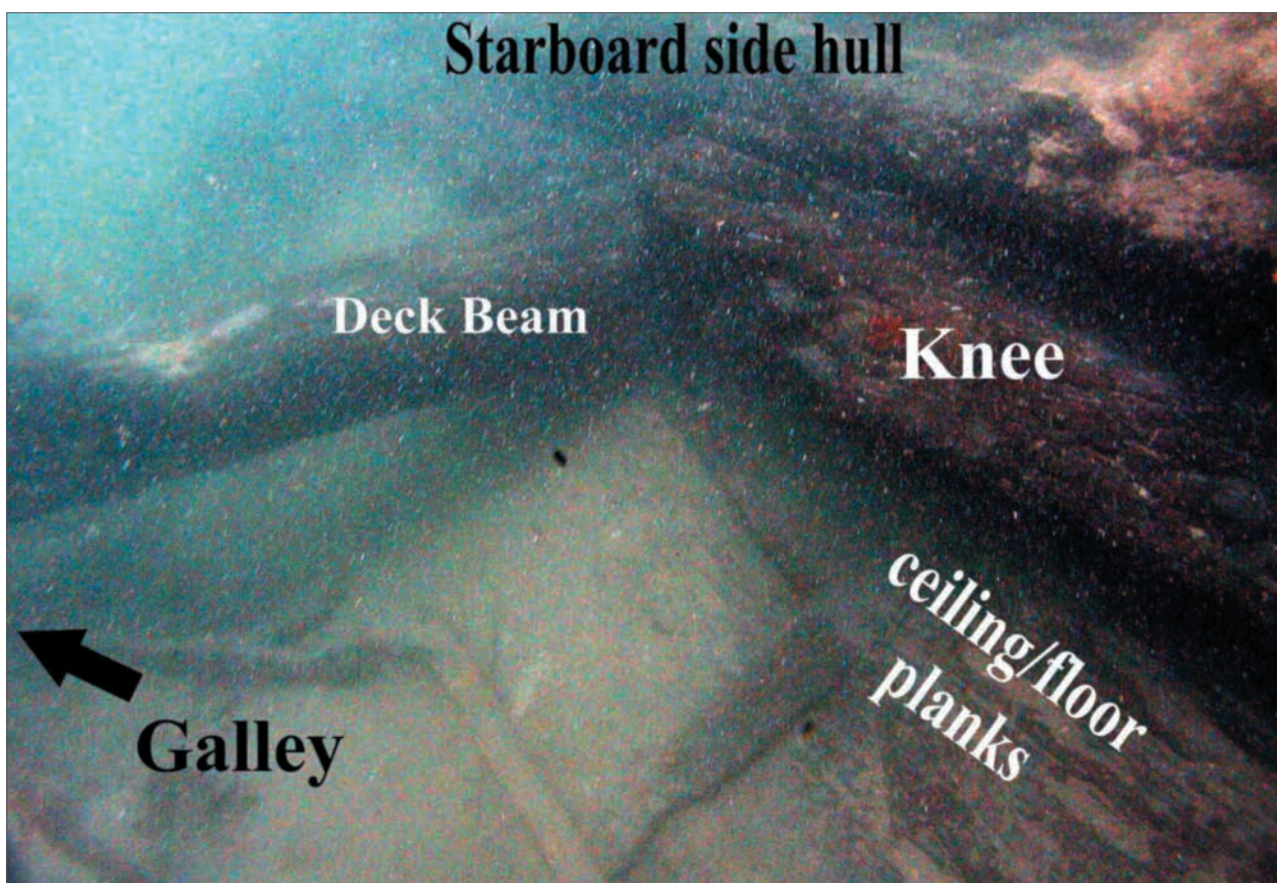
Figure 8.14 Starboard side of the trench 07/09

A number of elements relating to the structure of the ship were found on the starboard side. Two vertical timbers, which extended from the bottom and rose up near Survey Points 07 and 09,

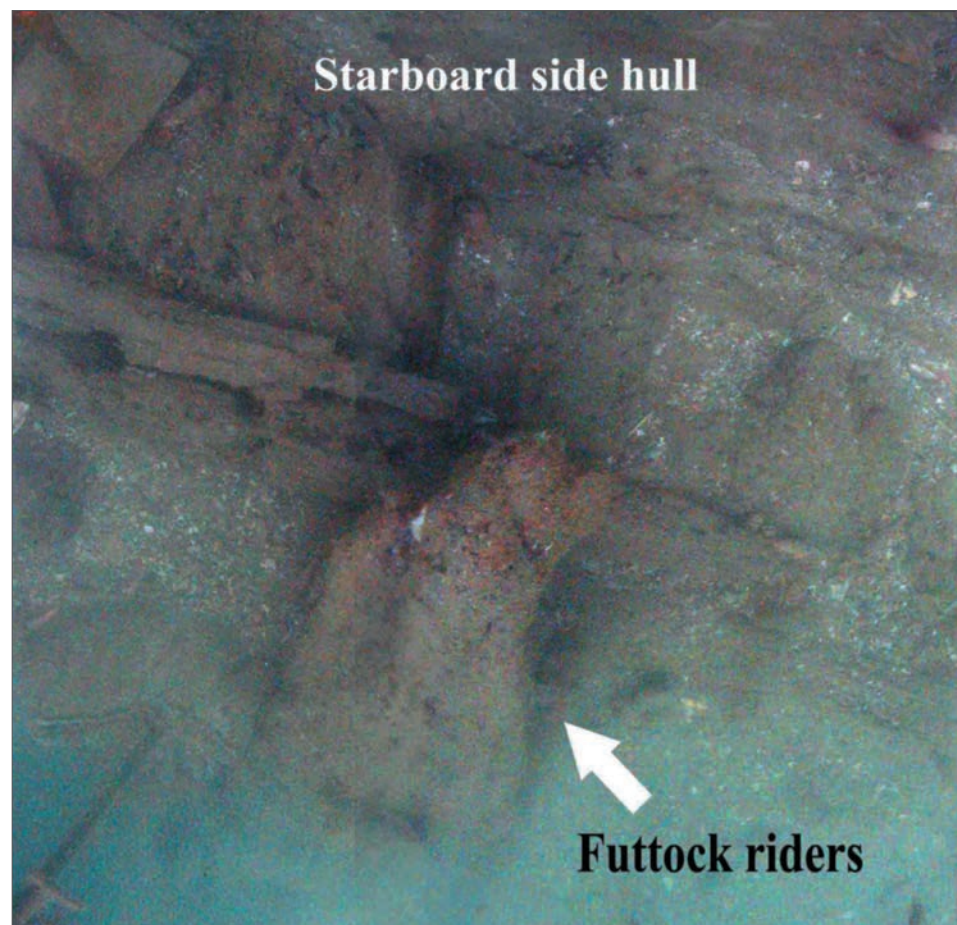
Figure 8.15 One vertical timber on the starboard side

were found. From their shape, their location and the marks on them they are assumed to be futtock riders. Beneath the position where the deck beam is fixed to the hull, a number of wooden planks, which make up the lower deck, were found. These planks had withstood the test of time and were well preserved. Caulking material could still be seen where the planks joined each other.

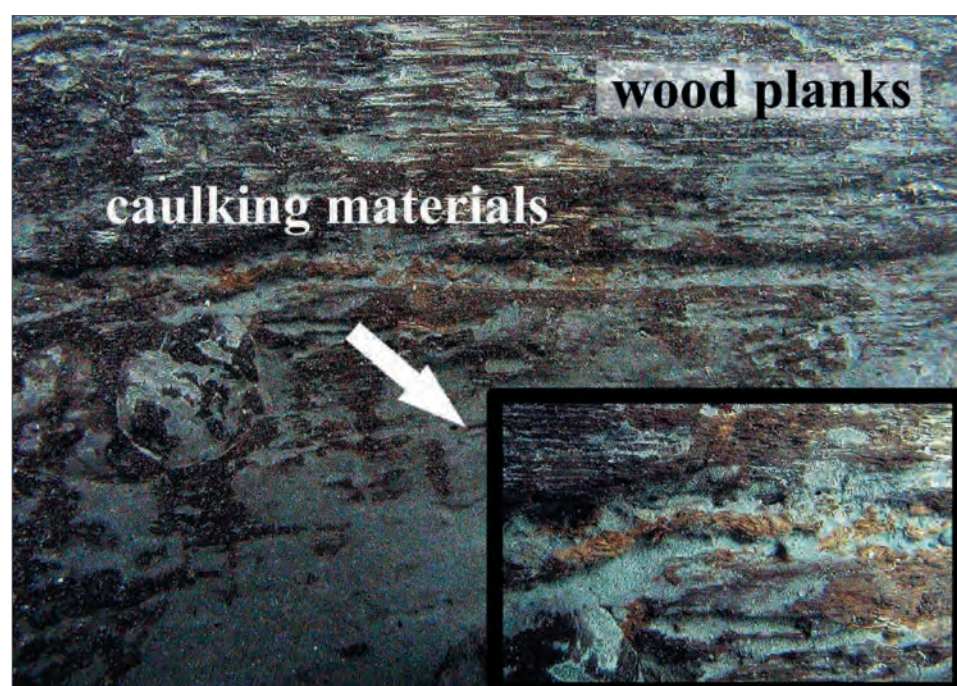
Figure 8.16: Ceiling planks with calking materials

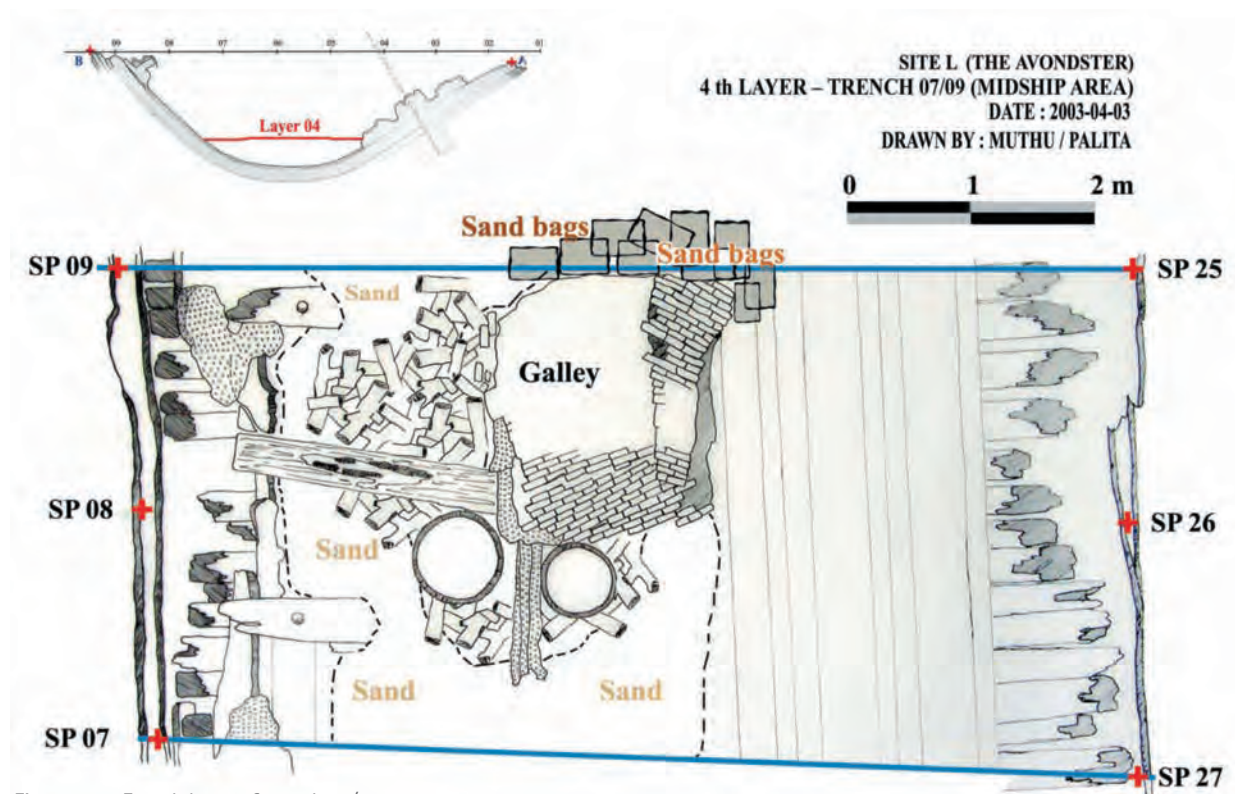
Figure 8.17 Fourth layer of trench 07/09

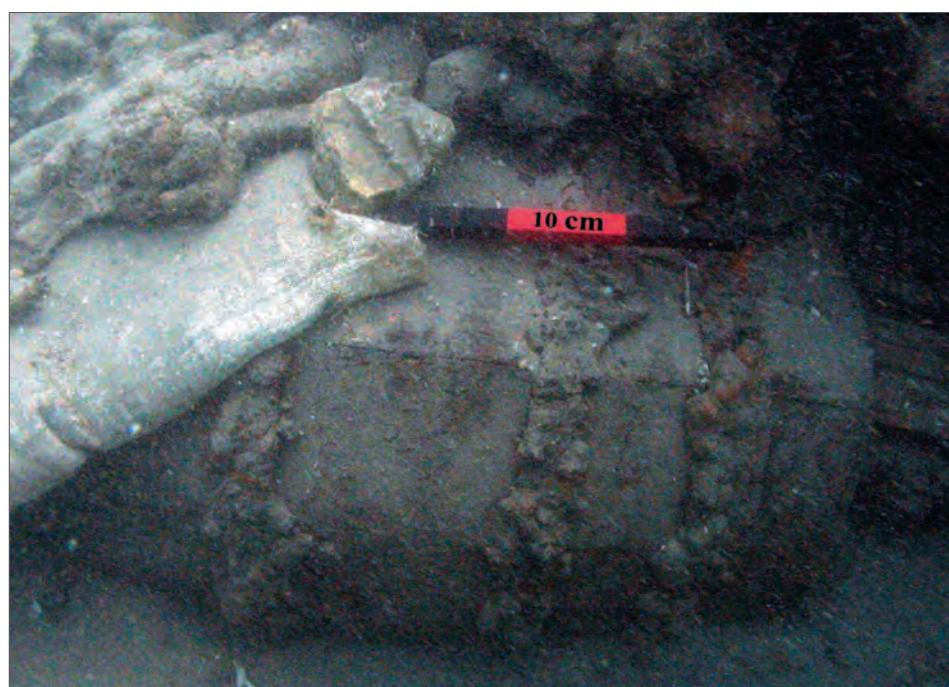
Figure 8.18 Barrel No. 3

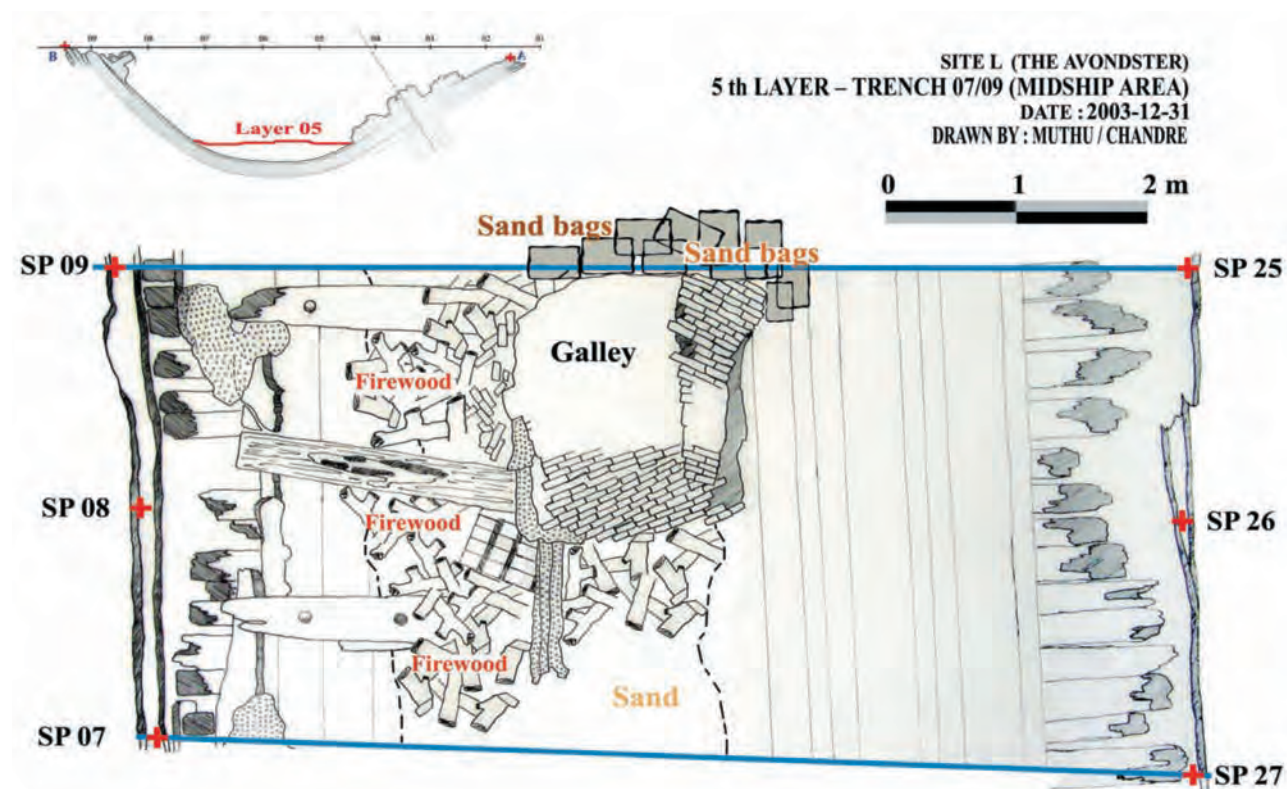
Figure 8.19 Fifth Layer of trench 07/09

The excavation of this layer was interrupted for a number of months due to monsoon conditions. Numerous pieces of fire-wood were found in this area, which were numbered and sampled. After recording they were re-buried outside the hull and covered with sand bags. Many more pieces of fire-wood were evident beneath the fire wood layer that was removed.

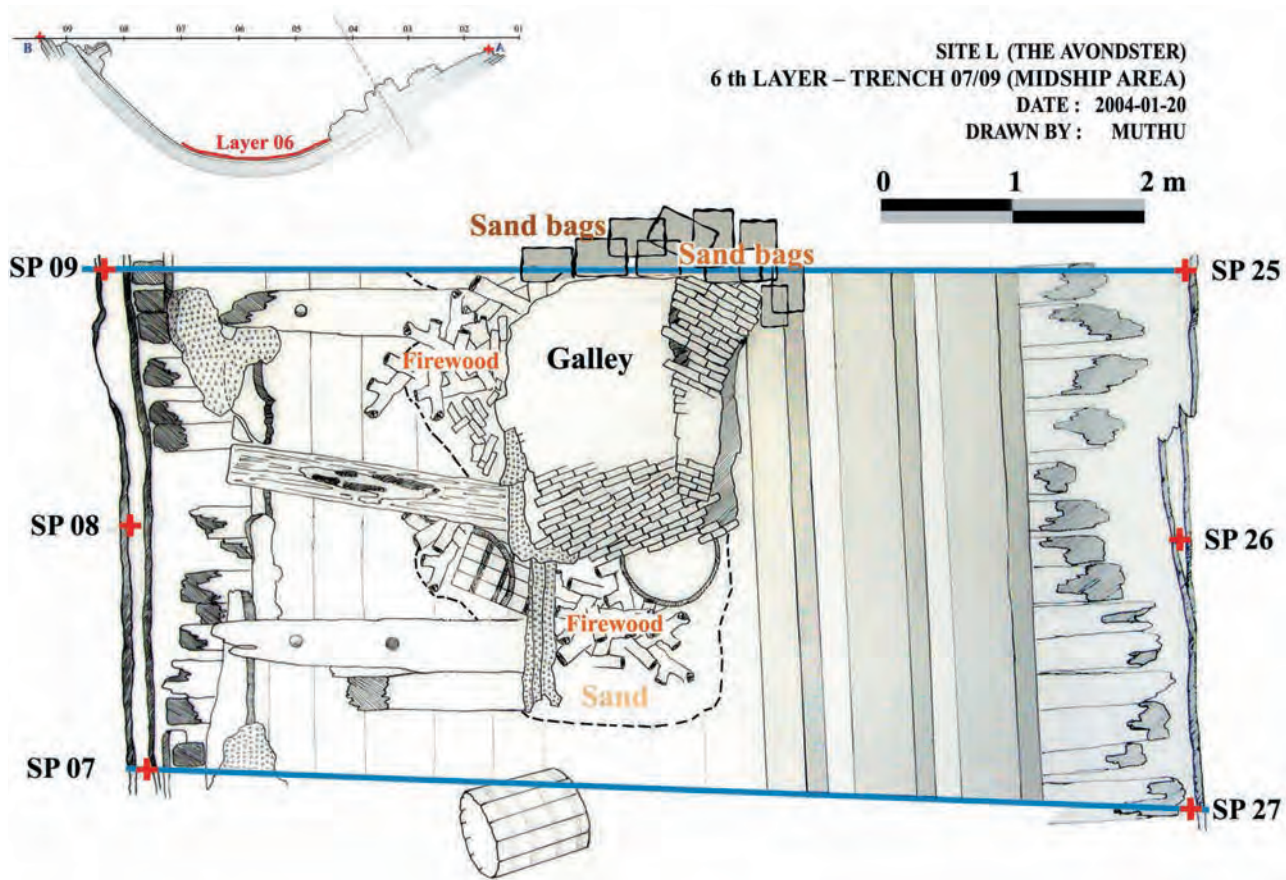
Figure 8.22 Sixth Layer of trench 07/09

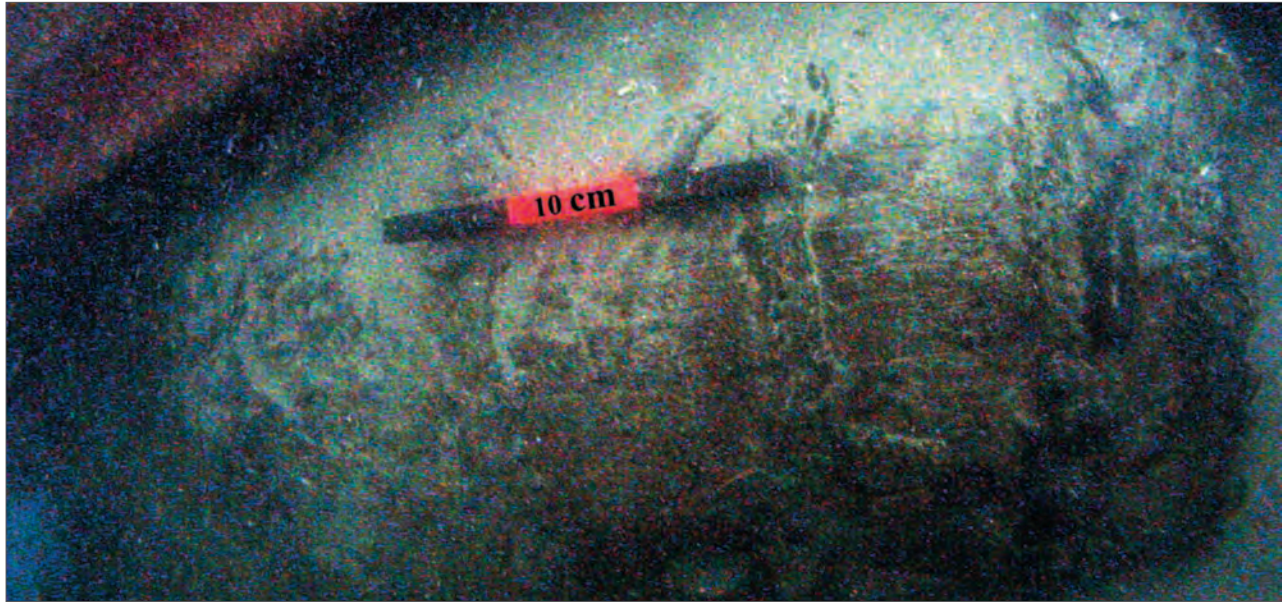
Figure 8.21 Barrel no. 04 near the Western border

To reach the bottom of the trench to take a cross section, the remaining sand was removed completely, in at least one section of the trench. When this was done in the narrow strip at the Western border of the trench another barrel (no. 4) was revealed. The excellent condition of this barrel suggested that the original contents might even be preserved. It was left in-situ for future excavation.

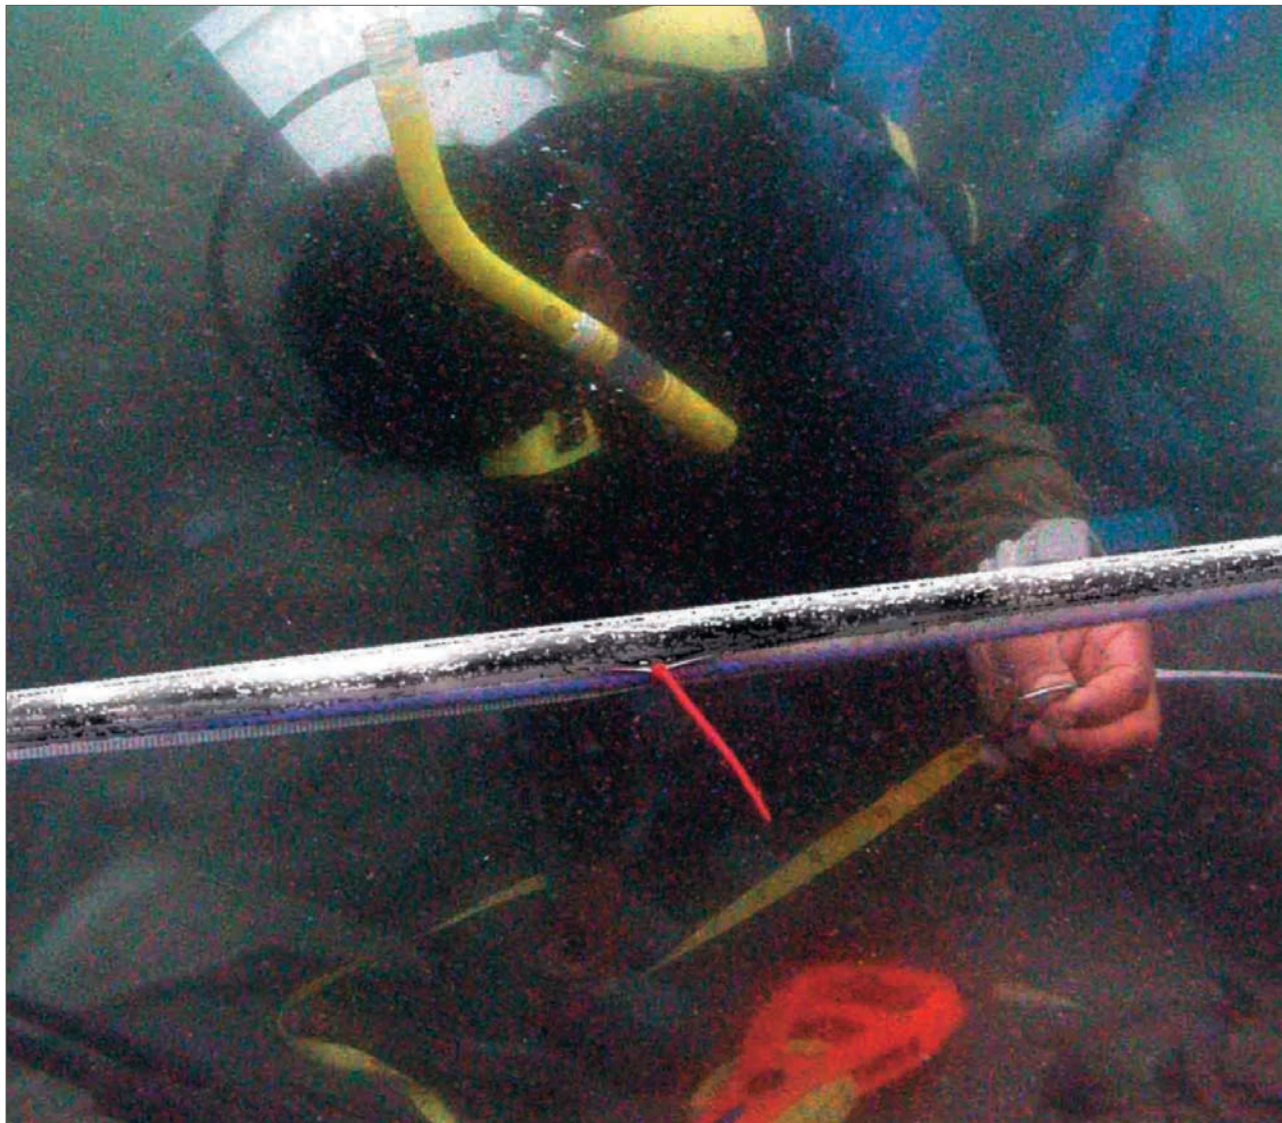
Figure 8.20 Taking measurements from levelled aluminium pole

An aluminium pole was positioned across the trench, between Survey Points 07 and 27 to take cross section measurements of the trench. The pole was levelled and measurements were taken according to the three-dimensional rectangular recording system. An additional pole was required to support the horizontal pole at the centre, in order to maintain a level position. After taking the cross section measurements, this was removed to continue with the excavation work.

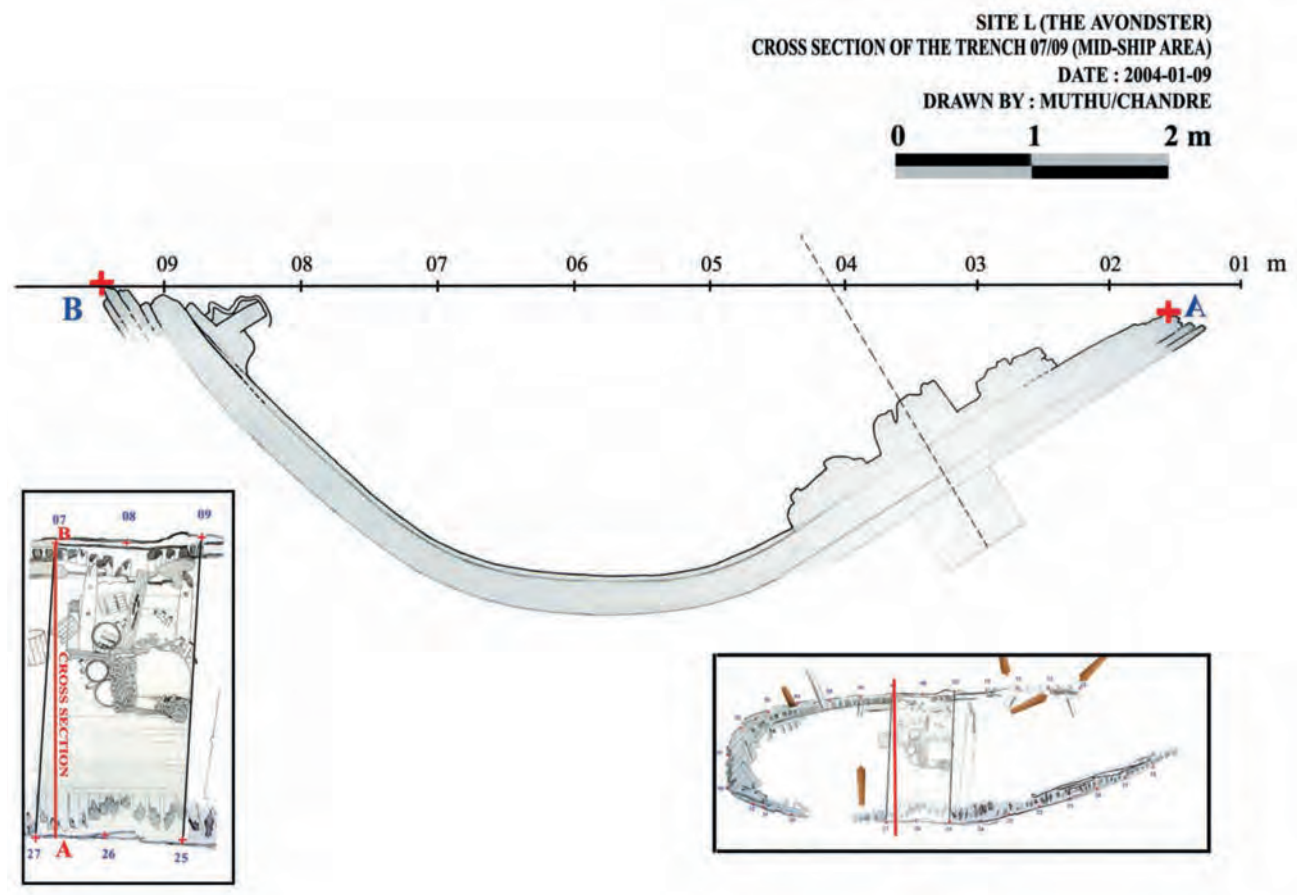
Figure 8.23 Cross section of trench 07/09

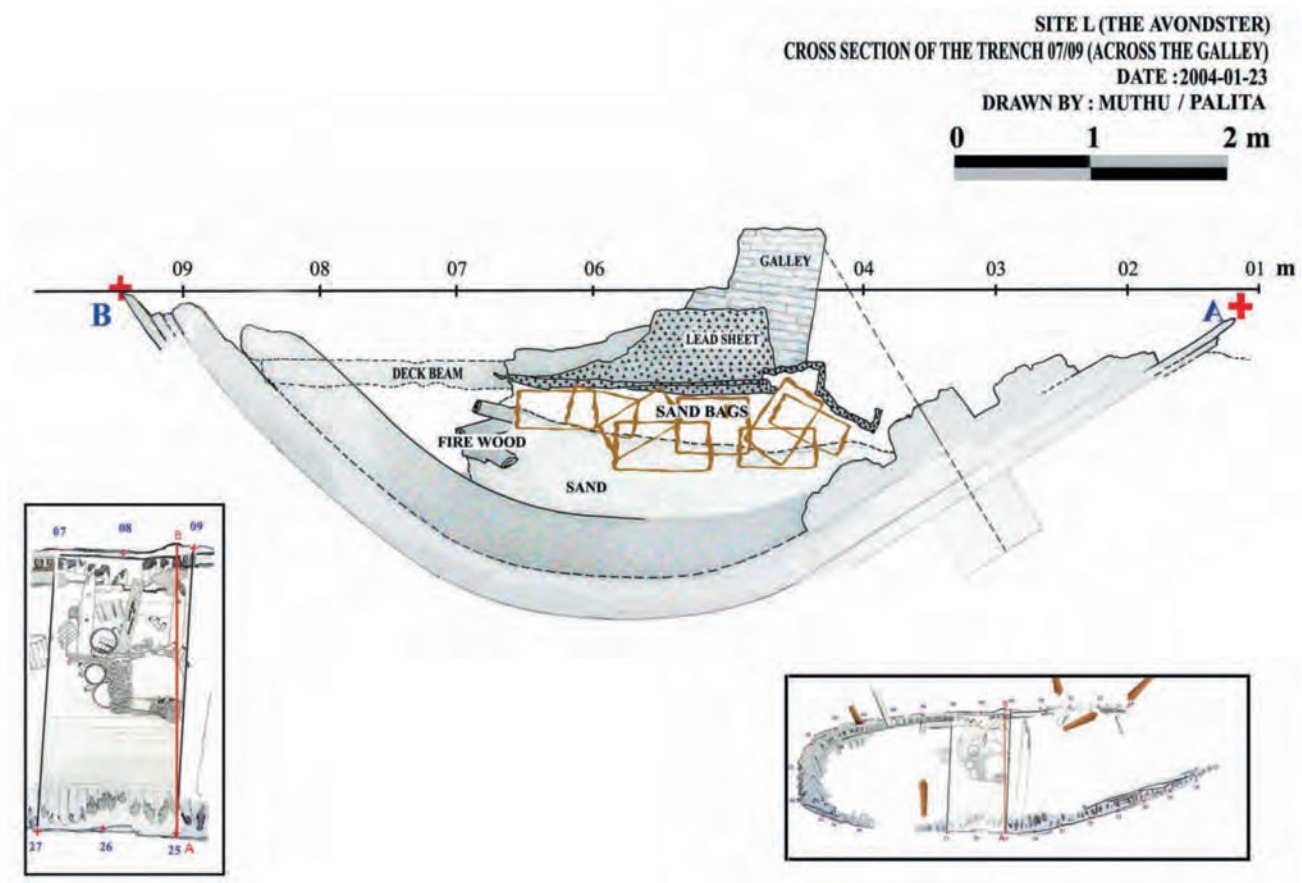
Figure 8.24 Cross section of the Trench 07/09 (across the galley)

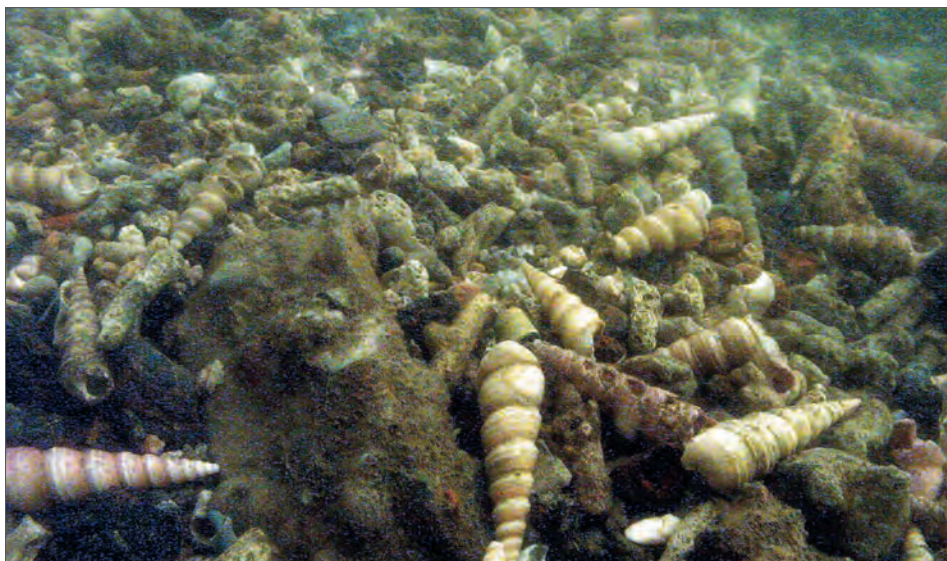
*Figure 8.26 Surface of the extended part*

and named "the extended part of trench 07/09". After taking a surface look at this section measurements were taken for the reports.

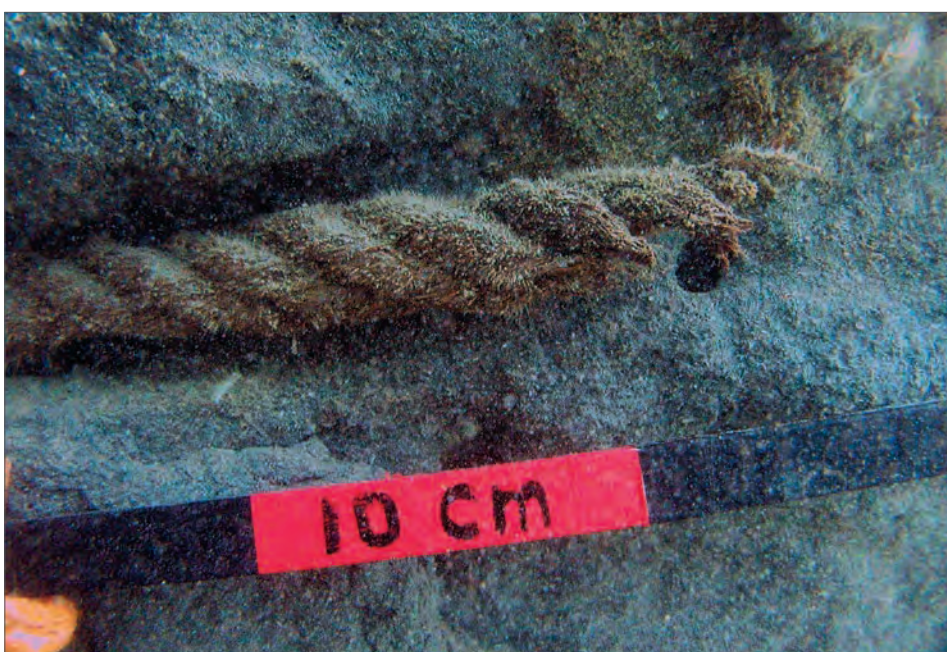
*Figure 8.27 Rope attached to the outside of the hull*

Before the excavation started, hundreds of crab remains and lots of concretions had to be removed from the surface of the trench. The excavation started on the 23rd February 2004 when a layer 40 cm in thickness was removed. This layer was formed of gravelly new sand and half decayed crab shells. A lot of pottery pieces were found in this layer as well as a little weight. After removing this layer the old grey slush sediments could be seen. Part of a wooden nail and a piece of a rope (diameter 5 cm) attached to the surface of the outside hull with slush was also found.

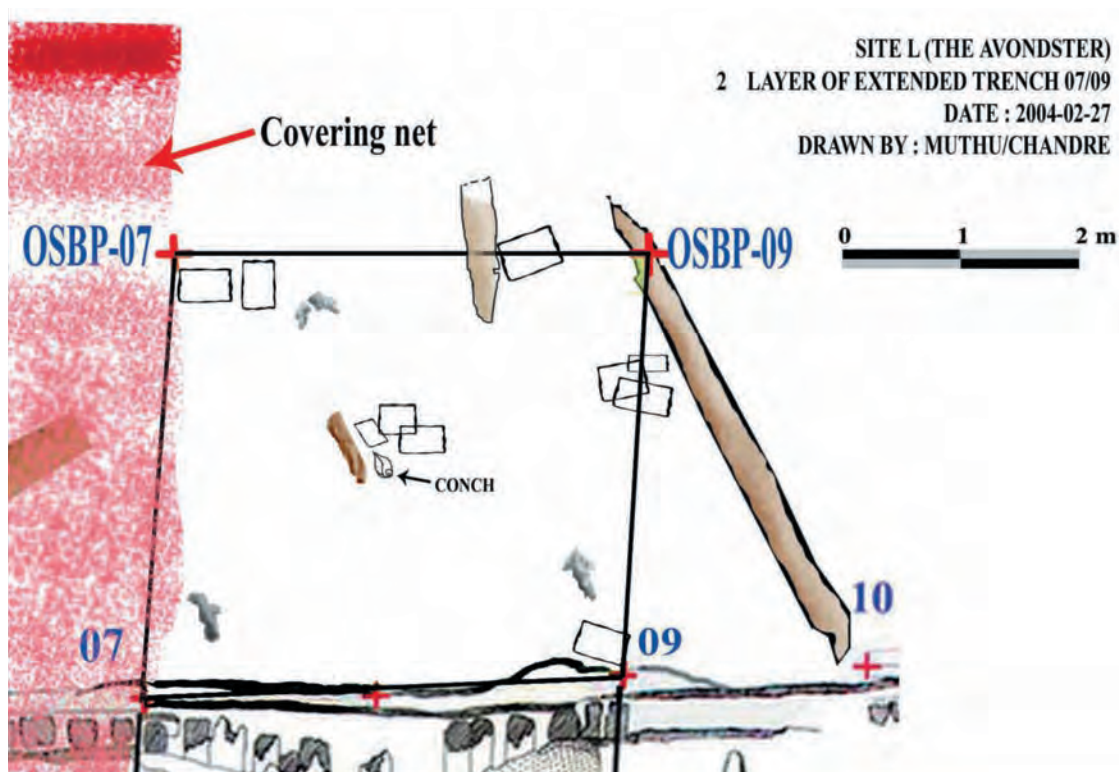
Figure 8.28 Second layer of extended trench

The excavation of the second layer took place from 27th February 2004. Fewer artefacts than expected were obtained from this trench, but a lot of pottery parts were found. A special find was a half decayed conch from the middle of the trench. Small parts of clay pipes and glass bottles were found all over the trench. There was a big wooden beam near the southern border of the trench and to the east large concretions could be seen. A layer of sand 55cm thick was removed from this second layer of the extended trench.

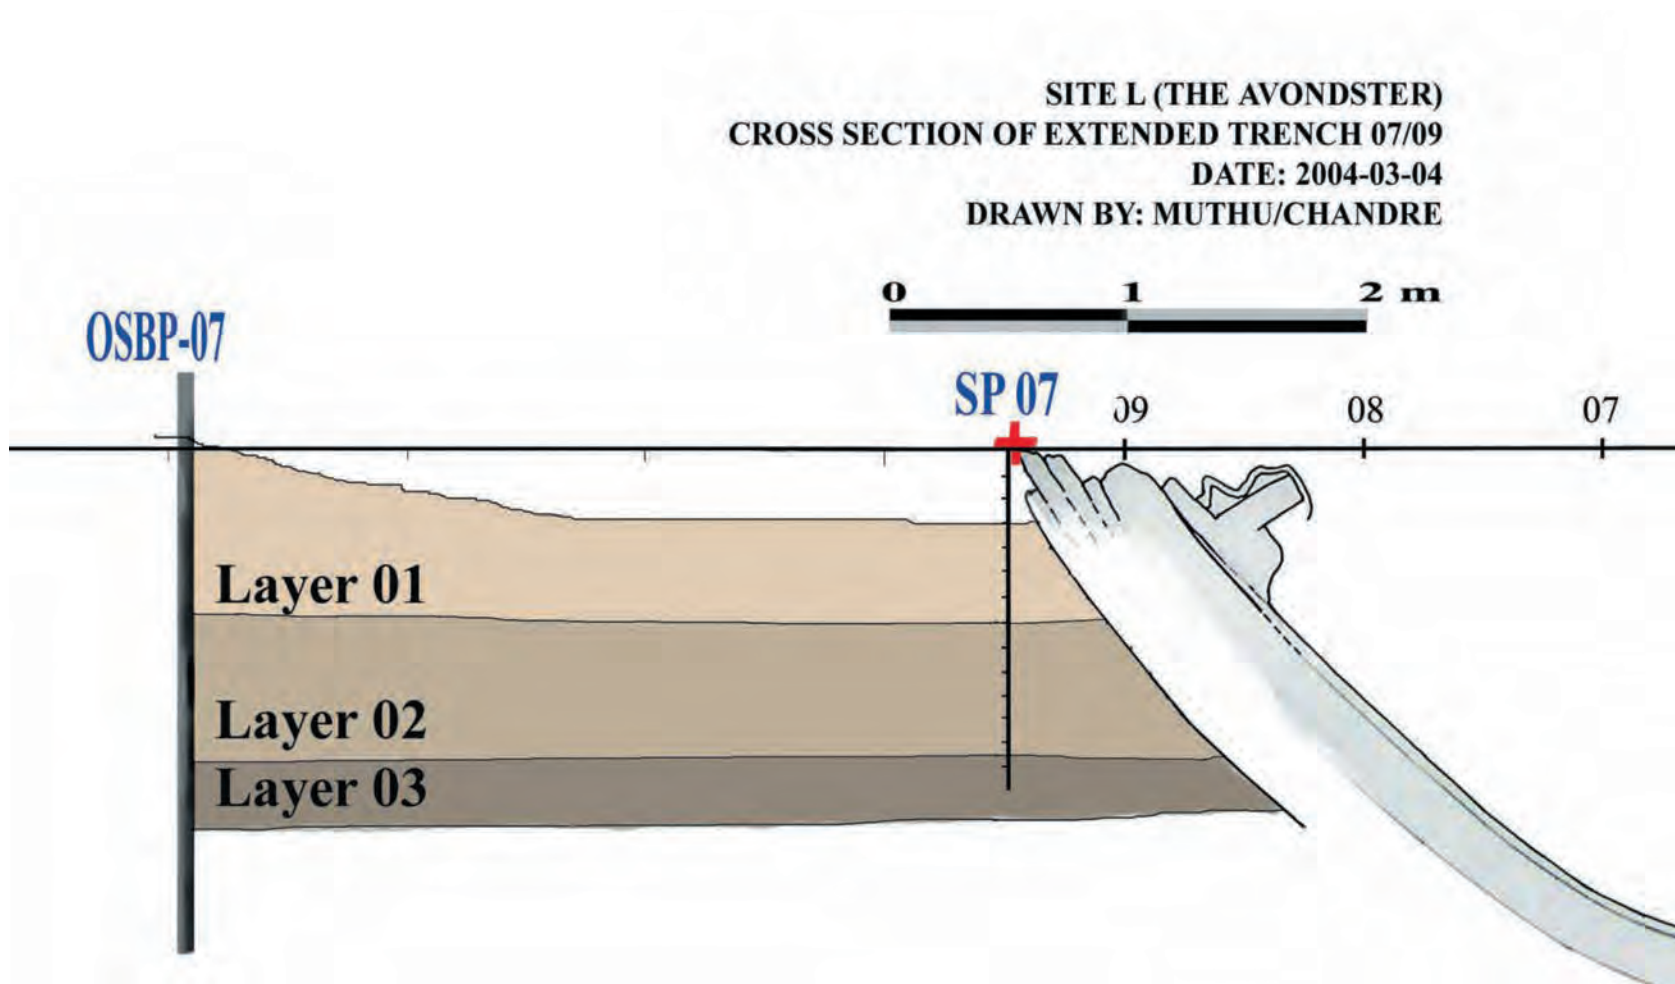
Figure 8.29 Cross section of the extended trench

The inclination of the ship could be determined to be 30 degrees to starboard. That means that more of the starboard side has been preserved then previously thought. It was considered that during the wreck forming process parts of the ship and artefacts would have been spread outside the ship's hull on the starboard side. The excavation of the extended trench 07/09 does not support that assumption.

A cross section of the hull of the ship was taken and important features like the keelson probably exposed. Although it cannot be confirmed where the master frame was located since the mast step has not yet been found, it will provide essential data for further analysis.

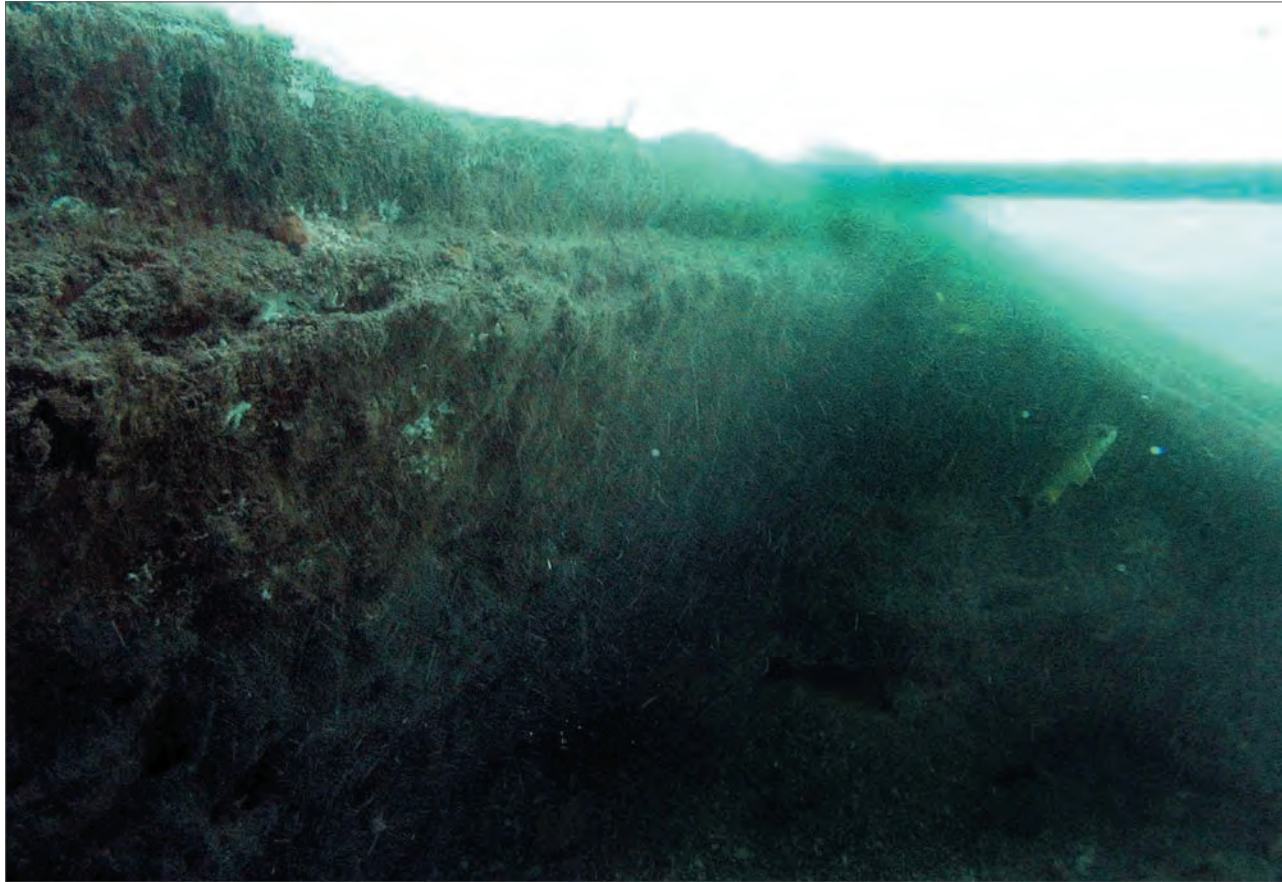
*Figure 8.30 The outside surface of the hull from the extended trench*
