# *Excavation report of the VOC-ship Avondster (1659)*

The  
Anglo-Dutch  
East-Indiaman  
that was wrecked  
twice in Ceylon

# 1 *Avondster: an East-Indiaman in Asia*

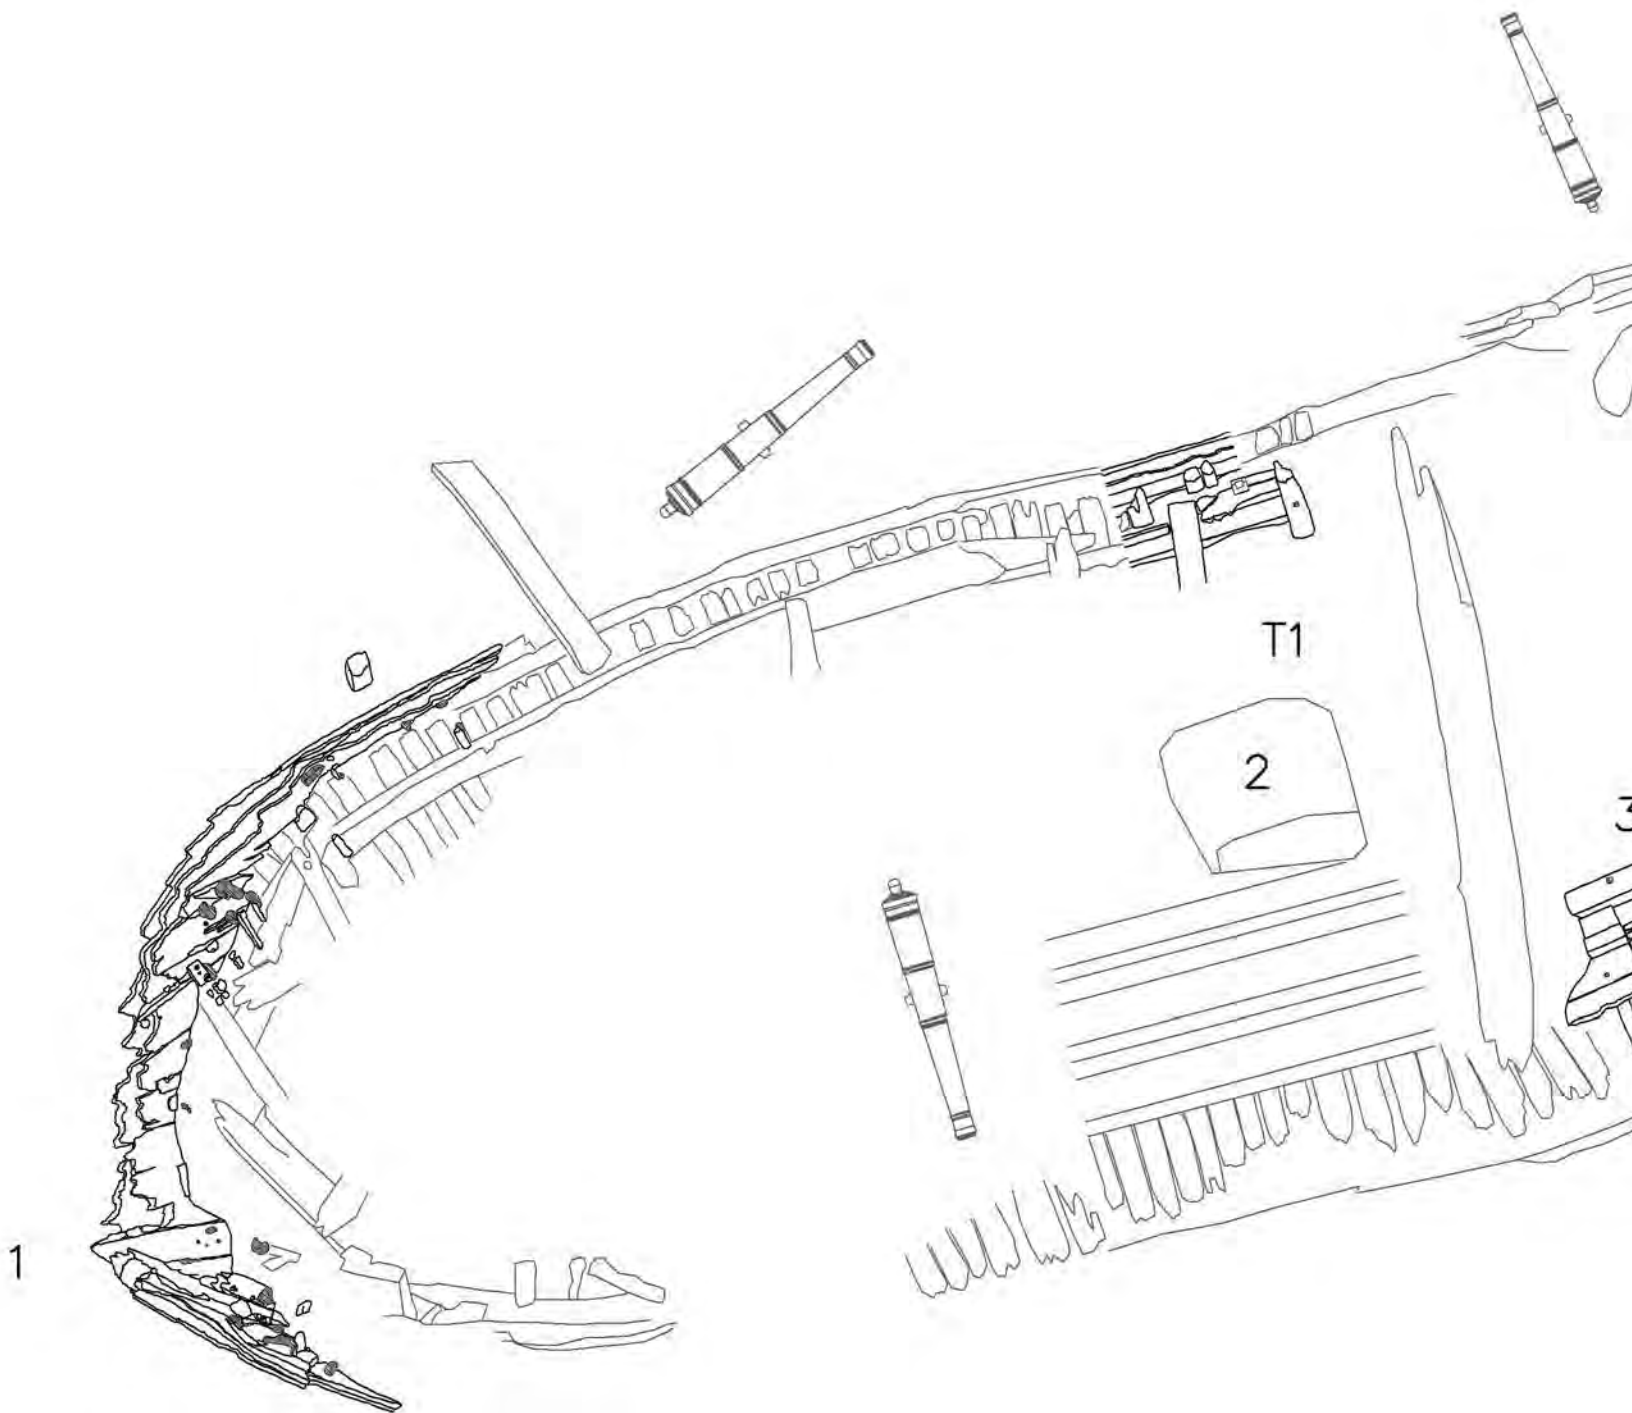
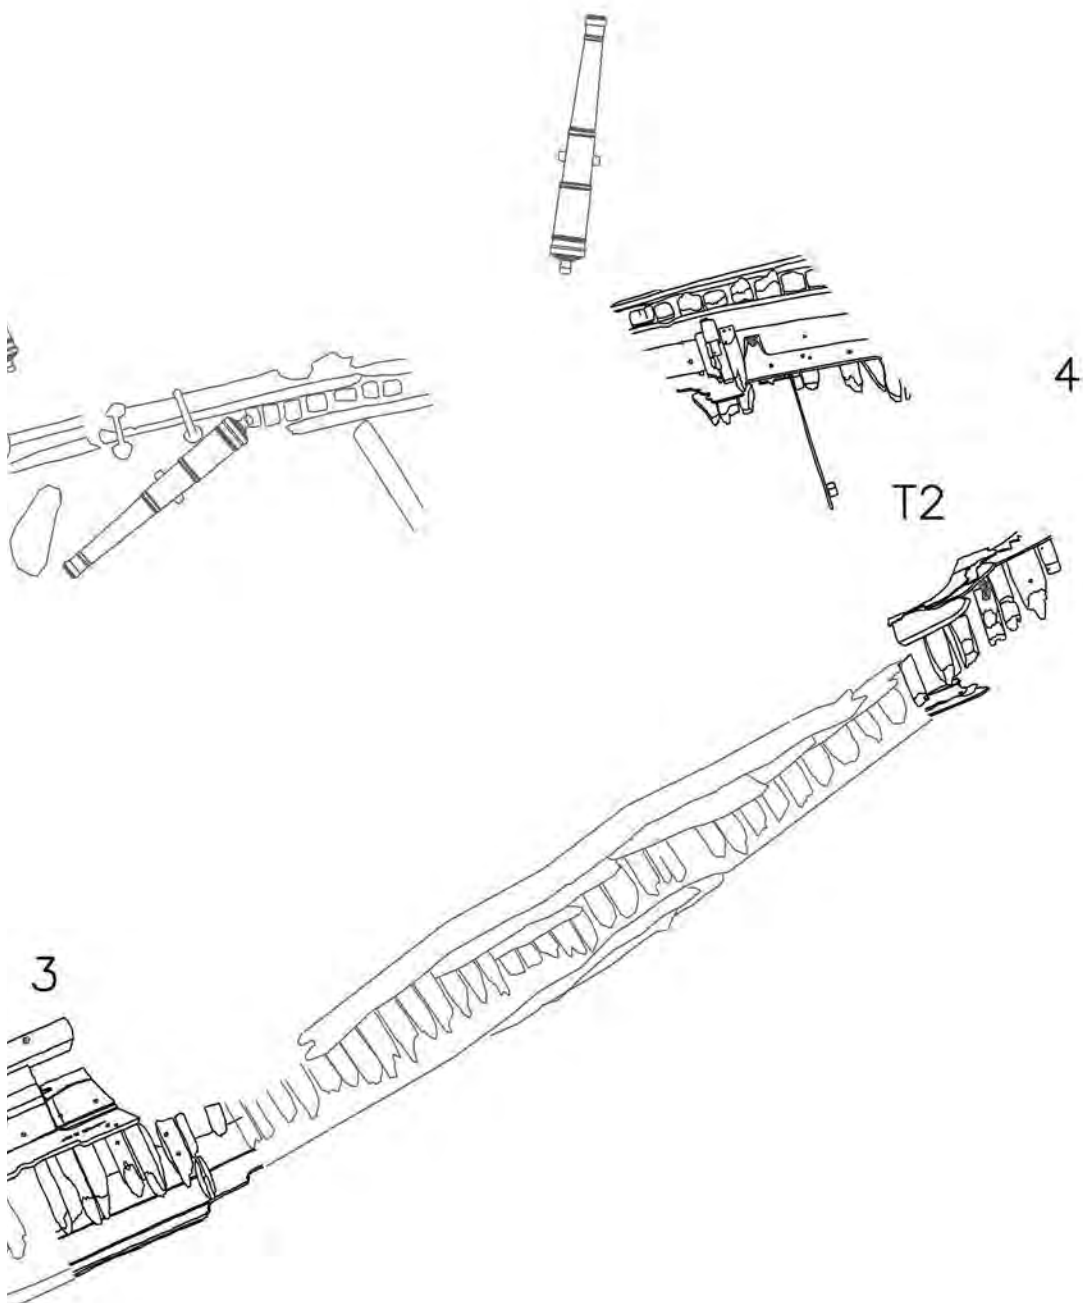
Figure 9.3 Plan of the exposed hull remains; the grey lines illustrate the areas recorded in previous fieldwork.

- 1. Bow,
- 2. Galley,
- 3. Keelson,
- 4. Stern,
- 5. Sternpost section,
- T1. Trench 01,
- T2. Trench 02

(drawing by K. Camidge and C. Murray, based on recordings of the 2003-2004 field seasons and previous site plan by R. Muthucumarana).

During the fieldwork carried out in February-March and November-December 2003 and November-December 2004 different areas of the site were recorded to enable the study of the ship's structure. Some of these areas were excavated while others were not (Figure 9.3).

The remains of the ship's hull consist of an integral structure around 30 m long and 8.60 m wide and a section of the stern, which is detached and lies, at the nearest point, 12 m from the former (see Figure 9.3). The said structures cover an area of about 220 m<sup>2</sup>. The presence of disconnected structures or components buried under the sand can not be discarded.

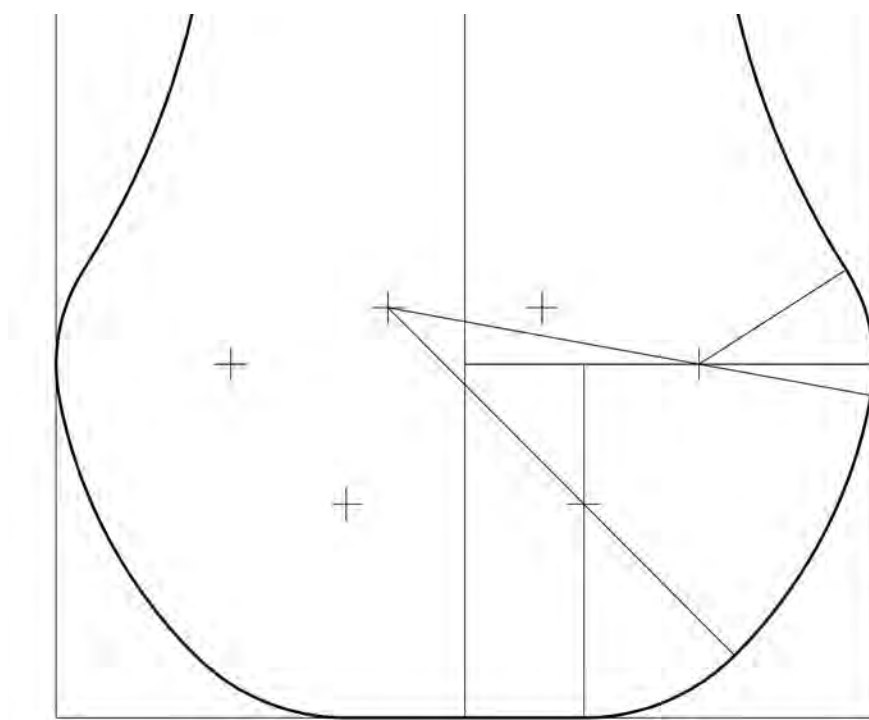
Figure 9.4 Reconstructed midship section of the Avondster based on the *Treatise on Shipbuilding* from c. 1620–25 (drawing C. Murray).

The midship section was, in the English shipbuilding of that period, a major factor in controlling the hull form. Most of the manuscripts explain the procedure to delineate it. Figure 9.4 shows the reconstructed midship section of the *Avondster* based on the proportions and geometry explained in the referred treatise. The radius of the principal arcs that mould the midship section – the floor, breadth and reconciling sweeps – are a given proportion of the main breadth (Salisbury & Anderson 1958). This reconstruction could not be compared so far with the archaeological remains since only small sections of the frames have been exposed during the excavation.

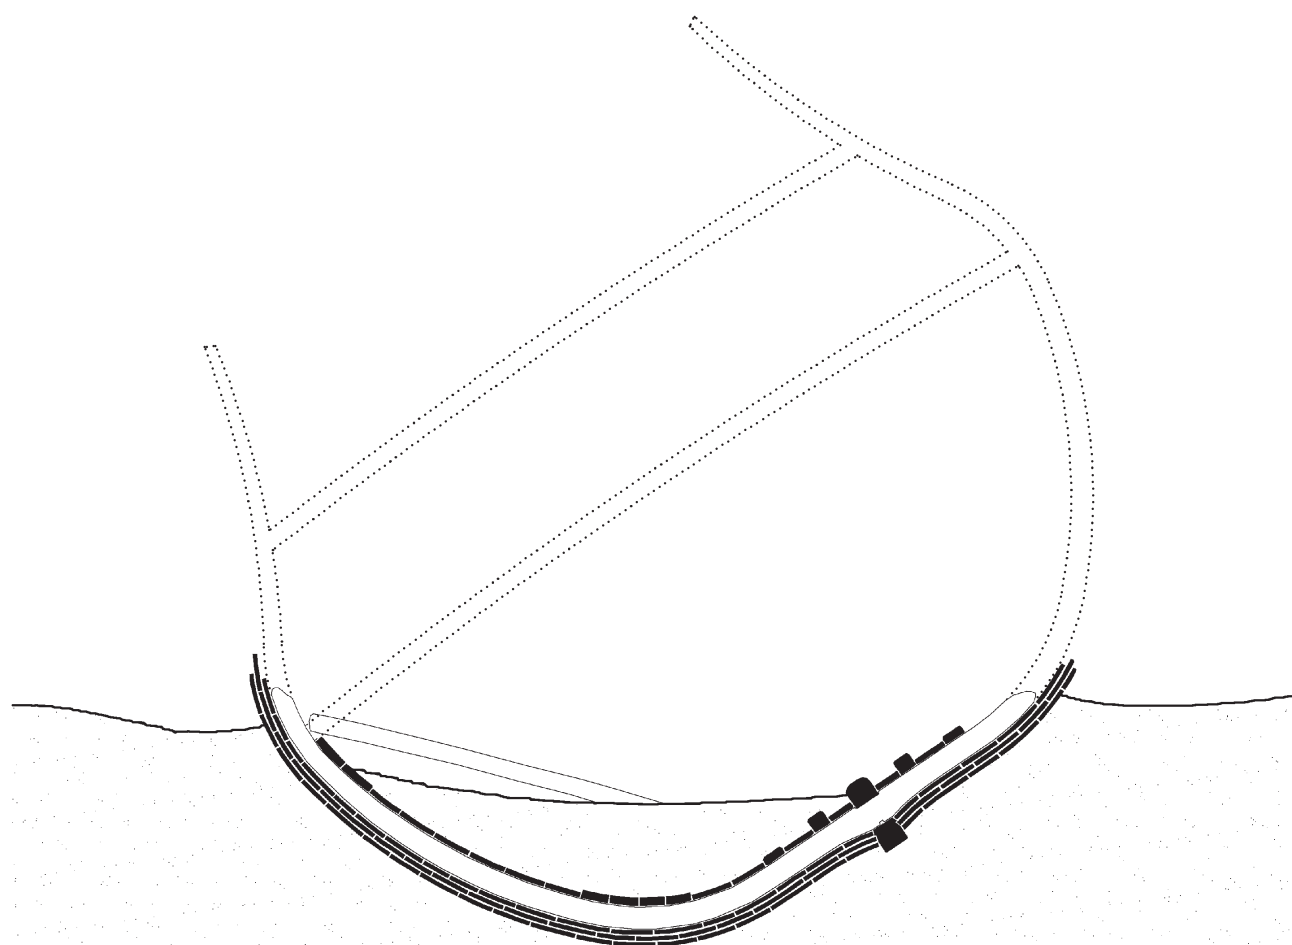
Figure 9.5 (A-B) Schematic cross sections of the surviving structure based on the recorded exposed remains and the reconstructed section of Figure 9.4 (looking abaft): A. Midship, B. Stern. The missing parts are drawn with dotted lines (the stern keel section lays separated from the main structure); the buried remains are hypothetical (drawing C. Murray).

The wreck is lying on the seabed on its starboard side (Figure 9.5 A–B). Measurements taken in the stern area after excavation gave a list of 34 degrees, which seems to be consistent throughout the length of the surviving hull structure. The disposition of the cannons along the starboard side, some of them outside of the ship, is consistent with the mentioned list. This also indicates that the wreck lay in that position for a long period, even before it broke up. From observations made during previous fieldwork, it is quite probable that collapsed parts of the upper structure are still buried under the sand outside the starboard side (Manders et. al. 2003, Parthesius et al. 2003). However, an excavation trench outside the wreck following the line of the midship trench (Trench 01) did not reveal any significant structural part (see chapter 8 on Trench 01).

The remains of the main structure do not project above the sediment level more than 40 cm. Due to the pronounced list, the starboard side is buried to a significant extent and is therefore much better preserved than the port side. The starboard side has survived as high as the main deck, well above the turn of the bilge. The port side has survived not beyond 2.5 m from the centreline.

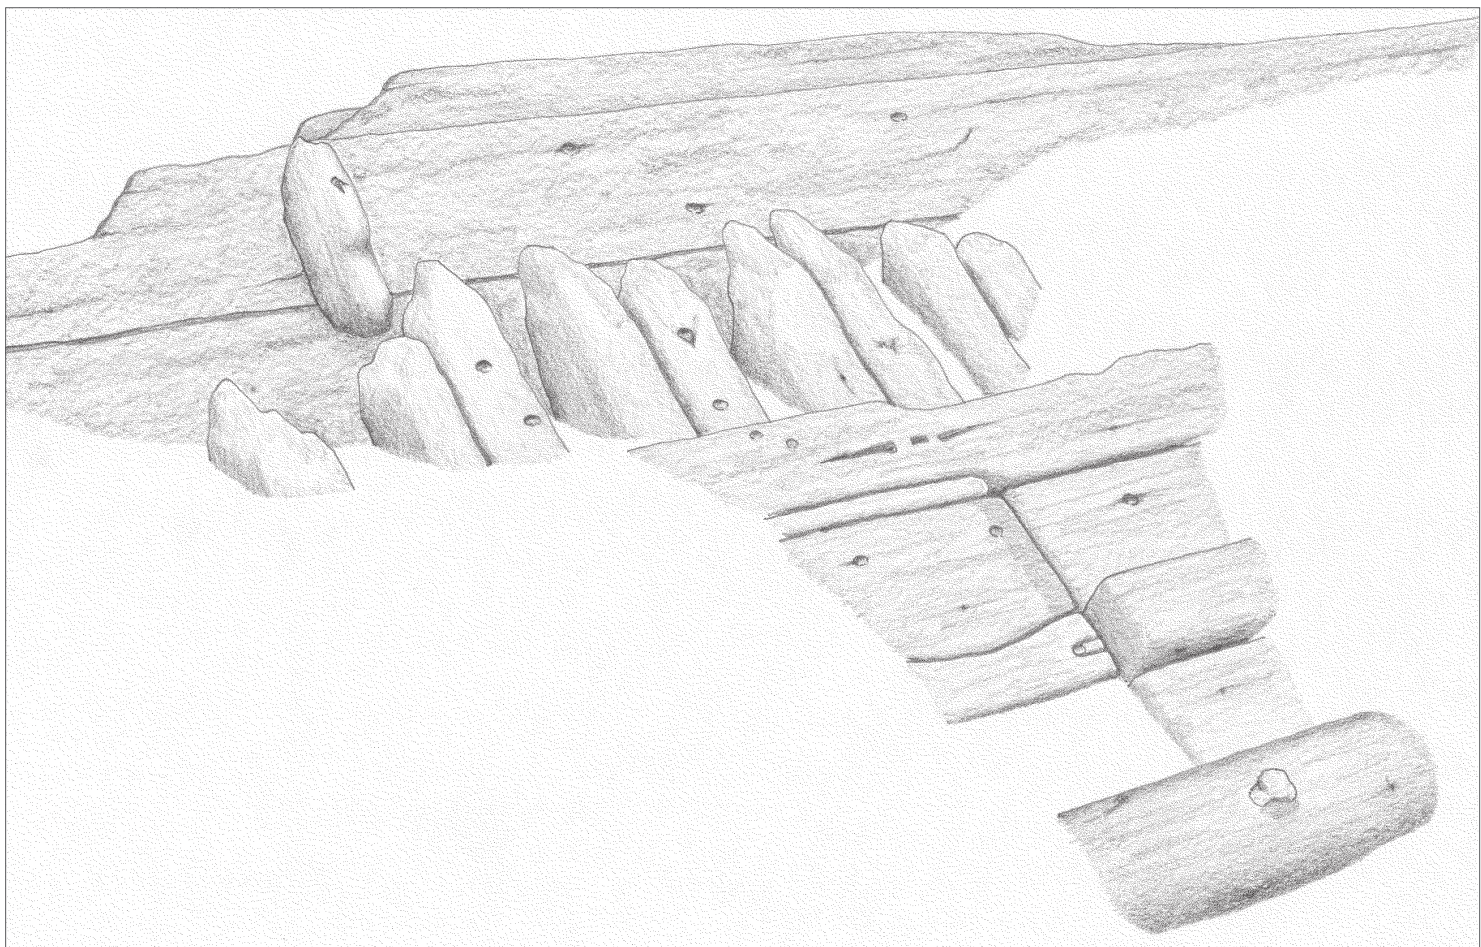
*Figure 9.6 Sketch of the port side bottom remains excavated amidships. The timber with an iron concretion at the low right corner of the illustration is the keelson (drawing C. Murray)*

A certain pattern in the framing structure was detected, at least 22 of the 26 recorded single frames are arranged in pairs (Figure 9.6). This disposition suggests a double-frame construction system, in which the frames comprise of two rows of overlapping futtocks. Double frames were used in shipbuilding of the period, mainly in the bigger yards for the construction of warships and Indiamen (Goodwin 1987, Morris et al. 1995). According to Anthony Deane's *Doctrine of Naval Architecture* (1670) the frames of an average size ship consisted of a central floor timber, three overlapping futtocks and a top timber on each side of the keel (Lavery 1981).

A set of longitudinal timbers of different sizes placed atop the frames at the midship area are part of the ceiling, the internal planking of the hold (see Figure 9.6). The outermost element towards the portside, which is 110 cm from the centreline, seems to be a stringer, a thick plank that provided additional longitudinal strength (see Table 2). The inboard edge of this timber has a rebate where a narrow piece of pine is fitted, probably a repair made at some point in the ship's life. Adjacent to the centreline lays a common ceiling plank. Next to it the limber strake, the lowest permanent ceiling plank, is placed. The thickness of the timber indicates it also has a structural function

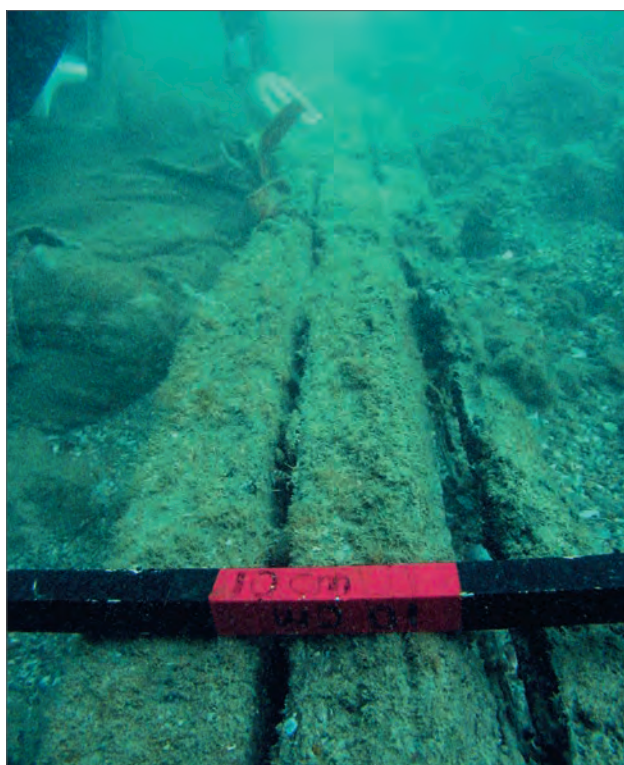
Figure 9.7 The three layers of the *Avondster* external planking; from left to right: sheathing, middle layer and inner layer.

The external planking is visible in most parts of the site, both on the starboard and the port sides. It is 'carvel-built', that is, built with planks laid flush onto the frames and fastened to them. Interestingly, the planking comprises two layers of planking plus a third layer of sheathing (Figure 9.7). It has a total thickness of as much as 21 cm, which is even thicker than the frames!

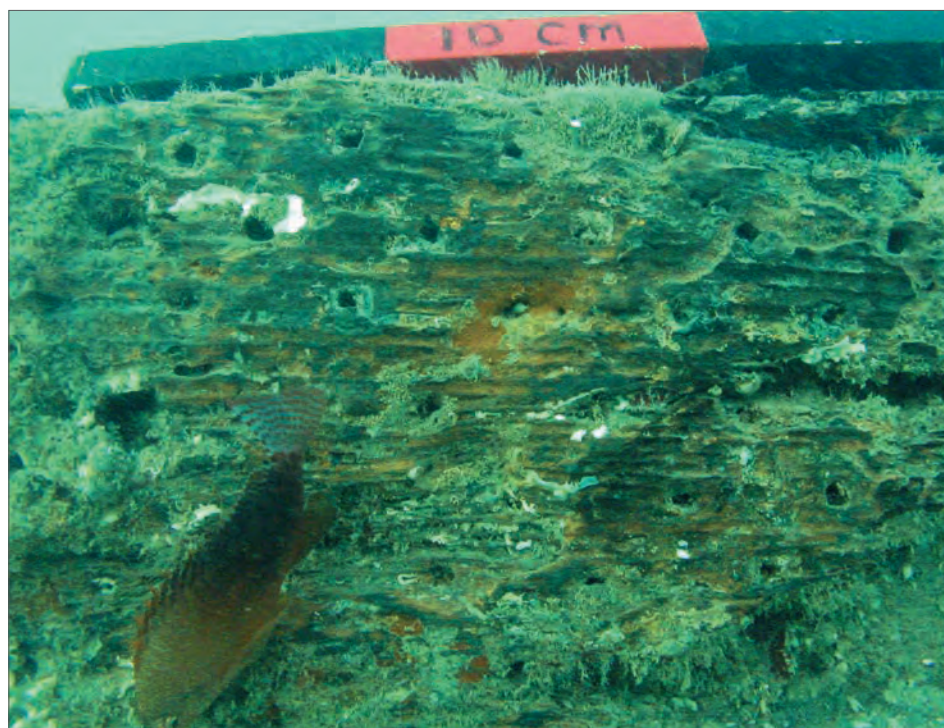
*Figure 9.8 Holes left by the iron nails, now corroded away, driven in the external surface of the pine sheathing for extra protection against wood borers.*

of a small portion of this sheathing, rectangular holes of 5 by 6 mm in a diagonal pattern were exposed (Figure 9.8). This additional protection from wood borers was also found in other Dutch wrecks like the *Batavia* (1629) and the *Buitenzorg* (1759). In a written reference from 1634 it was required that the protection by external nailing become standard practice in VOC ships sent from the Netherlands (Coolhaas 1960). A similar method was also used in England where it was known as 'filling nails' (Bingeman et al. 2000).

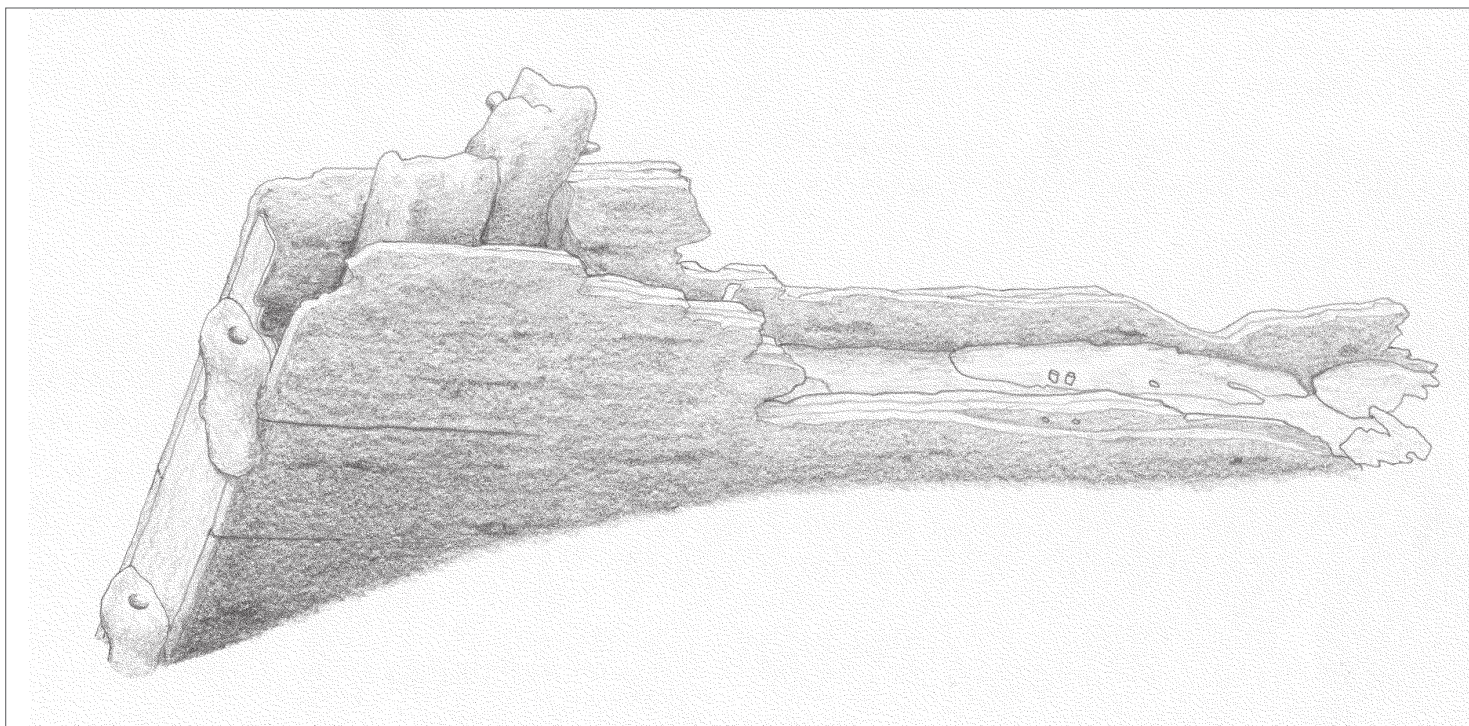
*Figure 9.9. Sketch of the lower stern hull section that lies on the seabed detached from the main structure. The sternpost has broken up just above the upper surviving rudder gudgeon (drawing C. Murray).*

The assumed sternpost has a slight upward curvature and is flanked on both sides by the strakes of the external planking. From the angle that the strakes join this piece, the surveyed segment would belong to the lower section of the sternpost. No traces of associated timbers like the apron (the inner false post) were observed within the exposed structures. Remains of a caulking or protective material were observed in this area inside the joints of some timbers. It seems to be composed of a matting of animal hair and tar. A similar product was found in the wrecks of the B&W2 (before 1609), *Sea Venture* (1609), HMS *Dartmouth* (1690) and the VOC ship *Batavia* (1629). Its applied on the hull together with sacrificial wood sheathing in the seventeenth century British Navy, as well as on VOC ships, is known from historical records (Bingeman et al. 2000). lower segment of the sternpost is one of the main structural components of the hull section which is detached from the main structure (Figure 9.9). This hull section is a homogeneous structure which presumably retains its original shape. Most of the internal structure could not be recorded since it is covered by the external planking.

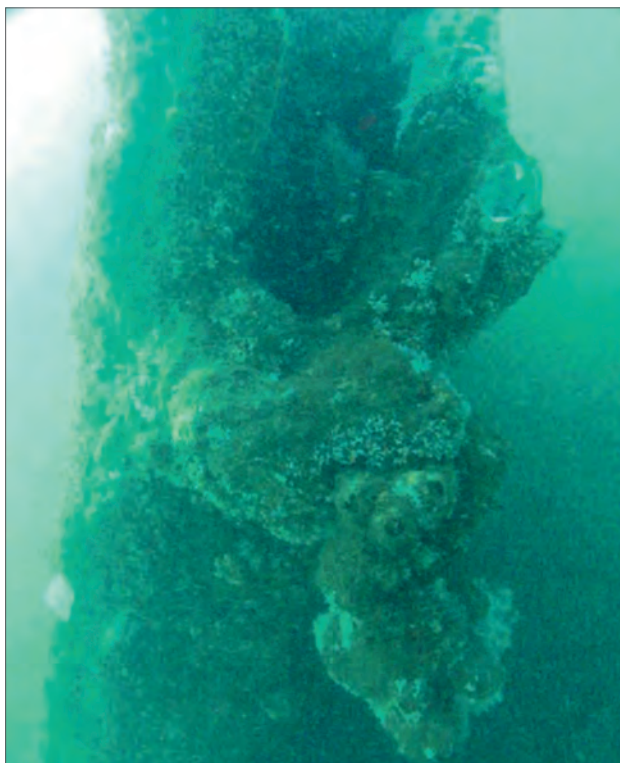
Figure 9.10. The surviving upper rudder gudgeon, heavily concreted, still attached to the sternpost.

Two iron concretions protrude from the aft side of the sternpost, which are presumed to be the remains of the rudder gudgeons (Figure 9.10). The distance between the top sides of both gudgeons is 108cm. The braces of these fittings are not visible, seeming to be covered by the planking. Interestingly, the sides of the sternpost are also covered by the external planking, although it seems to be only by the pine sheathing. No traces of the rudder were observed in this area.

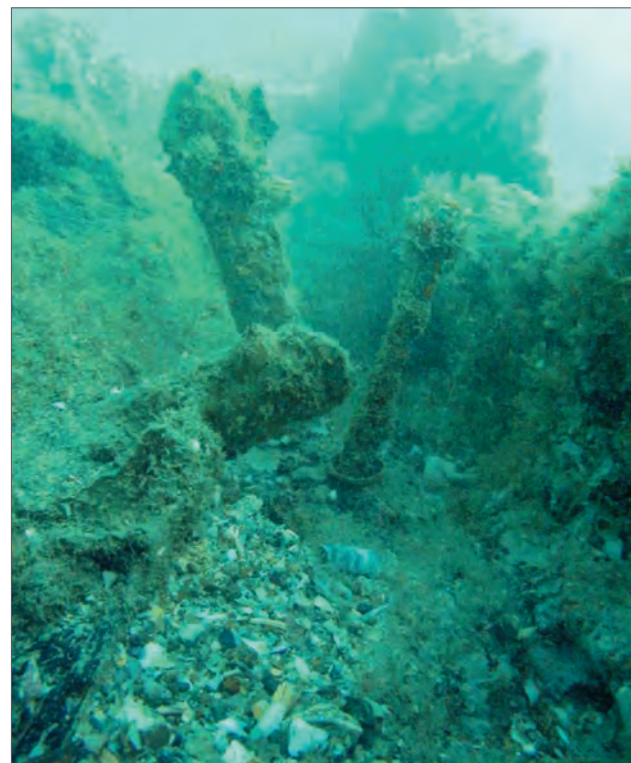
Figure 9.11. Iron bolts protruding from the wooden remains of the stern hull section, between the planking strakes.

Two vertical timbers project out from the top of the stern structure afore the sternpost. The one abaft is probably the inner post, a timber attached to the forward surface of the sternpost to increase its strength. The forward timber could be the upper part of the deadwood knee. A number of iron bolts can be seen protruding afore this timber, between the lower strakes of planking (Figure 9.11).

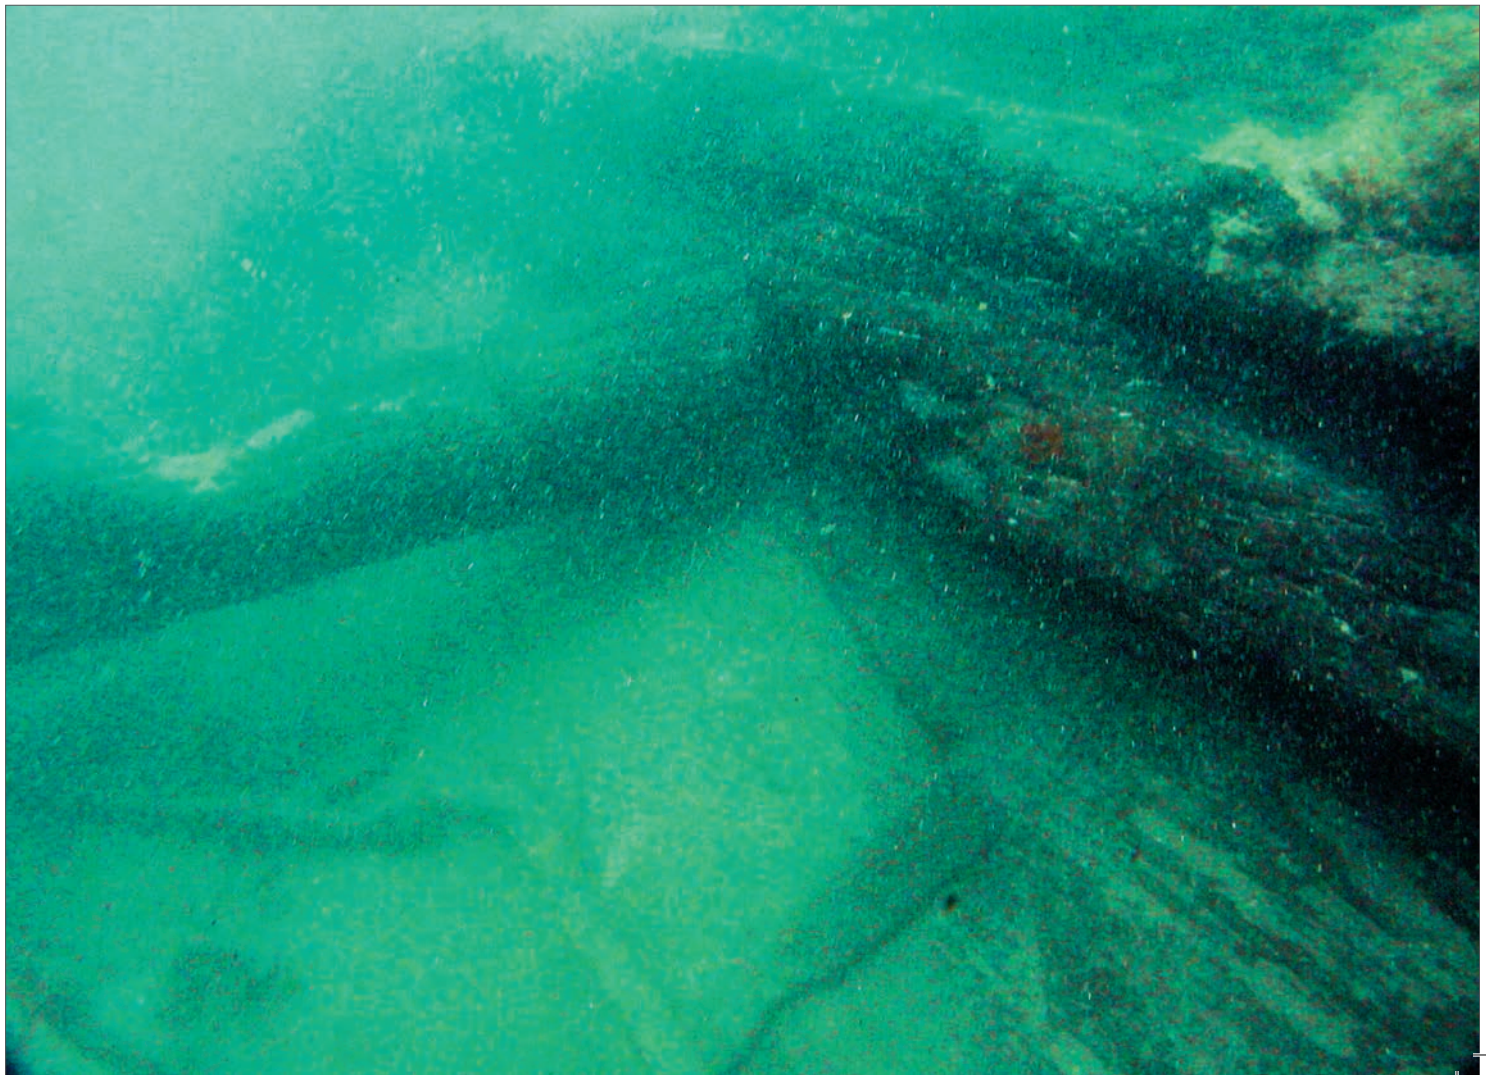
Figure 9.13 Midship starboard side section.

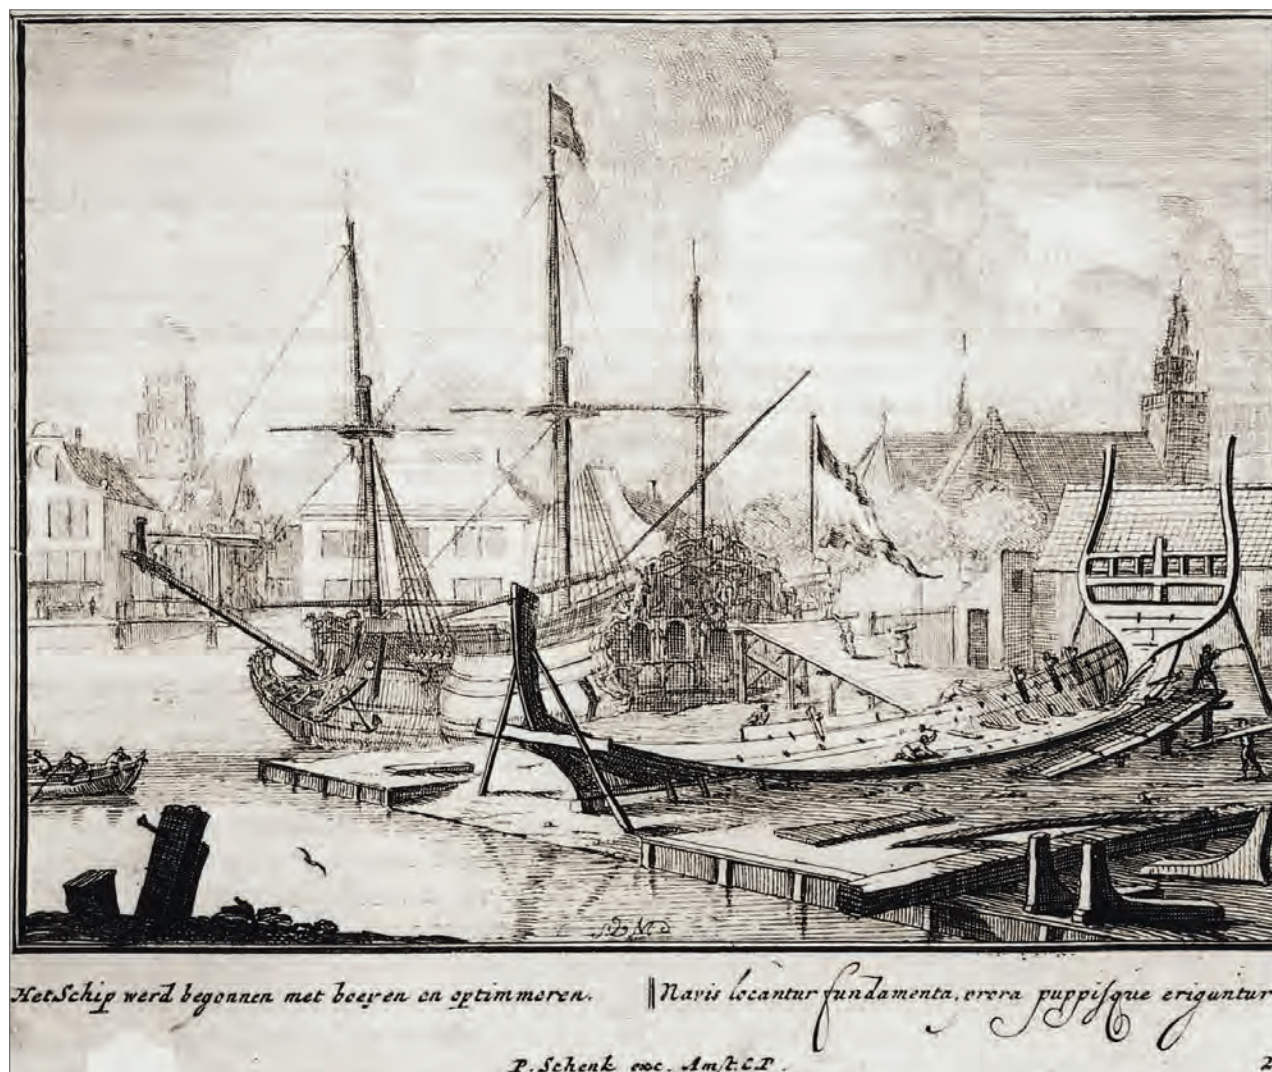
Figure 9.14 Drawing by Sieuwert van der Meulen from his series *Navigiorum aedificatio* from around 1700, showing the Dutch flush-planked shipbuilding (Groot & Vorstman 1980).

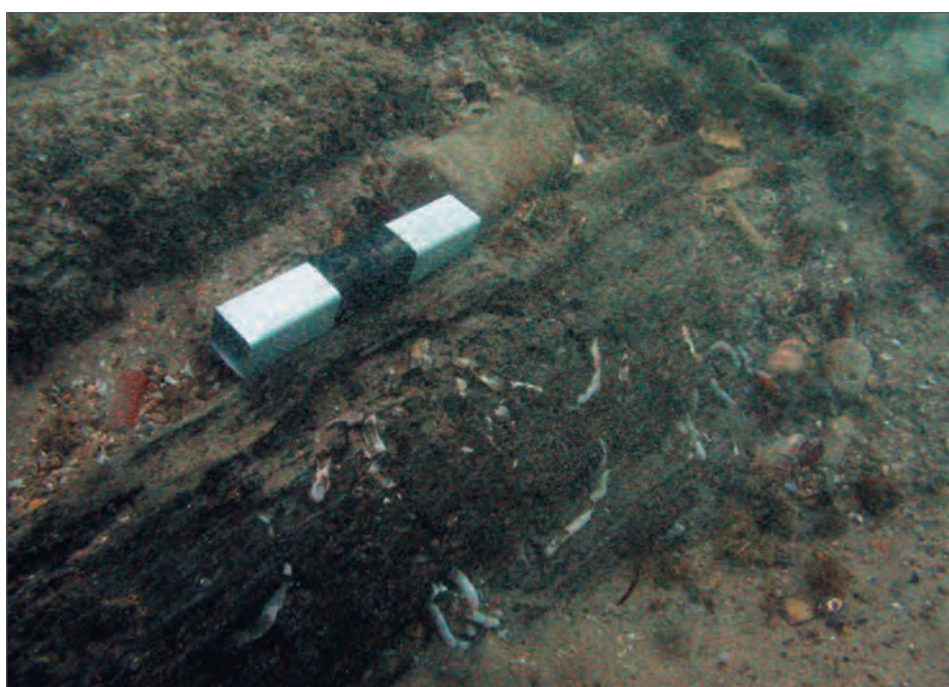
Figure 10.3 Exposed oak wood in the bow section, severely attacked by shipworm (*Teredo navalis*)

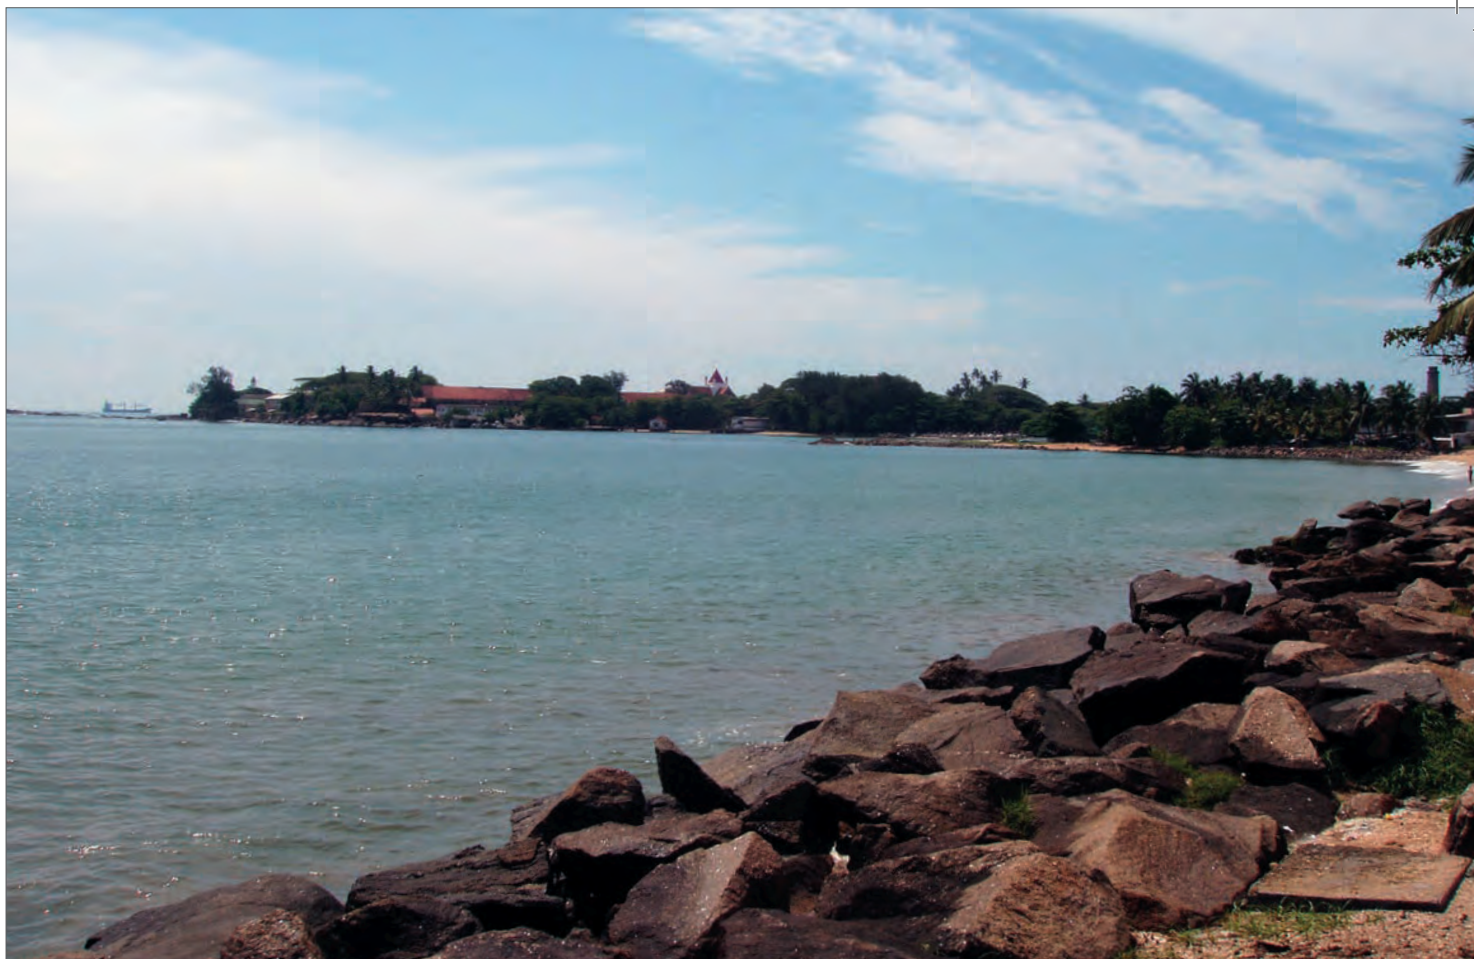
*Figure 10.4 View from the stone barrier, protecting the road, towards Fort Galle and the ocean. This stone barrier is causing strong erosion on the wreck site that is lying just about 80 metres in front of it.*

The building of a road with a rock wall on the beach line only 50m from the wreck, a few decades ago, is almost certainly the reason for the strong erosion [Figure 10.4]. The road has been built on the former beach, effectively severing the river outlet. Waves coming from the ocean are abruptly stopped against a rocky wall instead of breaking on a gradually sloping sandy coast and are then redirected out to sea again. This effect, called winnowing, creates a strong current around the wreck site, undermining the structure and removing the protective layer of fine silt and sand. Because of this stone barrier the river cannot deposit its fine sediment on the site anymore. It seems that in one decade the seabed around the wreck site has eroded dramatically. In 2003 new work was executed on the stone barrier close to the wreck. Some jetties were constructed in the water. Immediately the currents changed course and more sediment was removed from the site in places that were relatively stable prior to the new constructions. It is also possible that the seasonal excavations have had an influence on the stability of the wreck site itself. Excavating sediment and building structures on and near the wreck obviously creates different current patterns on a local scale, increasing erosion. Although previously noted on other sites, this phenomenon has not been extensively investigated.<sup>2</sup>

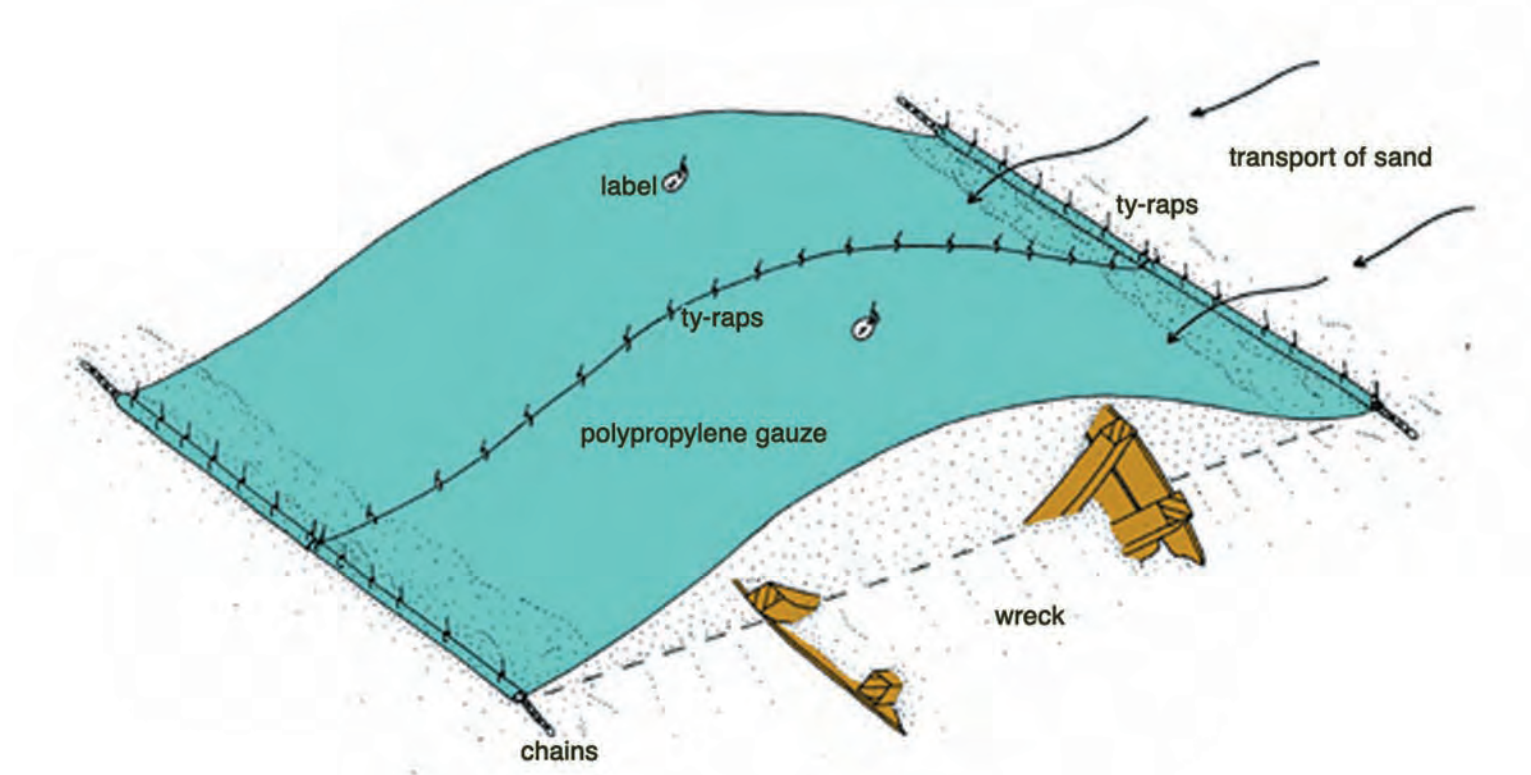
Figure 10.5 Principle of in-situ protection with polypropylene nets. This is how it is executed in the Netherlands (wrecks in the Wadden Sea). The in-situ protection on the Avondster is derived from this principle. Drawing M.Manders/M. Kosian

It was decided to do a test protecting the site with polypropylene nets (Manders 2002 and 2003a) (Figure 10.5). This method has been used extensively in the Netherlands. There, shipwrecks that lie in a dynamic environment with high levels of sediment transport are covered with these nets. The sediment that is suspended in the water column during periods of high water movement can penetrate the net through the tiny holes. At the same time, the net will also break the current, so sand particles will settle under it. Within a short period of time the wreck site is buried. In many ways, the environmental conditions in the Wadden Sea (NL) and the North Sea (NL) are different from that in Galle Harbour. It is much colder (0 – 22 °C) and

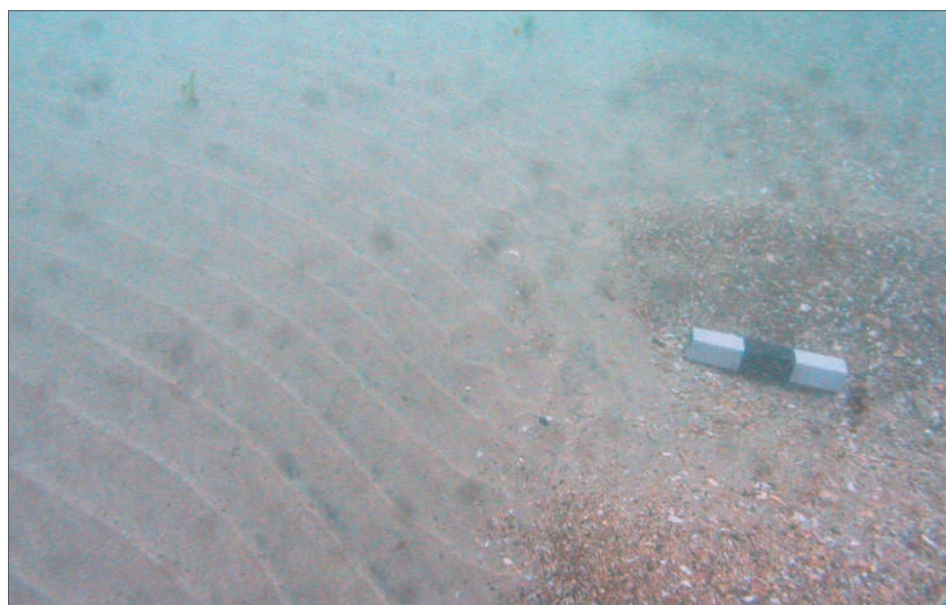
Figure 10.6 Fine and coarse sand on the Avondster site.

with stronger tidal movements (in the Wadden Sea 3-4 metres) more sand is transported up and down the seabed and also more gradually. The tidal range in Galle is only 0.5 metres. Sand is merely moved by swell and a variable surge. On the other hand, the conditions in the Netherlands can also be compared with those at the *Avondster* wreck site; both locations are shallow, have a sandy seabed and both do have natural sand transport (Manders 2003a)[Figure 10.6].

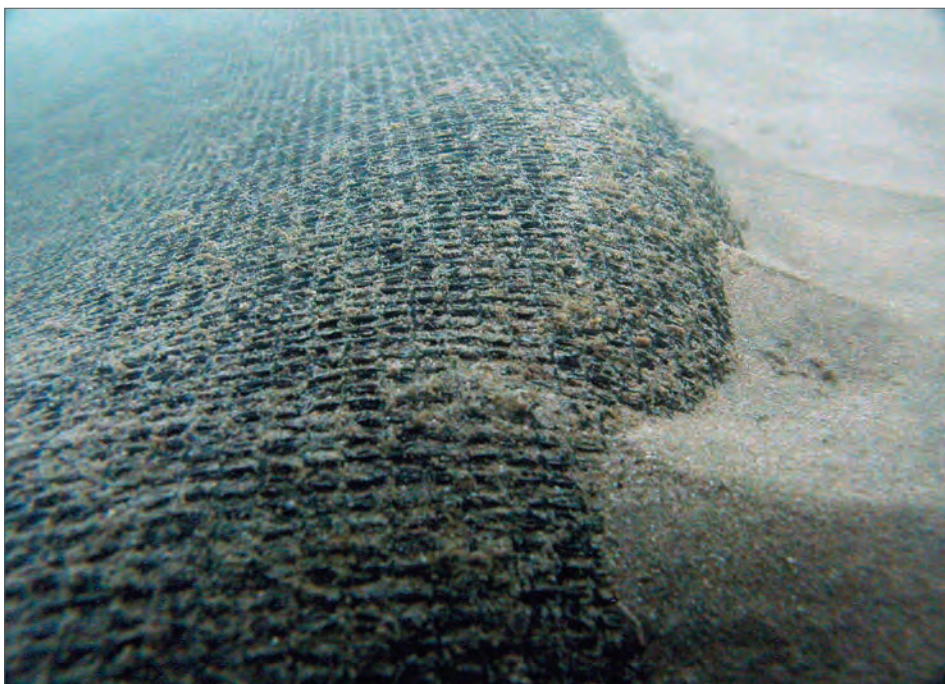
*Figure 10.7 A-B First test executed on the Avondster site with shading net (woven, 100 % polypropylene and 60 % density). Old chains served as weights to keep the net down on the seabed.*

This method was applied on the *Avondster* site in February 2003. An area of approximately 4 x 4 meters on the aft, port side of the wreck (the southwest of the site) was covered with black shading net (woven, 100% polypropylene and 60 % density) [Figures 10.7 A-B]. The net was weighed down with old chains. In this particular area the ships structure was slightly exposed, with a 40 to 50cm deep scouring gulley on the outside of the wreck. Within two weeks a 15cm layer of very fine silt or sand settled under the net, while outside of this test net, only coarse sand and shells were visible; sand and shells that could not have penetrated through the holes of the net (Weerasinha 2004). Most deposited silt and sand under the nets was found on the borders of the wreck structure. Sand had completely filled up the scouring gulley, just outside the wreck, under the portside. Only a thin layer of silt/sand of a few cm thick was deposited inside the wreck. After a further two weeks little further accretion occurred and the holes in

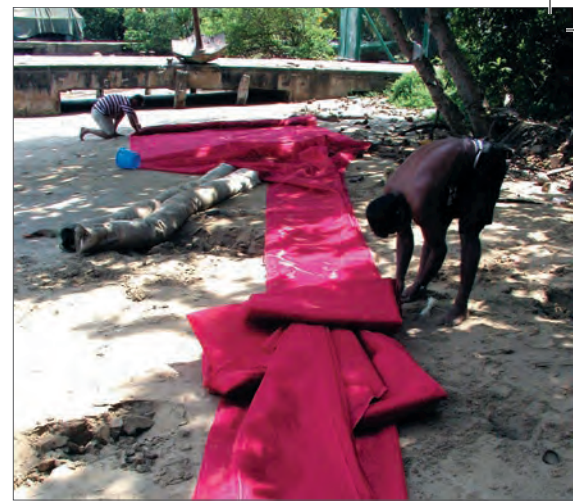
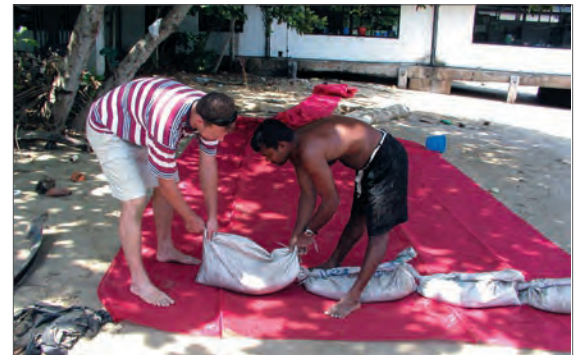
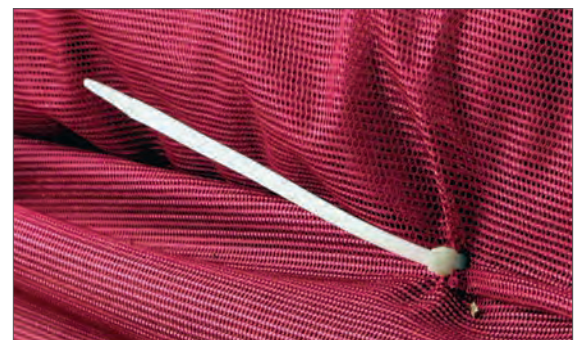
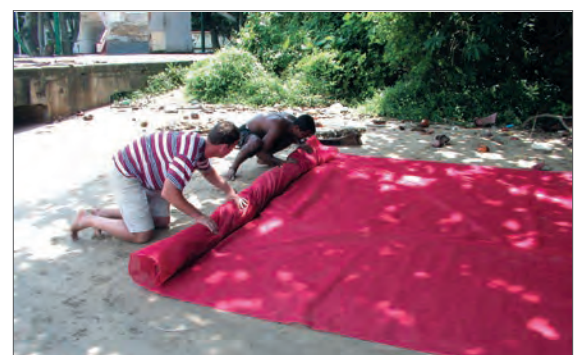
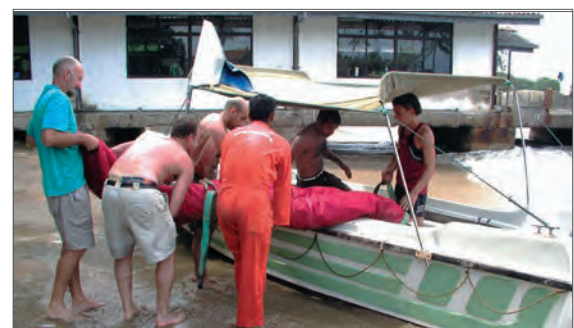
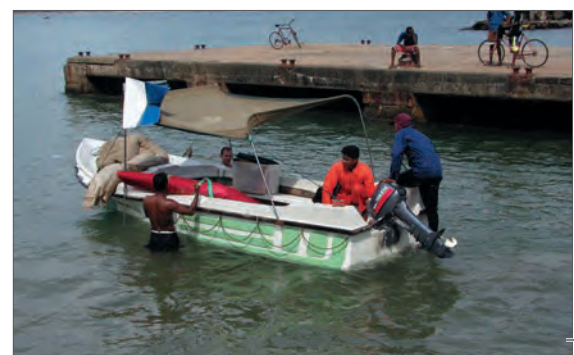
*Figure 10.8 A-E The nets were weighted down with sand bags that are rolled in the nets and closed off with Ty-raps (cable ties)*
