# *Excavation report of the VOC-ship Avondster (1659)*

The  
Anglo-Dutch  
East-Indiaman  
that was wrecked  
twice in Ceylon

# 1 *Avondster: an East-Indiaman in Asia*

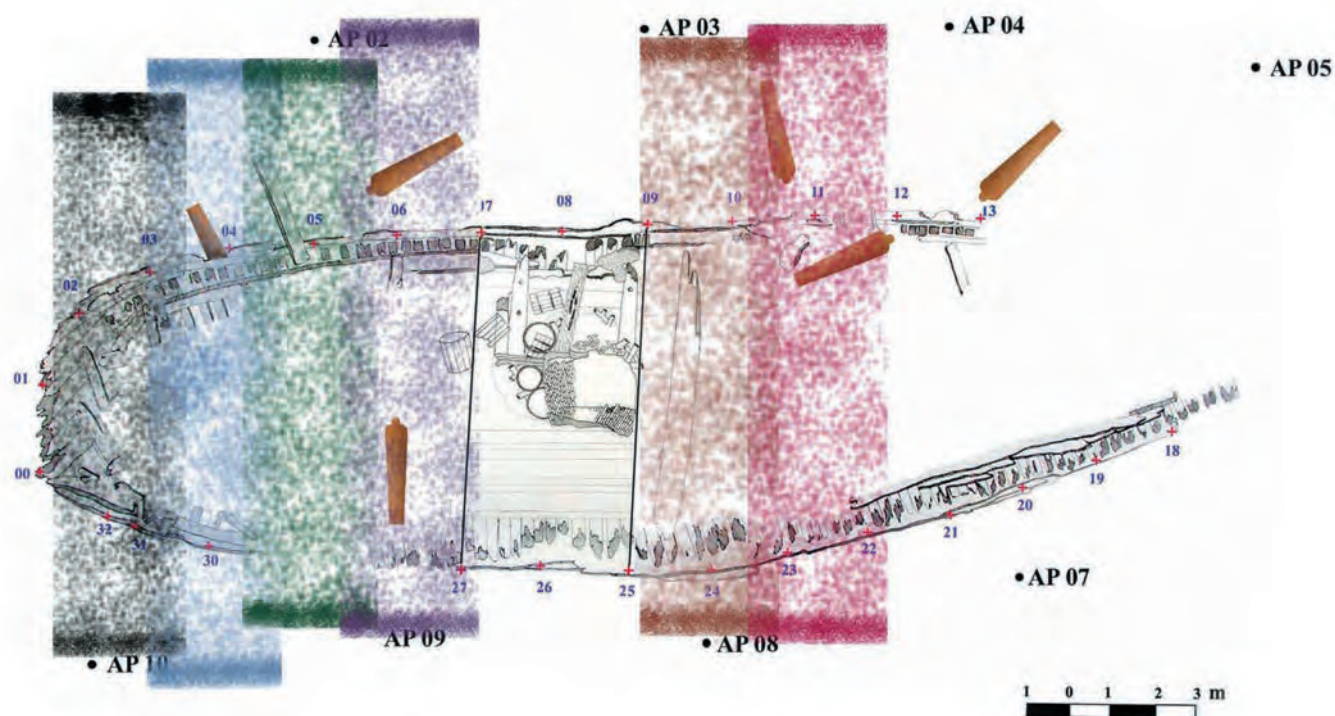
Figure 10.10 The site plan of the Avondster wreck with the projection on how the nets were laid down on the site. Drawing: R. Muthucumarana.

possibly still lying under the sand. The strips of netting were weighed down on both ends with sandbags. We chose sandbags instead of chains because it proved to be very difficult to find suitable iron chains for a low price. Old chains are re-used in Sri Lanka over and over again and are therefore, still valuable. In addition, it is not a good idea to introduce more iron to the site. Iron can increase the growth rate of marine biota thus increasing biological deterioration. The corrosion products can also impregnate organic materials increasing degradation rates *in-situ* and their presence can cause post conservation problems when artefacts are eventually recovered and treated.<sup>10</sup> The sandbags were half filled and rolled in the net. The different strips of net were overlapped and connected to each other with Ty-raps (cable ties), maximum 50 cm apart. Placing the nets on the site was difficult. The nets were prepared on the shore and were very heavy. It took four to six people to carry them to the boat and on each trip only four nets could be transported to the site [Figure 10.9]. In the water, it took two divers to place the nets on the wreck. With the nets still rolled up, they were laid down square in the middle of the wreck site and then rolled out to the portside and to the starboard side. The net projected an extra 4 metres past the port side and 8 metres or more to the starboard side because it was expected that more of the wreck and objects would be found there [Figure 10.10].

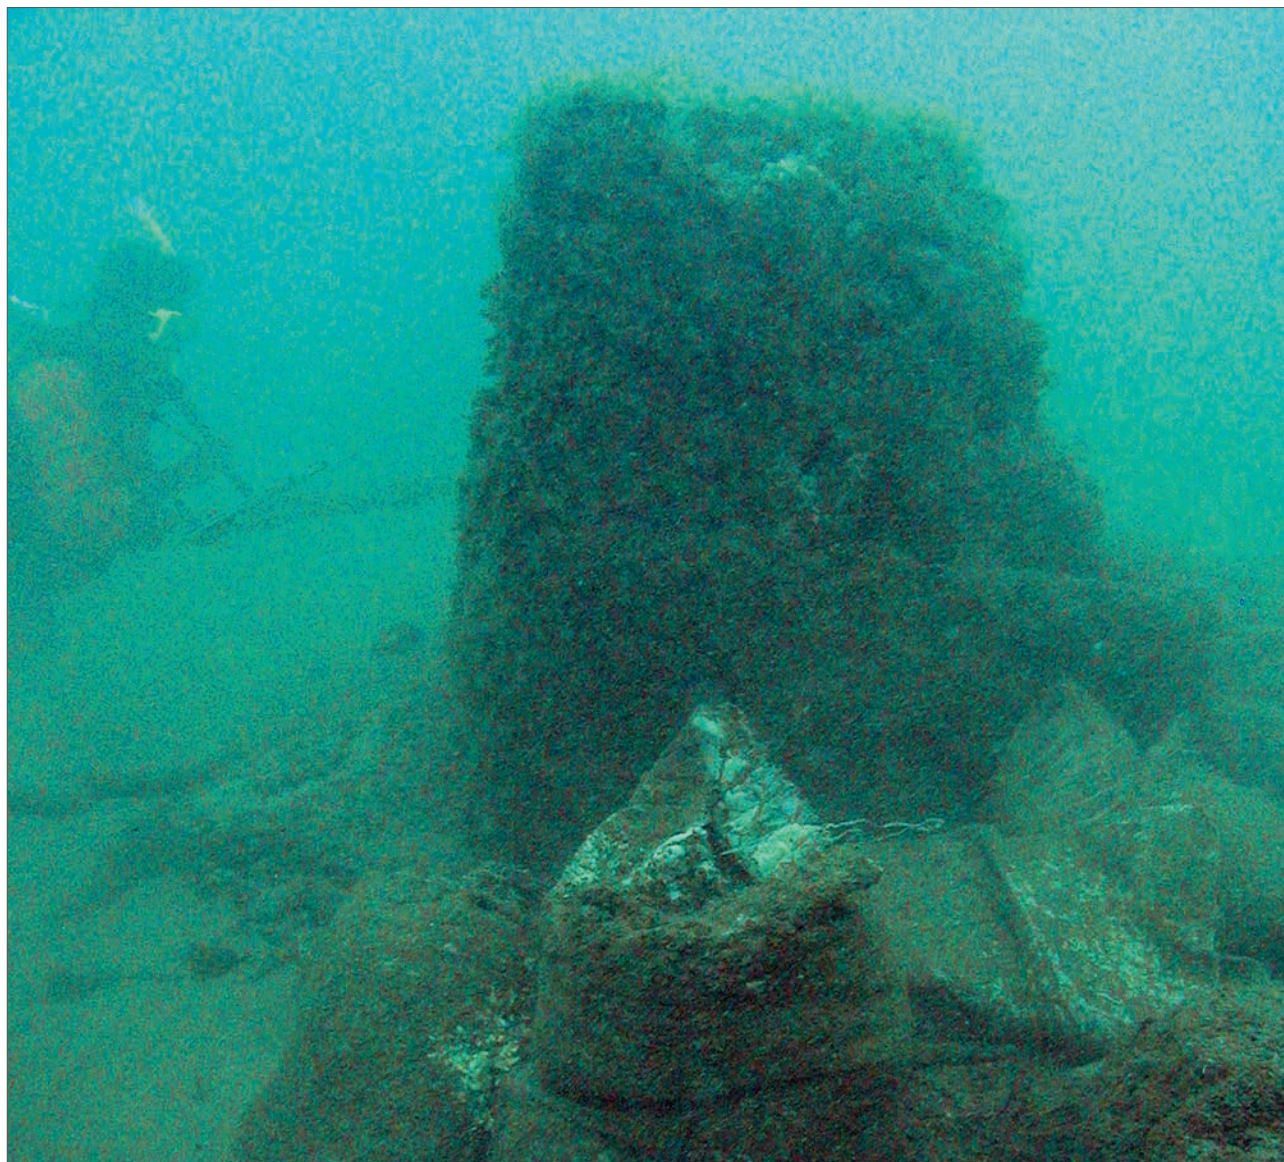
Figure 10.11 The galley is sticking out a few metres from the seabed.

but there is also still a lot left of the ships structure, cargo, inventory and personal belongings that is worth protecting. The galley and the stern section are protruding a few metres above the seabed [Figure 10,11]. It will be impossible to cover them with polypropylene nets at this moment as well. We propose the following: To lay the nets around the galley, while the brick stone structure should be well reinforced with sandbags. Maybe, after the whole site has been buried under a layer of sand, attempts can be made to cover the galley as well. At this time, the height differences are too large. The stern section is laying a few metres away from the rest of the ship's structure. Possibly the best thing to do is to raise the stern section from the seabed, investigate it, conserve it "ex-situ" and exhibit it afterwards in the new maritime museum in Galle fort.<sup>11</sup>

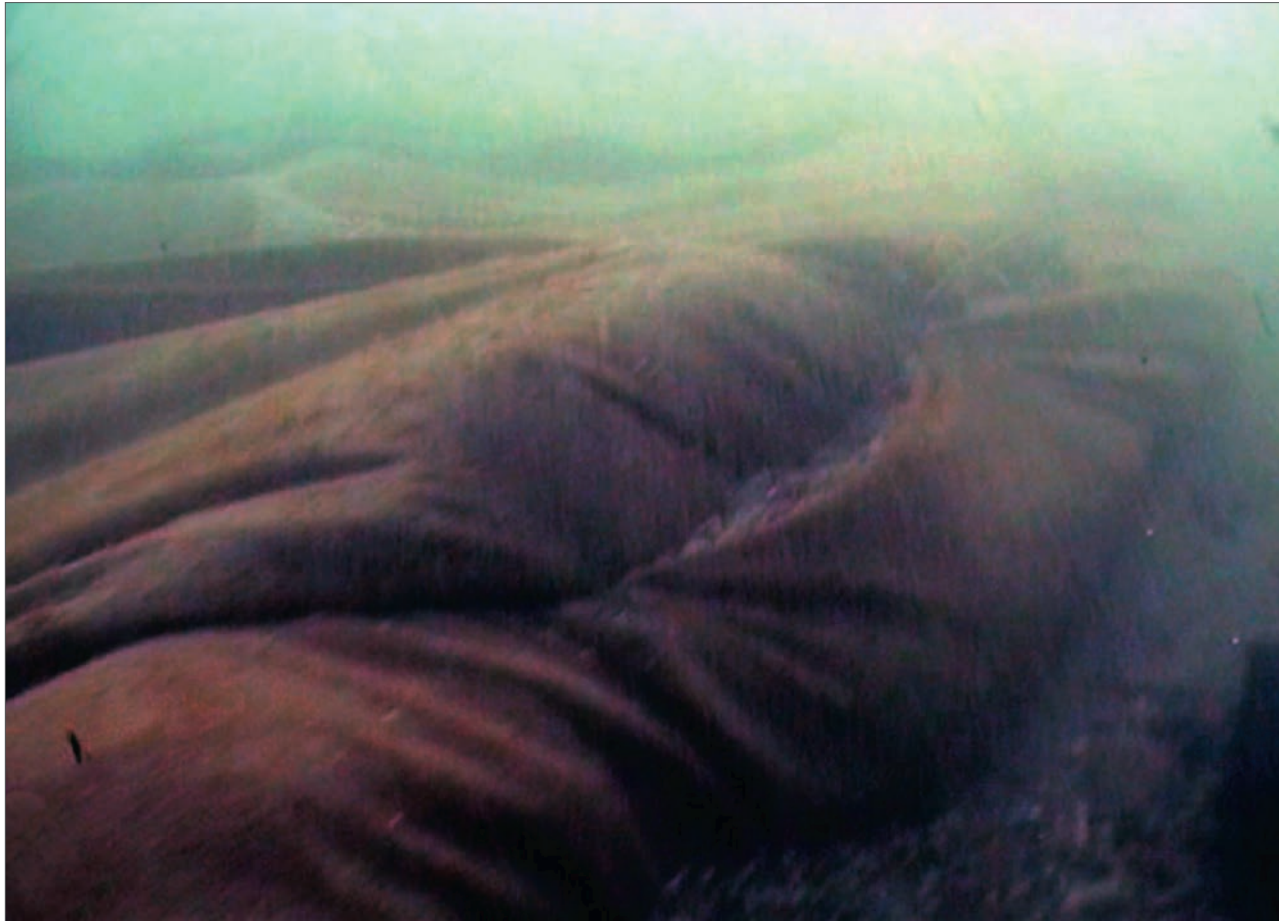
Figure 10.12 The nets and how they are lying on the wreck site now. It is clear that, even after a Tsunami, they are still holding sand on the site. The protection method works extremely well.

To protect the wreck site effectively prior to excavation, the whole structure has to be covered with sand again. With the proper equipment, like water dredges or airlifts, the protection is easy to remove. The wreck can be easily excavated in parts, while the rest of the site is still protected. Also, fishing nets will not get caught on the wreck parts. The favourable conditions under the net will keep the wreck site in good condition, as it was for almost 400 years before erosion of the seabed threatened the site. After the protective measures are in place it is important to monitor the site regularly. At a shallow site like the *Avondster* high swells and bad weather conditions, which are abundant during the monsoon season, pose a potential threat.

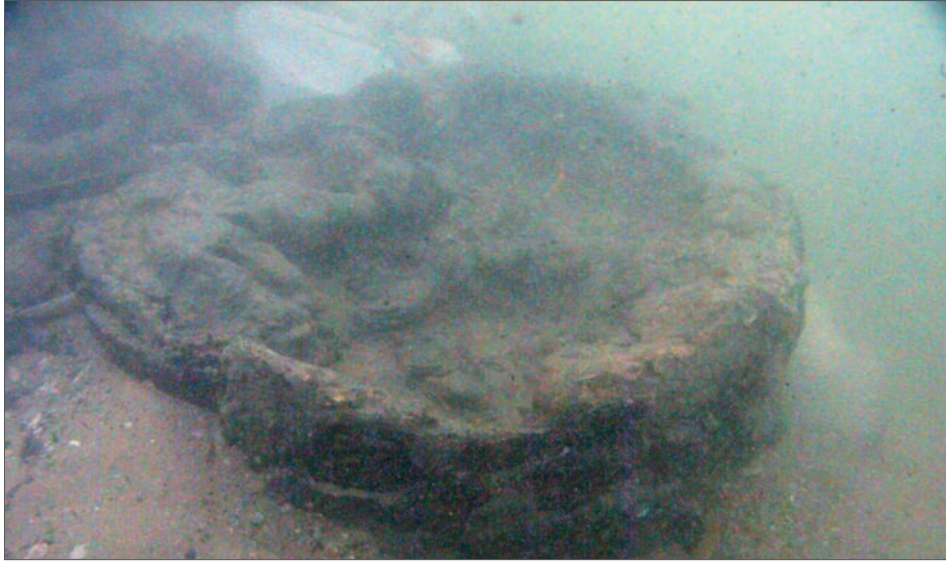
Figure 11.3 The barrel in-situ

During the fieldwork season of March 2003 an intact barrel was uncovered on the wreck of the *Avondster*. The top of the barrel had become exposed above the sediment line and wood previously covered was now unprotected (Figure 11.3). After consultation between archaeologists and conservators a decision was taken to raise the barrel.

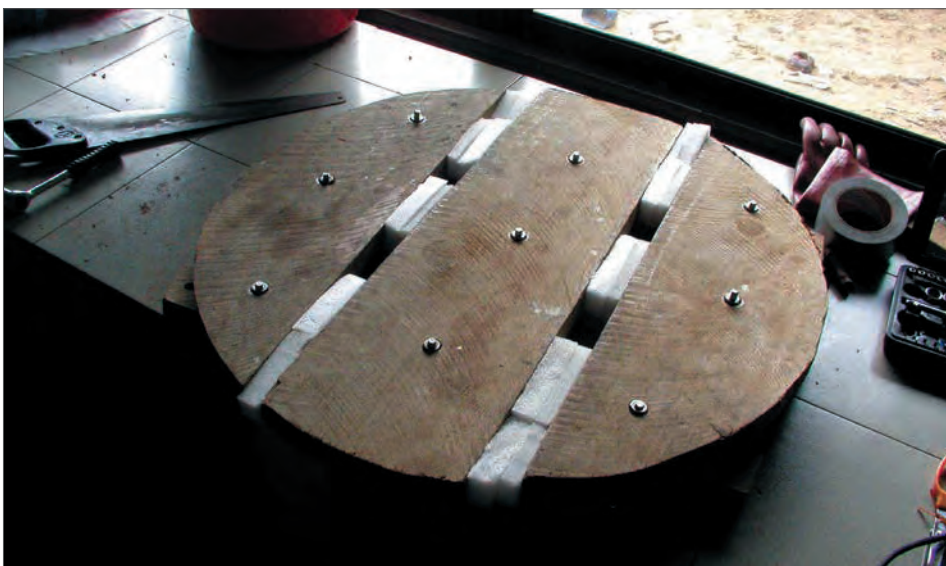
Figure 11.4 Disc support for the barrel

Due to the weight and awkward size of the barrel a number of people were required to lift and handle it. Archaeologists and conservators worked together to design a container suitable for storage, lifting, handling and treatment of this object. A large disc was constructed from timber, timber batons were attached to the underside with stainless steel bolts (Figure 11.4). This disc was designed to support the barrel during treatment and to bear the weight when handled. A lifting system was designed by conservator Kamal de Soysa in which the disc was attached by nylon rope to a weighted pulley system attached to the roof structure (Figure 11.6). Using this system the barrel could be lifted from the storage-treatment tank in a controlled and safe way.

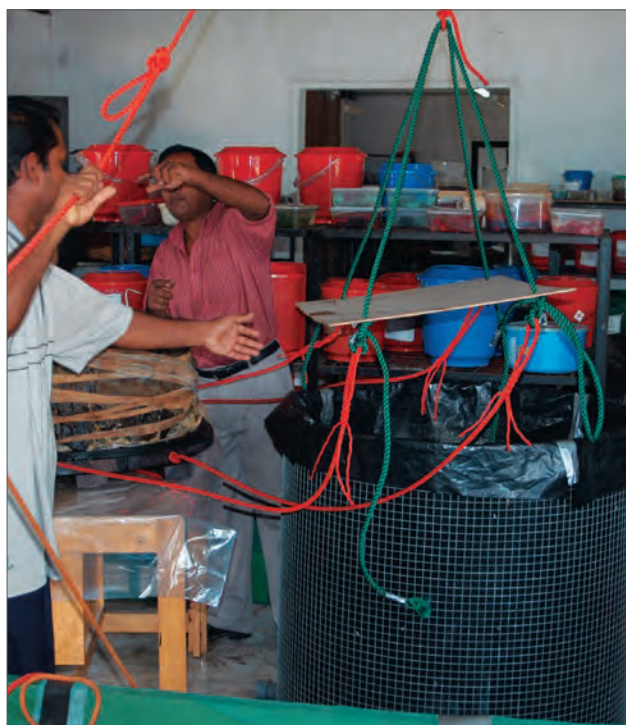
Figure 11.5 Pulley system for handling the barrel

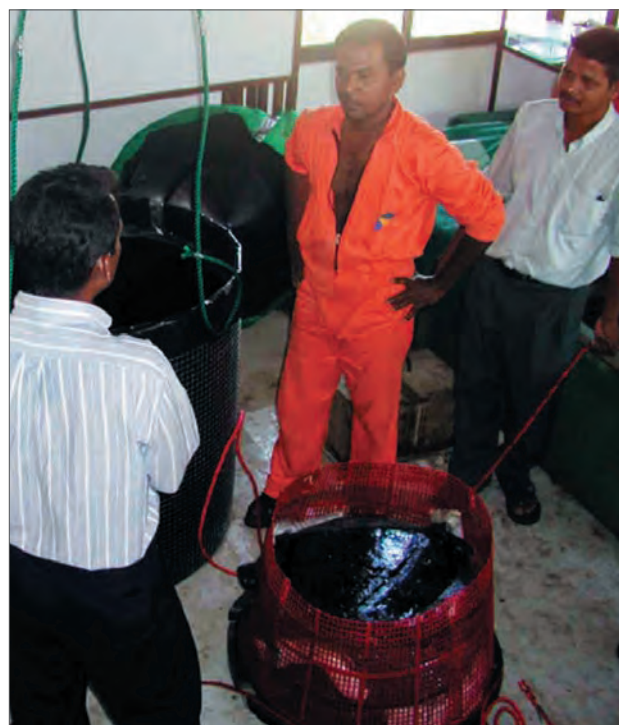
Figure 11.8 The barrel with the support system

As it remained unclear how sound the barrel structure was, precautionary measures were taken to support the staves of the barrel by constructing a light frame around it. *In-situ* the barrel was supported by the sediment. To provide support out of the sediment, the elastic pharmaceutical bandages used for excavation were removed and reapplied to provide even coverage and light support to the barrel.

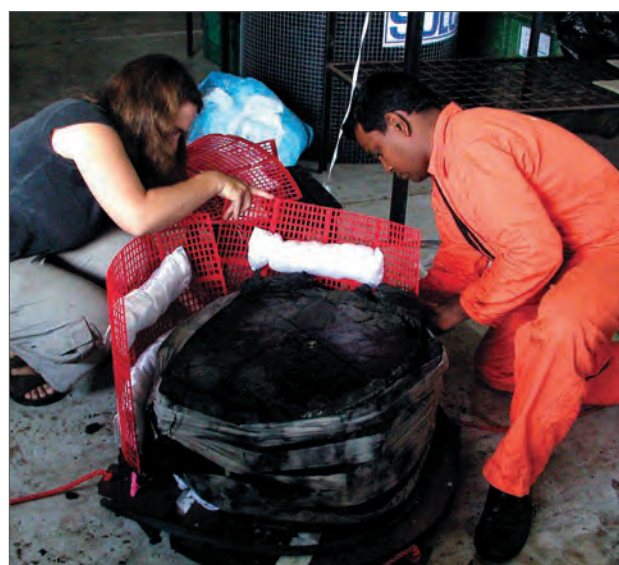
Figure 11.7 Protecting the barrel staves

Plastic mesh sheeting (a plastic basket cut into sections) was placed around the barrel to provide additional support. The interior was selectively padded to ensure a good fit and to prevent abrasion of the barrel surface. The mesh sheets could be removed in sections to allow monitoring of the condition and surface cleaning without removing the barrel from the support. Polyester fabric and wadding was used as the padding material as it would not degrade in the aqueous storage & treatment solutions (Figure 11.7).

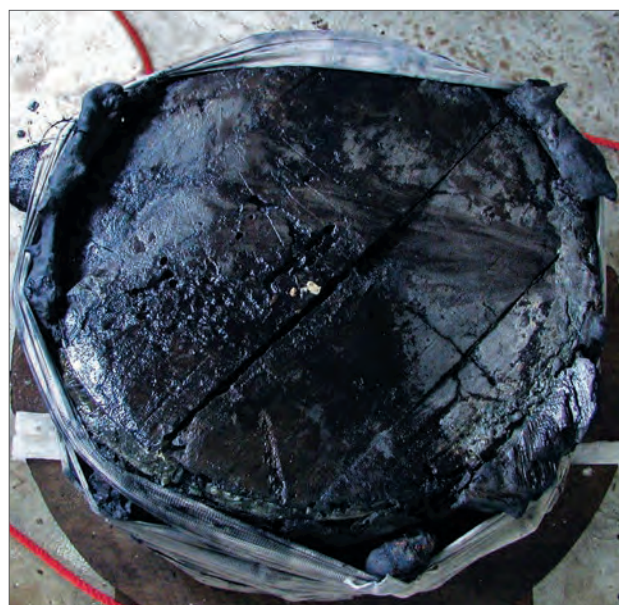
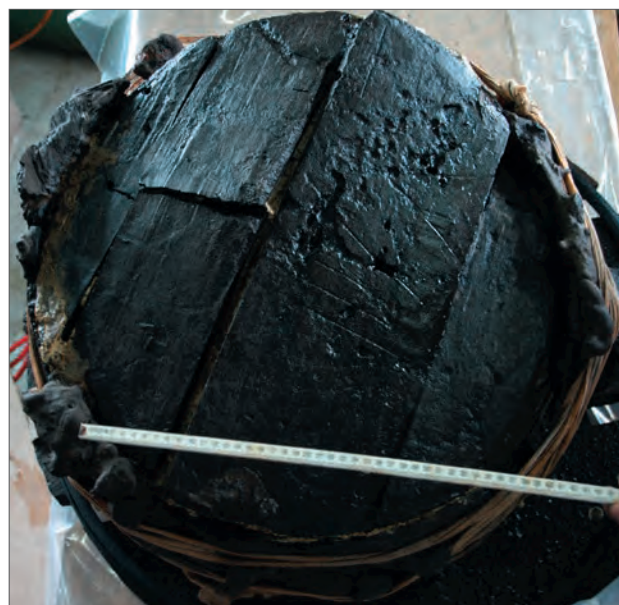
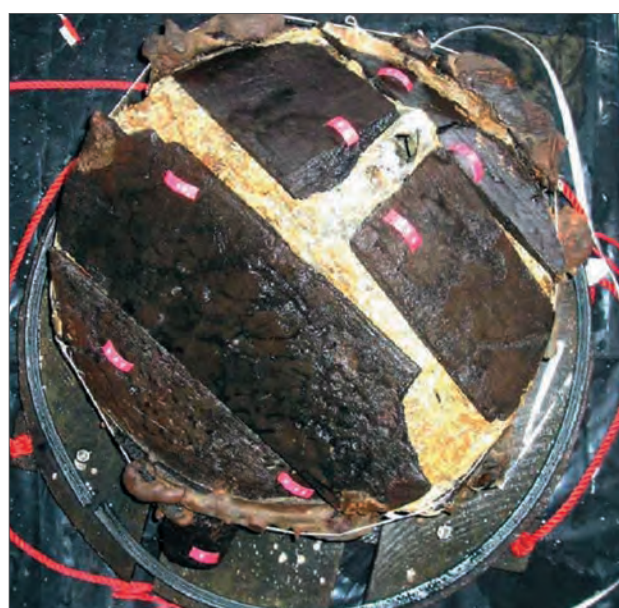
Figure 11. (9 – 10– 11) Time line of deterioration: the base March 2003, March 2004 and November 2004

By November 2003 some structural changes to the barrel had been observed (Figure 11.10). The wood at the base of the barrel appeared to be moving, with the centre moving slightly upwards from its original flat surface. These changes in condition were of serious concern to the MAU conservators and Avondster Project consultants.

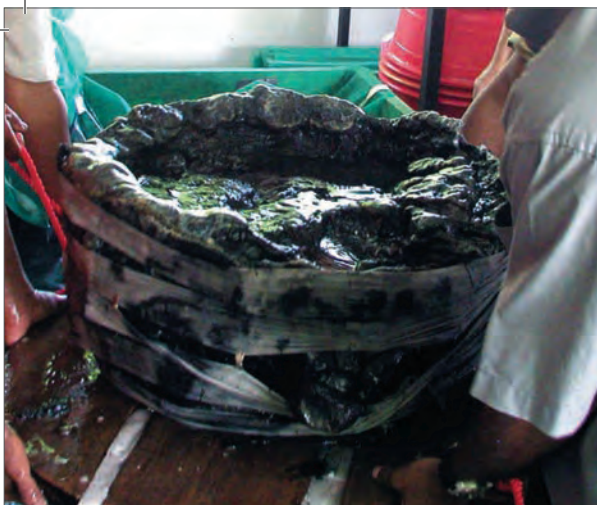
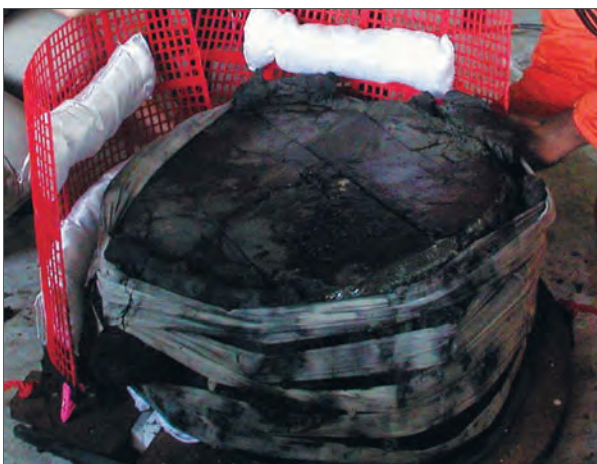
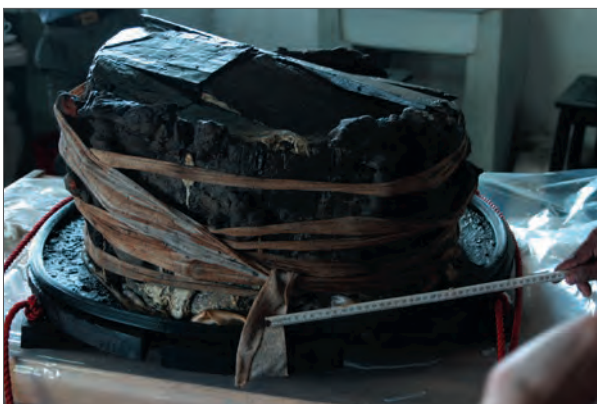
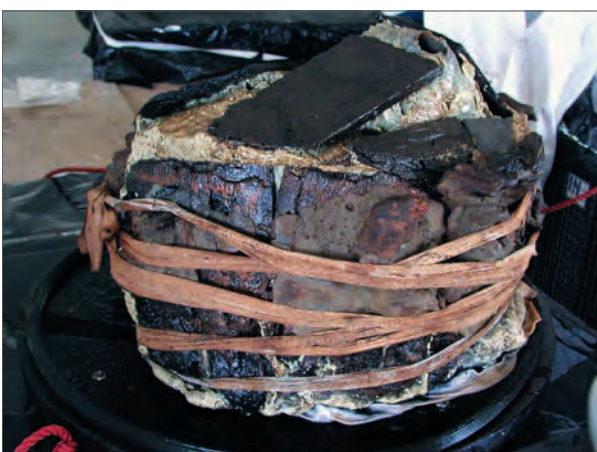
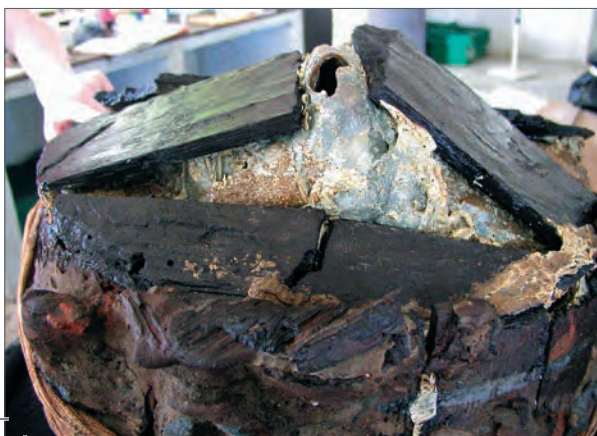
*Figure 11.12 (A – E) Time line of deterioration: the staves March 2003, March 2004 and November 2004; (E) shows the movement of resin caused by an air bubble*

continued flow of the resin had caused such serious structural changes to the barrel that it was no longer considered possible or safe for the barrel to remain as an intact entity (Figure 11.12 A-E). The decision to dismantle the barrel was not taken lightly.

The movement of the resin had deformed the barrel completely, with significant movement of the staves and the base. The corroded and concreted hoops had started to crack, the staves had begun to separate and an increased amount of resin was oozing through. The pieces of the base (on the top due to the previous inversion) had been forced upwards, on an angle, with a large surface of resin newly exposed. A large 'air' bubble formed within the resin had forced resin upwards, causing the lifting and angled movement of the base wood components. By the time the bubble had reached the surface only a thin shell of resin remained, which had subsequently shattered (Figure 11.12 E). The interior of the bubble was irregular, but measured at over. Although the exact cause of the bubble formation is unknown, two theories have been suggested: either air had been trapped inside the barrel before the ship wrecked or the resin underwent deterioration that caused the production of gas.

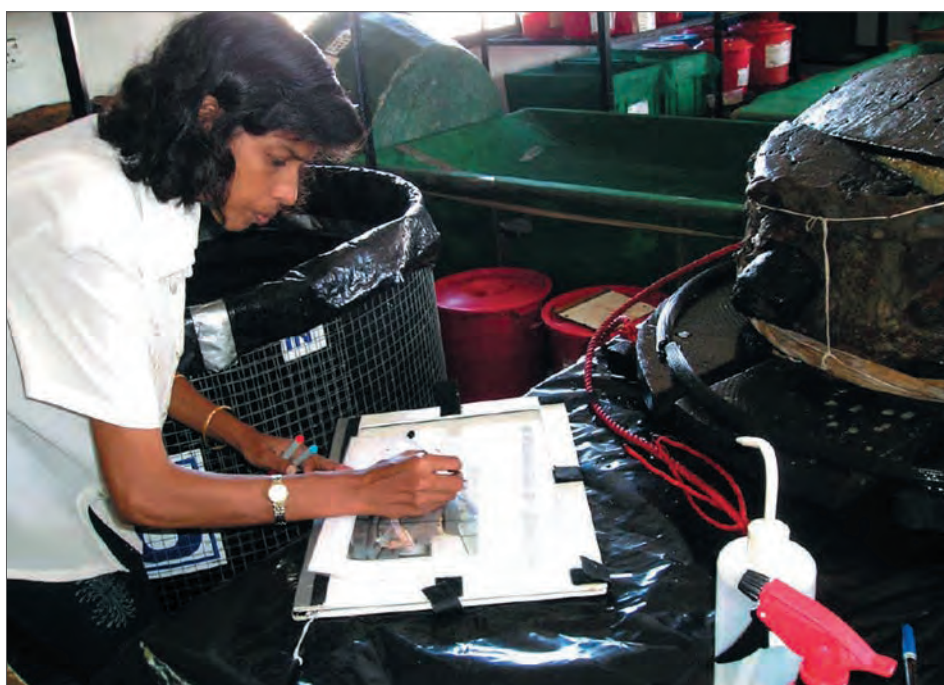
Figure 11.13 The recording process

The level of detail required was very high; recording was carried out in written, photographic, diagrammatic and overlay form. For recording purposes the barrel was divided into seven sections, with written descriptions prepared for each. Digital photographs of the different sections were taken and printed at A4 size and covered with a transparent plastic overlay. MAU conservators recorded details of manufacture as well as of deterioration on these overlays using permanent markers (Figure 11.14 & Figure 11.15).

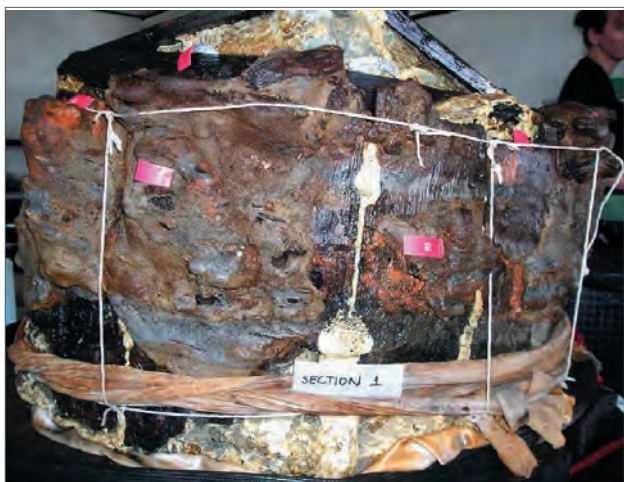
Figure 11.14 An example of the photo-documentation

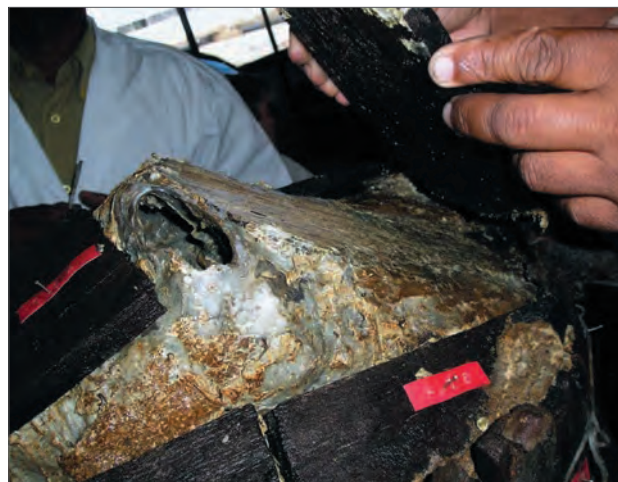
Figure 11.15 Removing the staves

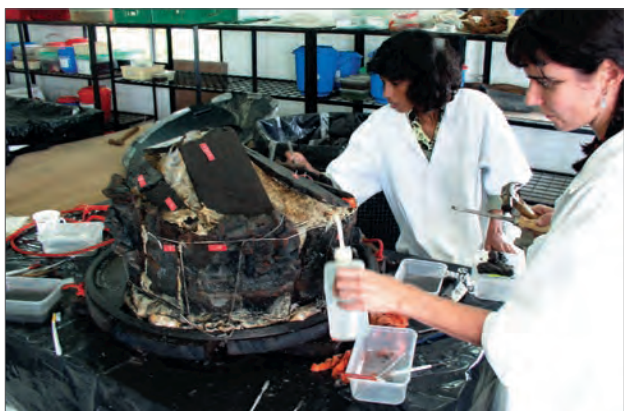
Figure 11.17 Deconcreting the barrel

The wooden staves were not homogeneous – some areas were more degraded (soft like sponge) than others (in some areas the wood was very solid and coherent). The upper part of the barrel was clearly more deteriorated due to its exposure (to aerobic conditions, surge, borer attack, etc.) showing loss, fractures, perforations, teredo galleries, etc. The wood of the base was more solid but the pieces had separated from each other and fractured due to the movement of the resin. The movement of the resin also caused fractures in some of the staves. After the removal of all the concretions the wooden pieces were separated from each other and from the resin (Figure 11.17). The first to be removed was the wood of the base of the barrel,

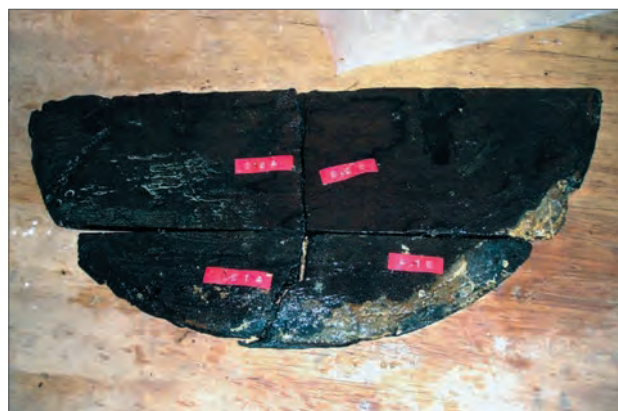
Figure 11.18. A staff after separation from the barrel

which was located on the top of the artefact. In areas this wood had already separated from the resin – a result of the movement. In the adhered sections, the wood was removed by carefully introducing metal spatulas in between the wood and the resin or by chiselling the resin. The same method was used on the staves – using thin spatula blades and chiselling into the resin. In instances where the staves were not be easily separated from each other, they were detached together and a polyurethane foam padding was placed in the back to retain the curve and avoid breakage. After each stave was removed, it was recorded with digital photographs, cleaned (to remove remains of resin), and placed inside a container with tap water (Figure 11.18). The resin was retained and is to be returned to the barrel when reconstructed, and can be included in exhibition. During the whole process the barrel was kept wet by constantly spraying a fine mist of water over the surface.

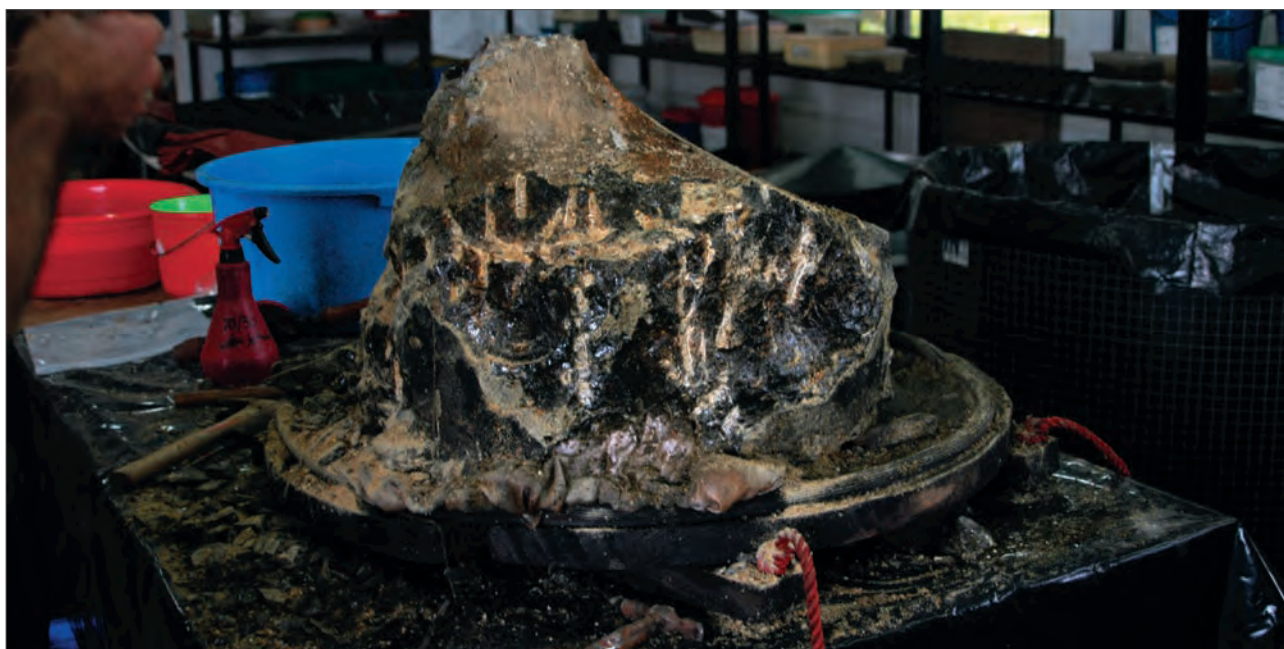
Figure 11.19. The resin of the barrel (December 2004)

A number of days after the dismantling treatment of the barrel was complete the 2004 Tsunami struck Galle Harbour. The components of the barrel were lost – the resin (Figure 11.19) was swept away, as were the concreted iron remains, the majority of the wooden components were also lost, a small number were found in the clean-up operation. It was a number of weeks before it was considered safe for staff to return to the damaged MAU premises and much of the surviving artefact material had dried in that time. The surviving barrel staves had dried and were severely deformed.
